2013 ANNUAL REPORT

TRACKING WORK-RELATED DEATHS IN MICHIGAN

Tracking Work-Related Fatalities in Michigan

June 2, 2015

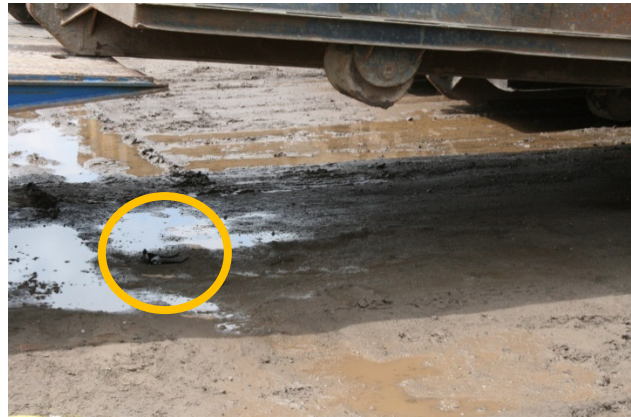
[Case 105](#). Male roll off driver crushed while reaching under raised dump box.

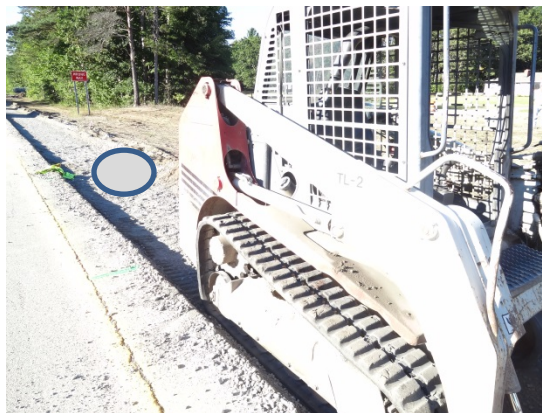
[Case 50](#). Male laborer for an excavation company crushed when a Takeuchi TL 130 skid steer backed over him.

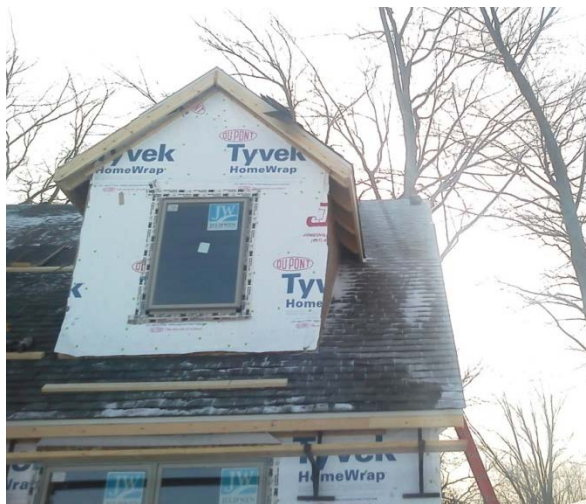
[Case 14](#). Male carpenter/roofer was working alone while installing shingles on a dormer on a 2-story house with a 10/12 roof pitch when he fell 9-15 feet.

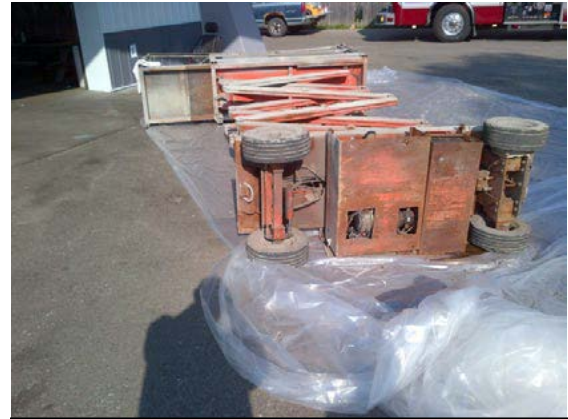
Case 19. Male painter died when the tire of the elevated Skyjack 3220 scissor lift in which he was working entered a depression in a parking lot caused by a recessed storm drain and tipped to its side.

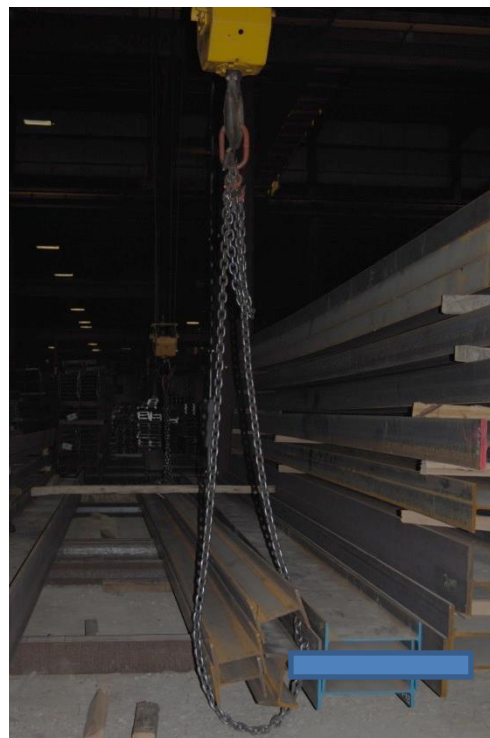
Case 98. Male temporary worker/crane operator crushed when steel beams fell from a stack.

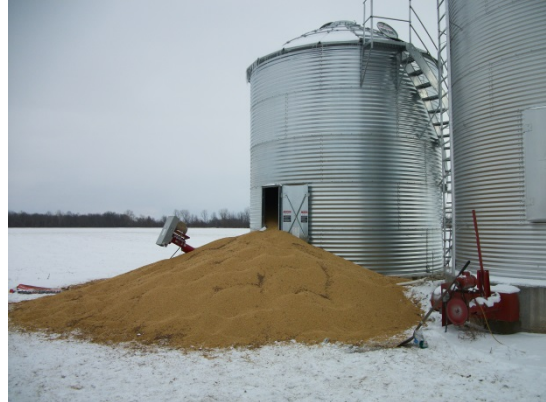
[Case 3.](#) Male farmer was engulfed by soybeans in a silo while attempting to clear a clogged auger.

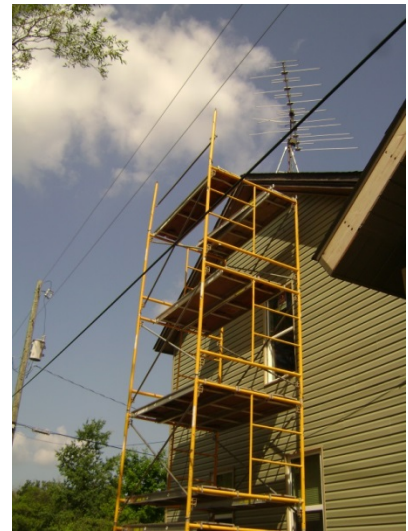
Two individuals died as a result of coming into contact with electrical current. One individual who was a volunteer renovating a house was electrocuted while erecting a scaffold; either he directly contacted an energized 7,200-volt overhead power line or the safety rail he was holding contacted the overhead power line. A tree trimmer was positioned approximately 17 feet above the ground in a tree when his upper back contacted an energized 7,980-volt overhead power line. There had been heavy rain the night before the incident and the morning of the incident.

[Case 7.](#) Male volunteer electrocuted when he contacted an energized 7,200-volt power line while renovating a home.

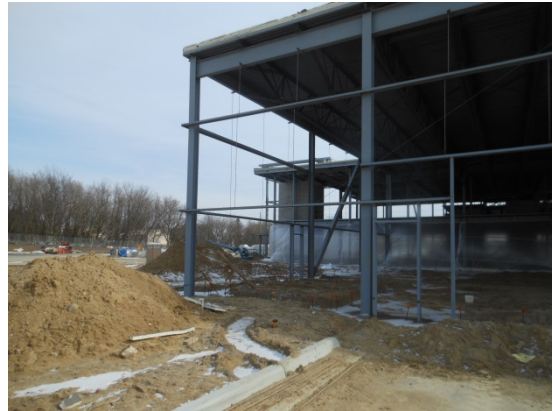
Case 15. Male roofer fell approximately 26 feet when the cantilevered 2" rigid roof insulation he stepped on broke away.

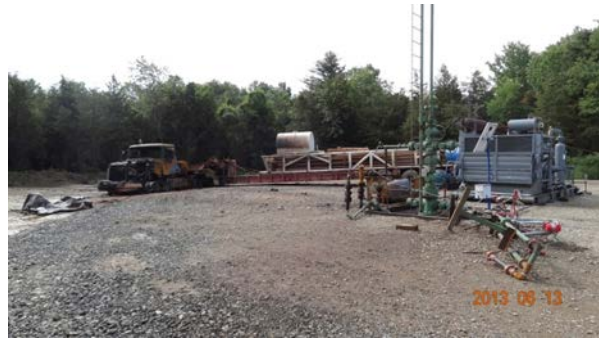
[Case 30](#). Truck driver was burned following an attempt to contain a natural gas leak which occurred when his 53-foot long semi-tractor trailer struck associated piping at a well site.

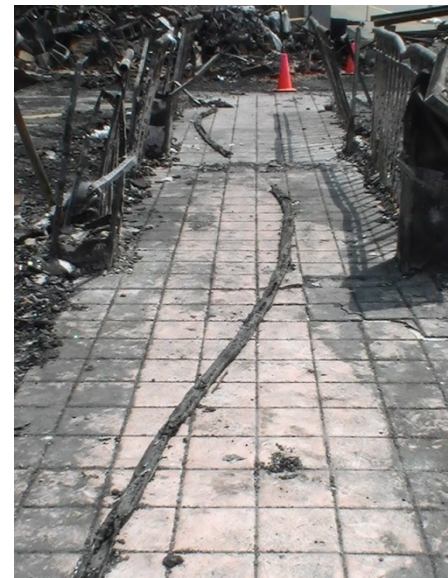
[Case 47](#). Male career probationary fire fighter died while fighting an intentionally-set fire in a commercial building.

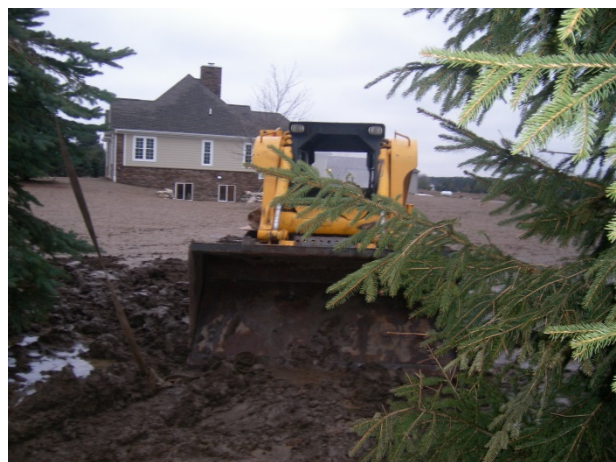
[Case 55](#). Male landscaping business owner crushed between the lift bucket arms connecting the cross member and the front frame of a Gehl Model 7800 skid steer loader.

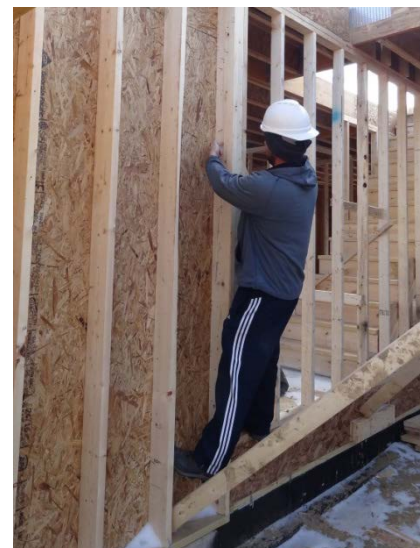
Case 95. Re-enactment of decedent’s position while using Paslode nail gun.

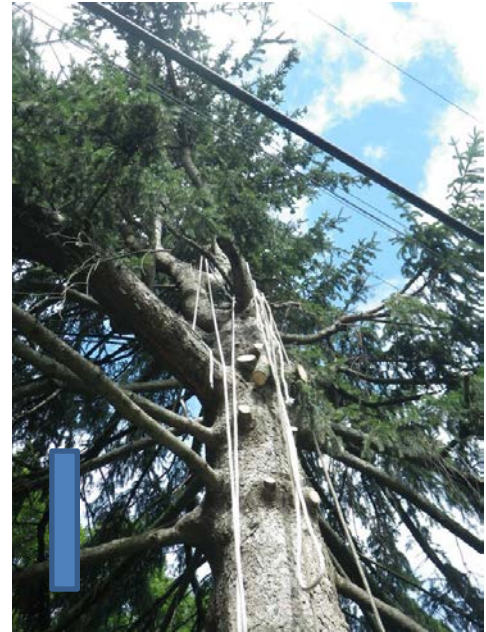
Case 8. Male tree trimmer electrocuted when his back contacted a 7,980-volt energized overhead power line.

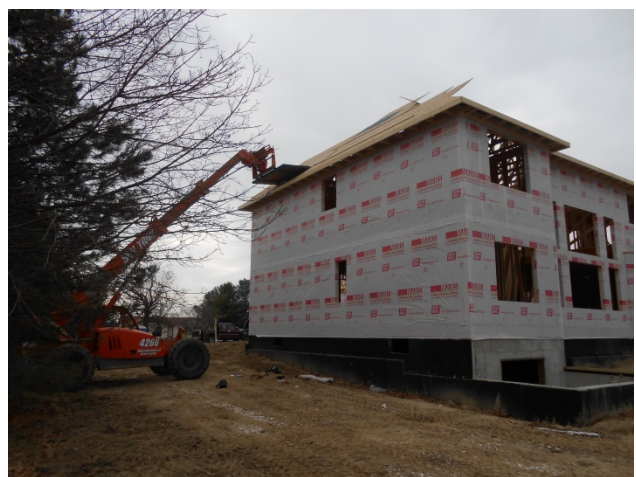
Case 11. A male carpenter in his 30s died when he fell 30 feet from a roof edge to the frozen ground below. The decedent was one of five crewmembers working on a home under construction. The decedent and a coworker were on the east side of the home, decking a 10/12 pitched roof. The OSB decking was icy in spots. The decedent was at the peak of the 2-story roof when he lost his footing. His coworker turned when he heard a scream and saw decedent sliding down the roof trying to catch hold of anything on the roof to stop his fall. The crew had not

Case 11. Male carpenter fell 30 feet from a roof edge to frozen ground.

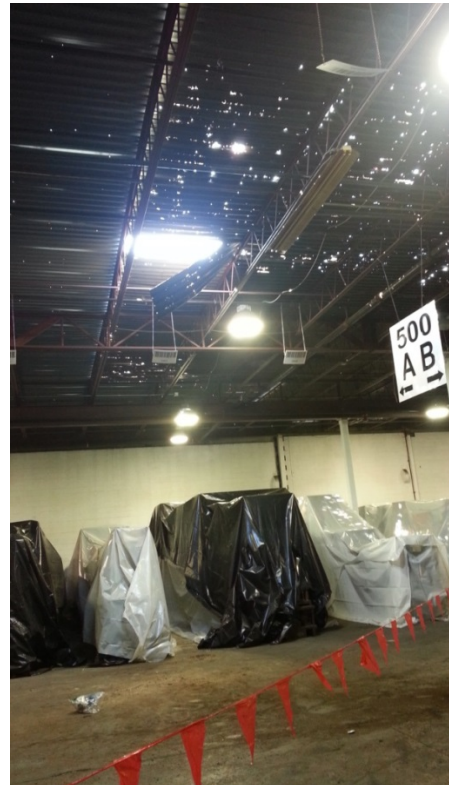
Case 13. A male roofer in his 30s died when he fell through a rusted metal roof deck approximately 22 feet to the concrete floor. The firm was contracted to remove an existing roof on a commercial property and replace the metal decking (where necessary) and then replace the entire roof. The roof had been repaired five years ago. The metal decking was covered with pressed board, insulation and rubber. The firm's safety coordinator, several foremen, and 36 employees were on the roof when the fatality occurred. The section of roof where the decedent was working had been cleared of the rubber and insulation. The metal roof decking showed significant rust and erosion, with holes in the area where the decedent fell and in numerous other areas on the roof. Daylight was observed through the decking before and after the incident. The decedent was wearing a harness without the use of a life line and lanyard attached to an approved anchor point (cobra cart) located 30 feet away. He was in the process of removing the pressed board when he fell approximately 22 feet through the deteriorated metal roof decking to the concrete floor below. There were several means of fall protection available for use on the roof, however employees either did not use the fall protection systems or used them incorrectly. Emergency response was called. He was transported to a local hospital where he was declared dead. (MIFACE Summary [325](#))

Case 13. Male roofer fell through a rusted metal roof deck approximately 22 feet to the concrete floor.

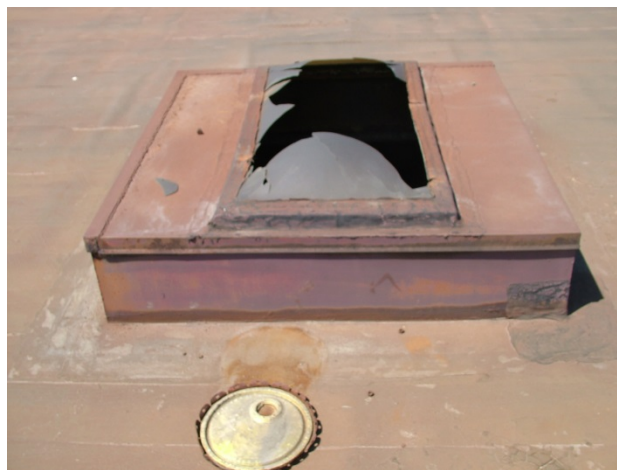
Case 18. A male sheet metal fabricator in his 40s died when he fell approximately 30 feet through an unguarded/unprotected, plastic dome-type skylight to equipment/concrete floor. The skylight involved in the incident had a plastic convex dome that measured approximately 22 inches wide by 45 inches long. The dome was positioned on top of a 55-inch square, 10-12-inch high metal curb. Ten feet east of the skylight was a ladder/catwalk roof access attached to a ground level dust collector. The decedent used this access point to climb to the roof. The roof surface was dry, and covered with a thin layer of debris consistent with buildup from years of weather. Company A had awarded an industrial dust collector system relocation project to the

Case 18. Sheet metal fabricator fell approximately 30 feet through unprotected skylight.

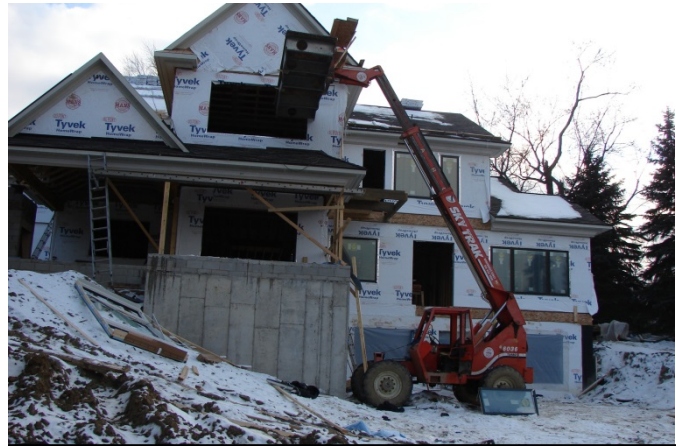
Case 20. A male construction laborer in his 40s died when he fell approximately 28 feet from a shop-built 4-foot deep by 16-foot long scaffold platform affixed to the forks of an extendable boom, rough terrain Skytrak 6036 forklift. The scaffold platform was affixed to the Skytrak forks via “C” clamps. The scaffold did not have guard rails. The decedent was a member of a three-person work crew engaged in setting windows in a residential home. The decedent and a coworker loaded a 56-inch by 106-inch window on the platform, standing it up and leaning it against the carriage of the forks. One coworker was inside the home on the second floor awaiting the delivery of the window. The forklift operator lifted the decedent and the window up to the second level. The forklift operator could not see the decedent’s movement because the film on the window blocked his view. The forklift operator was getting ready to ask the decedent if it was alright to lower him to the second floor window when there was a 25 mph gust of wind. The wind picked up the window like a sail and knocked it over. The decedent was holding onto the window, and both the window and the decedent fell to the ground. Emergency response was called and CPR was performed. The decedent was transported to a local hospital where died. (MIFACE Summary [327](#))

Case 20. Construction laborer fell approximately 28 feet from shop-built platform.

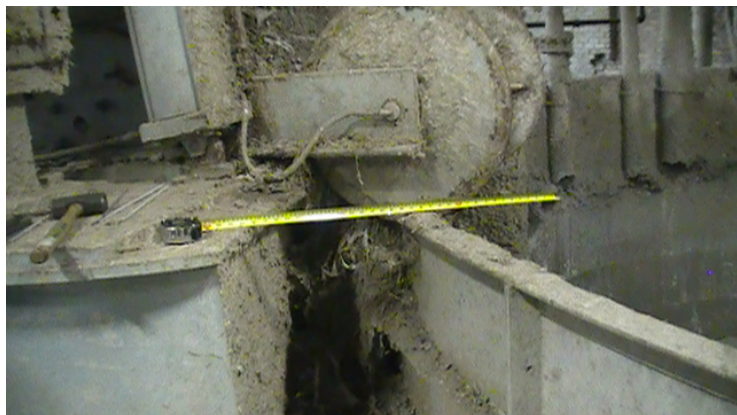
approximately 5 feet across, powered by a 500 HP electric motor at 900 rpm and a spinning rotor blade at the bottom which shredded recycled paper and mixed it with water to produce paper pulp. The ragger unit was a coarse cleaning unit, removing all lightweight trash from the spinning waste paper. The ragger material resembled a large woven synthetic rope line and had an arm that held the spool. The arm of the ragger was stationary and was designed to hold the ragger line in the pulper tank so that it could effectively capture the debris in the tank. To access the ragger spool, the decedent used a wood 4-step step ladder. He used the step ladder as a straight ladder and placed it in the corner where the ragger unit frame and the pulper

Case 21. Male maintenance worker fell into paper pulper.

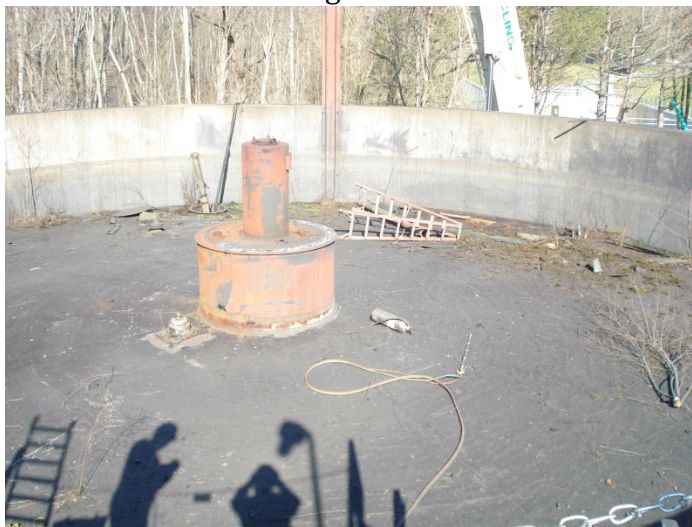
Case 28. A male plumber/pipefitter in his 40s died when methane gas emitted from an active sewage digester tank was ignited by another contractor's cutting torch while conducting demolition work in a digester tank. The incident occurred at the secondary digester tank that was in the process of being demolished. The 60-foot diameter cylindrical tank had exterior walls measuring 18.5 feet from the ground to the top of the wall. The 450,000 gallon secondary digester had a floating lid made mostly of steel, but had a wood "lid" which permitted gases to escape. This lid was engineered to move up and down according to the level of wastewater in the tank and was used to hold in the methane gas as well as other harmful gases. The lid weighed approximately 100,000 pounds and rode on steel vertical rails attached to the interior of the tank walls. In the center of the lid was a hub located 30 feet from the interior walls. The secondary digester had approximately 150,000-200,000 gallons of wastewater in it at the time of the incident. The decedent and an employee from another demolition firm (Employee #2) were in the process of demolishing the tank, which had an active sewage flow. The lid had two open manholes and other cracks from demolition which allowed gases to escape while hot work was being performed. The decedent had used a cutting lance to remove the floating lid. The guiderails were rigged (hooked) to a 50 ton crane for removal while being torched to cut them free of the digester tank's walls. Employee #2 was cutting the bolts using a torch on the center hub. The decedent was walking on the surface of the tank next to the exit ladder while sparks and slag was sprayed onto the digesters lid. Employee #2's cutting torch ignited the methane gas that had accumulated under the lid and was escaping from cracks and open man holes. The resulting explosion propelled the lid approximately eight to ten feet into the air. The decedent was thrown out of the digester and landed outside of the tank, while Employee #2 was propelled up but stayed inside the digester when the lid dropped back into the digester. Emergency response transported both workers to the hospital, where the decedent died of his injuries approximately one hour after the incident. (MIFACE Summary [336](#))

Case 28. Male plumber/pipefitter died in methane explosion during sewage digester tank demolition.

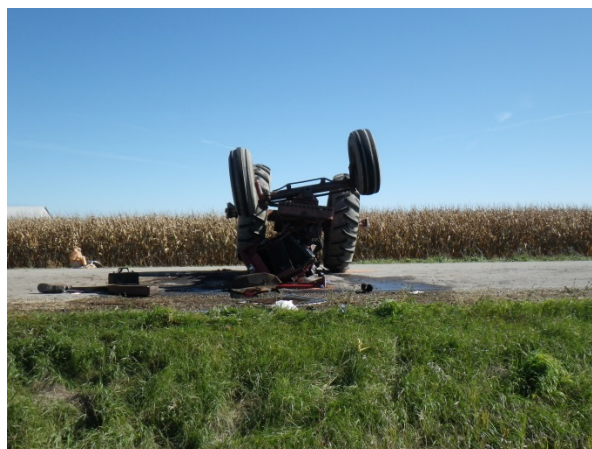
Case 49. A male farmer in his 40s died when he lost control of the tractor with an attached small grain wagon he was driving, causing the tractor to roll to its side and pin him. The dry, 2-lane rural road was a flat blacktop with no curves or hills. The International Harvester Farmall 856D tractor he was driving in 4th gear had badly worn Alliance 6-ply rear tires with approximately one inch of tread. The front tires were Farm King, 12-ply. The front

Case 49. Farmer pinned in tractor overturn on public roadway.

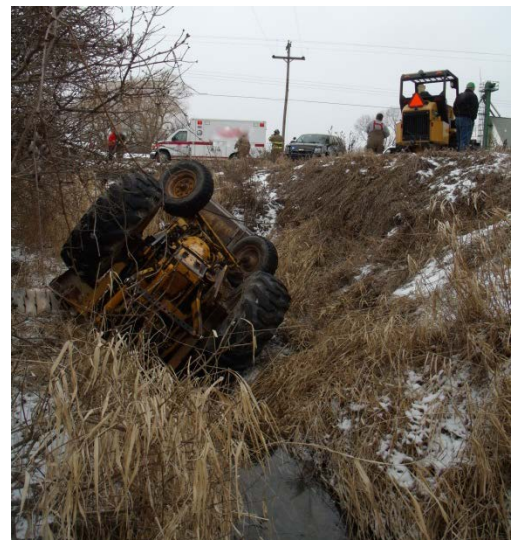
Case 51. A male fertilizer mixing facility assistant manager in his 30s died when his 1972 Case 580B Construction King tractor with a front end loader overturned after sliding down the walls of a drainage ditch. The tractor was not equipped with a roll over protection structure (ROPS) and seat belt. The decedent had unsuccessfully attempted to remove a 12-foot section of the rail of a railroad on the south side of the facility with the tractor bucket. The facility's General Manager determined that another method should be used to remove the rail. The decedent was in the process of backing the tractor away so he could move it to another area. The tractor length, including the bucket was approximately 15 feet. The decedent backed the tractor approximately 20 feet. The ground was snow covered. The back wheels of the tractor slipped into an approximate 9-foot-deep ravine with an unmarked edge. As the tractor was sliding down the ditch, he attempted to drive the tractor forward, but the tractor continued to slide into the ravine. When the front wheels of the tractor reached the edge of the ravine, the tractor

Case 51. Male fertilizer facility assistant pinned under overturned tractor in ditch.

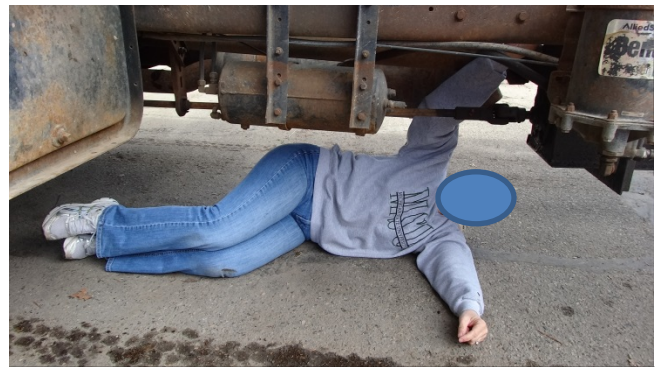
Case 56. A male owner of a trucking company in his 30s died when his clothing wrapped around the driveshaft that lifted the bed of the Ford LTL900 dump truck he had driven to the incident site. The decedent was having a problem with the power take off unit that operated the hydraulic system controlling the movement of the dump bed. The decedent crawled under the truck while the engine was running in what appeared to be an attempt to engage the driveshaft unit. Another contractor arrived at the site and found the truck stalled, and the decedent entangled in the driveshaft.

Case 56. Re-enactment of decedent's position under truck attempting to fix dump box PTO.

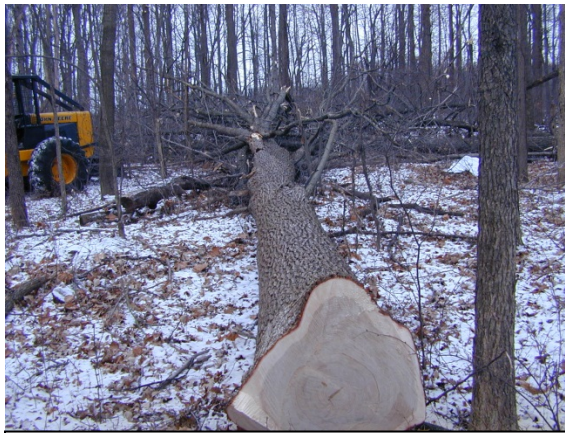
Case 89. A male logger in his 40s died when the tree he had felled struck his head. The decedent and his son had a contract to fell and harvest trees from a piece of private property. The police report indicated that the tree was almost all the way down, but was hung up in another tree. The decedent told his son to finish dragging the other finished fallen tree out to the wood pile and told his son that the "tree needs to finish falling". His son pulled the tree out of the area using a tractor. He could see his father trimming small branches from this tree. When the son arrived at the wood pile and unhooked the tree, he could not hear the chain saw. Running back to the area, he found his father under a large branch. His father was unresponsive as he pulled him from under the branch.

Case 89. Male logger struck by falling tree.

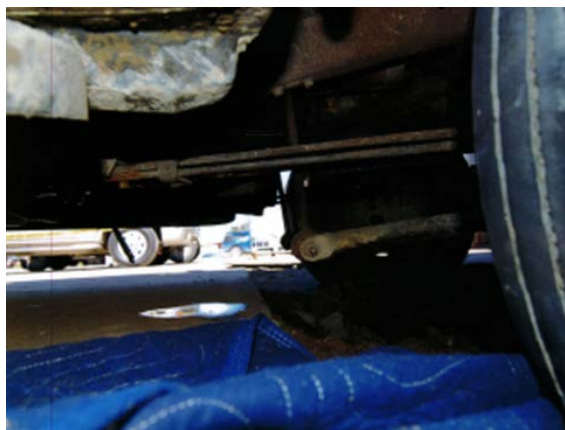
Case 91. A male truck mechanic in his 40s died when a pickup truck fell on him. The decedent was in the process of checking the truck for an oil leak. The truck had been driven up a slight incline and parked with the front wheels on a cement apron surrounding a building. The front wheels were positioned several inches east of a 5-inch deep trench and the back wheels on dirt in a concave-shaped 3-inch trench. There was a consistent elevation decline from the building to the west to allow for water drainage. The decedent started the truck, placed it in neutral, and partially depressed the parking brake. No wheel chocks were used to prevent truck movement. At some point while lying on his back working under the truck, the truck moved backward, with the front wheels entering a 5-inch deep dirt trench. The truck's sway bar and link to the rear of the front axle fell on the decedent's chest, pinning him against the cement. A building employee had left approximately one hour earlier and had noted the truck running. When he returned, the truck was still running, so he looked under the truck. Seeing the decedent, he screamed for help. Emergency response was summoned. A jack was used to raise the truck. The decedent was transported to a local hospital and declared dead. (MIFACE Investigation Report #[13MI149](#))

Case 91. Truck mechanic pinned under pickup truck sway bar.

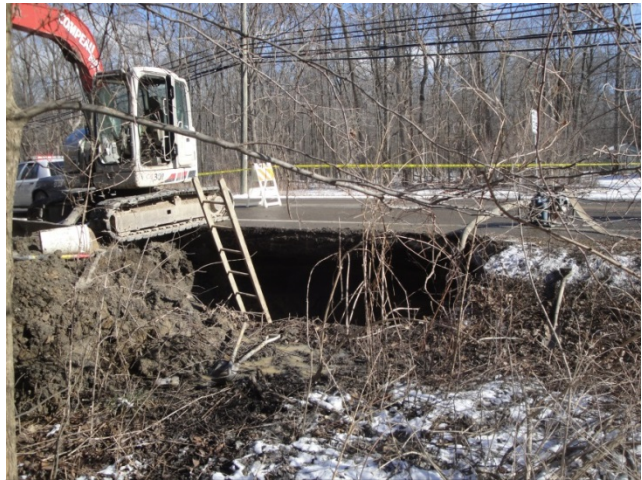
Case 92. A male township public works laborer in his 50s when one of the walls of an excavation collapsed while he was working on a leaking water main. The township contracted an outside excavation contractor to perform the digging of the excavation. The 6-inch water main had been leaking for approximately 18 hours and was located approximately three feet from and parallel to the north/south roadway edge. The water main remained pressurized and continued to leak water because the crew could not locate a gate valve. A pump was used to control the water entering the excavation. The township-designated competent person, who was also the site foreman, directed the excavator operator to dig the excavation. After the incident, MIOSHA measurements of the excavation found it to be 17-feet long by 5-feet wide (at the top) by 8-feet deep and cut parallel to the roadway. The east side of the excavation (4-inches from the roadway edge) was cut vertically to 8.5 feet in height. The west side of the excavation was cut to 7 feet and was sloped to a 78-degree angle because the township's competent person noted the west side wall slough. The base of the excavation was approximately 4 feet wide. The soil type was backfill/clay and was water saturated because of the leak. The decedent and a coworker (Coworker 1) entered the excavation to clean the leaking water main and found that they needed a larger clamp than what was brought to the site. Both workers exited the excavation and, after discussion with the site foreman, it was decided that the foreman would procure the larger clamp. The decedent re-entered the excavation to continue the cleaning of the main. The foreman directed Coworker 1 and another township worker who was onsite to monitor the sides of the excavation. The decedent was facing west when a 13-foot long by 8.5-foot high by 3-foot thick section of the vertical east wall (including soil from under the roadway) collapsed into the excavation. The soil completely covered the decedent. One of the coworkers called for emergency response and the site foreman. Both coworkers entered the excavation to try to locate and dig out the decedent. The coworkers were able to find him and clear the area around his head. The excavator operator excavated soil from the north side of the trench to allow the water to drain to the north in an attempt to limit the rise of water in the trench. The foreman arrived and the three workers were able to uncover his upper body. Emergency workers were on scene. The decedent was removed from the excavation and transported to a local hospital. He died several days after the incident. A trench box was available but was not used at the time of the incident. (MIFACE Summary [323](#))

Case 92. Male public works laborer struck by excavation wall collapse.

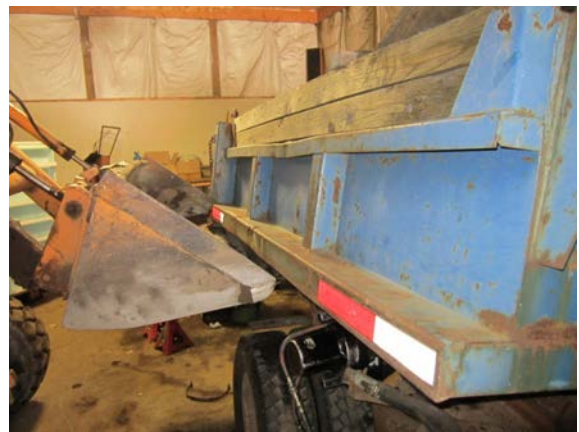
Case 94. A male paver/construction laborer in his 40s died due to compressional asphyxia when the raised truck bed on a 1986 Chevrolet utility dump truck he was working under came down and pinned him between the truck bed and truck chassis. The decedent was in the process of installing a new exhaust system prior to installing a remanufactured engine. It appears at the time of the incident, the decedent was installing a muffler. The decedent finished lunch and started to install the muffler. The decedent's coworker, who was in the lunchroom, arrived approximately two minutes later and found the decedent pinned by the dump box. The coworker did not hear any sounds indicating the dump box fell suddenly. The coworker attempted to call for emergency response, but could not do so because of a weak signal. With no engine in the truck and no power to the hydraulics, the coworker attempted to raise the bed using a skid steer, but was unsuccessful. The coworker ran to a nearby business and asked for help with the 911 call, and then returned to the decedent. The coworker tried using a floor jack and 2x4 boards to raise the dump box, but was unable to do so. The decedent was extricated by rescue personnel and transported to a local hospital where he was declared dead. The employer stated that he always required employees to use wood blocks to support the bed when working under it, but at the time the blocks had either been displaced or removed by the deceased. (MIFACE Summary [341](#))

Case 94. Male paver/construction laborer when the raised 1986 Chevrolet utility dump truck bed he was working under came down and pinned him between the truck bed and truck chassis.

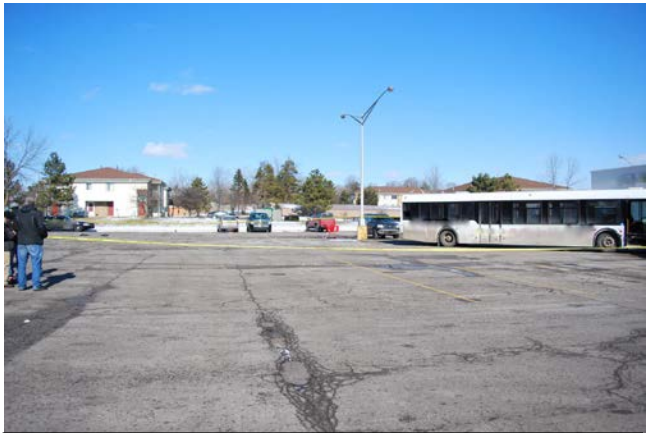
boarded, the bus began to move forward and the front door closed. In an attempt to stop the moving bus, she ran alongside it and tried to place her hands between the front door flaps to push the doors apart so she could re-board the bus. The front wheels of the bus ran over her foot and up her leg, causing her to fall down. A bystander attempted to move her away from the path of the bus, but was unsuccessful. As the bus continued to move forward, the rear wheels ran over her. Witnesses called for emergency response. The bus stopped after colliding with two parked, unoccupied vehicles. The decedent was transported to a local hospital by ambulance and was declared dead at the hospital. (MIFACE Investigation Report #13MI019)

Case 101. Female bus driver struck by her bus as she was attempting to stop it from moving.
