## MIFACE INVESTIGATION #01MI094

# SUBJECT: Bridge Painter Dies When He Falls Out of an Unsecured Rough Terrain Forklift Scaffold Platform

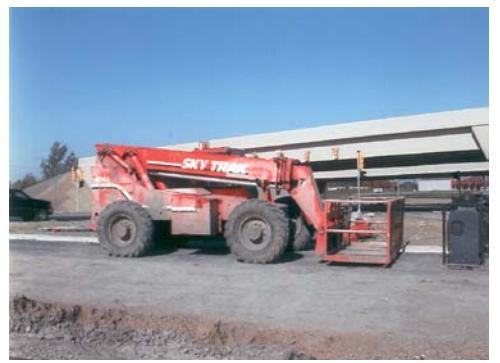
On October 19, 2001, a 31-year old male died from injuries sustained when he fell out of an unsecured telescoping rough terrain forklift scaffold platform (See Figure 1). The victim was painting a bridge as part of a highway construction project. The scaffold platform was raised to approximately 12 feet. The scaffold was not secured to the forks of the forklift; the forklift tines were not in the platform sleeves and the platform was not secured to the back of the forks. The victim was not tied off to the platform. As the victim walked sideways on the work platform, it began to tip to the side, and the victim fell out of

Figure 1. Rough Terrain Forklift

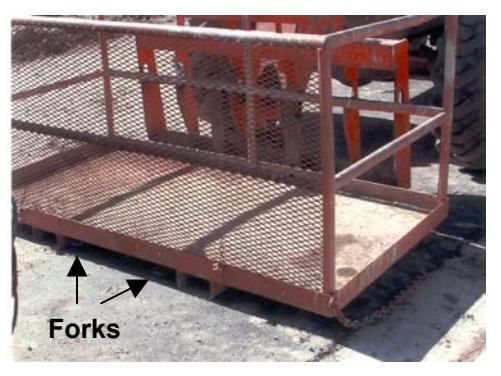
Prior to elevating the victim, the forks were not reset to accommodate the width required by the platform's fork sleeves. The driver placed the forks under the basket so the basket rested on the forks; the forks were located between the fork sleeves on the basket. Figure 2 illustrates the location of the forks. The forklift was moved to another location on the site during the rescue operation. It is unknown if, at the time of the lift, the wire mesh screen faced outward or was adjacent to the back of the forklift.

Figure 2-Location of Forklift Forks

resting on the forks. Operator training would have included the importance of setting fork width to accommodate the task to be performed.

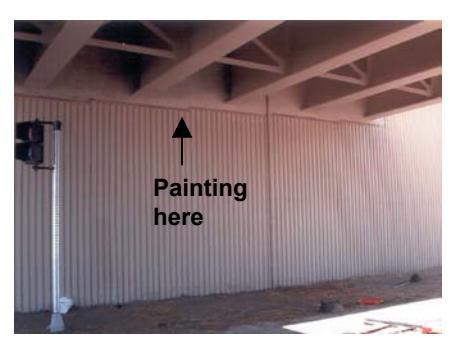
It is unknown the content and extent of operator training the Sky Trak driver received before lifting the victim. The Sky Trak driver elevated the victim approximately 16 feet so he could begin to paint the bridge underside. The victim began painting at one end of the bridge, moving a section at a time. It is unknown if the boom was lowered each time the Sky Trak moved to each new painting position. During the painting of the third area of the bridge's underside, the worker shifted his weight to the side of the platform (See Figure 3). The basket began to tilt to the side and the worker fell out. The victim landed on

Figure 3. Painting location

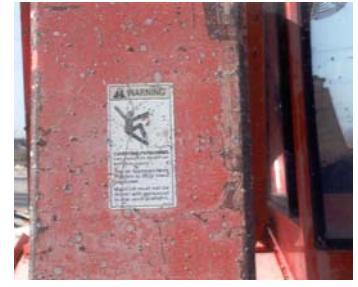
The Sky Track was designed by the manufacturer to elevate personnel scaffold platforms. On the boom was a warning label for carrying personnel. MIOSHA allows for the use of platforms on rough terrain forklifts if the manufacturer designates that the forklift may be used for that purpose.

Figure 4. Sky Track Warning Sign

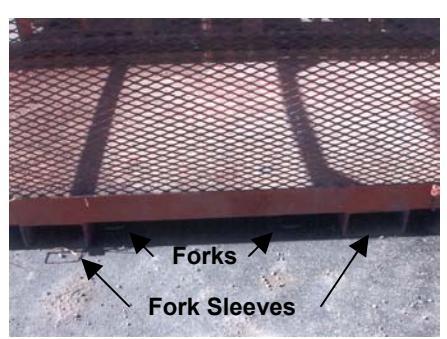
When the lift was made, the scaffold platform used with the rough terrain forklift was only resting on the forks; the forks were placed between the scaffold fork channels (See Figure 5). The Sky Trak was moved to each painting position, thus the platform could also move upon the forks. When the victim moved to the side, the center of gravity shift caused the platform to begin to tilt off of the forks, causing the victim to fall out of the scaffold. If the forks were reset to fit into the fork channels and the platform secured to the forks prior to the lift, the platform would likely not have tipped over. At the time of the incident, it is

Figure 5. Fork/Sleeve Location

unknown if the platform's mesh screen was facing outward (as in the picture) or adjacent to the mast, since the picture was taken after moving the basket off of the victim. The safety chain and pins are on the mesh side of the platform to enable the platform to be secured to the mast. If the platform used by the victim had the mesh screen facing outward, the safety chain could not have been used to secure the platform to the forks. Properly positioning the basket on the forklift forks and securing the scaffold with the safety chain would have likely prevented this fatality. • Prior to each personnel lift, a pre-lift meeting should occur to review appropriate requirements and procedures for safe work operation.

To safely elevate personnel using a rough terrain forklift scaffold, the forks must be placed in the scaffold sleeves, the scaffold secured against the back of the forks with a mechanical device, and the side of the scaffold adjacent to the mast have a solid or mesh guard sufficient to protect the passenger from contact with moving parts of the mast.
