MIFACE INVESTIGATION: #04MI130

SUBJECT: 52-year-old Female Janitor Died as a Result of a Vapor Flashback While Using Flammable Lacquer Thinner to Remove Carpet Glue From Concrete Basement Floor.

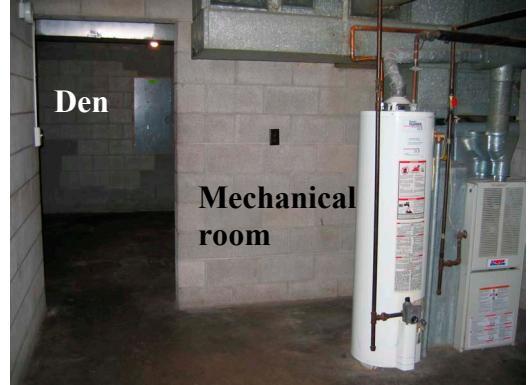
Figure 1. Victim was in "den" area at a different but similarly constructed basement

floor joists above was approximately 7' tall. Both rooms contained a 17" x 11" window that was located approximately 5'9" up from the floor. Both windows were closed while the deceased was working. The basement was divided into two rooms, the mechanical room and the den. The stairway to the basement exited to the mechanical room. The mechanical room was 12' x 12' and contained a natural gas furnace, natural gas hot water heater, plumbing and electrical for a washer and dryer, and a laundry tub. A 3' wide "door" opening allowed passage between the mechanical room and the 12' x 15' den (Figure 1).

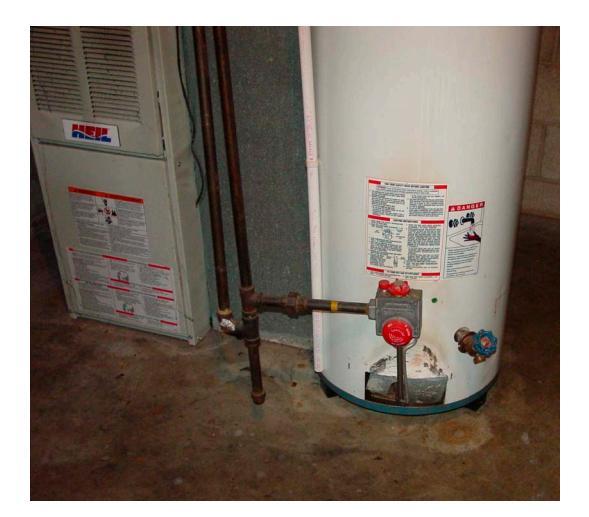
Figure 2. 40-gallon gas hot water heater warning labels near pilot light

Both the gas-fired furnace and the 40-gallon gas hot water heater were lit and operational. The hot water heater pilot light, located less than 4" above the floor was lit because hot water was needed to clean and prepare the townhouse for the next tenants (Figure 2). The hot water heater was located approximately $4 \frac{1}{2}$ away from the door between the two rooms. The hot water heater had affixed warning signs including a sign warning of an explosion/fire hazard associated with a flammable solvent vapor on the side near the top of the unit (Figure 3). The furnace pilot light and burners were located more than 20" from the floor.

The Fire Department suspected that the pilot or the burner for the hot water heater was the source of the flashback because of its location less than 4" from the floor. The furnace pilot and burners were located more than 20" from the floor level, and based on the properties of the vapor for the lacquer thinner, the water heater is suspected due to the location of the pilot. The report indicated that the volume of the vapor generated from the use of the lacquer thinner could not be accurately calculated due to the potential for numerous unknowns. These unknowns included the amount of thinner that was on the floor, the size of the pool of thinner, and the room temperature at the time of the ignition, the duration that the thinner had been sitting on the floor.

• Housing commission units should consider replacing older hot water heaters with heaters that are equipped with flammable vapor ignition resistant (FVIR) components.

commissions should conduct a survey of their units to determine the extent of use of the nonequipped FVIR water heaters and consider replacing them with FVIR units. When purchasing new hot water heaters, housing commissions should ensure that all new gas-fired hot water heaters have incorporated the FVIR technology, since there may still be pre-FVIR units available for sale, most likely for a reduced price compared to FVIR-equipped units.

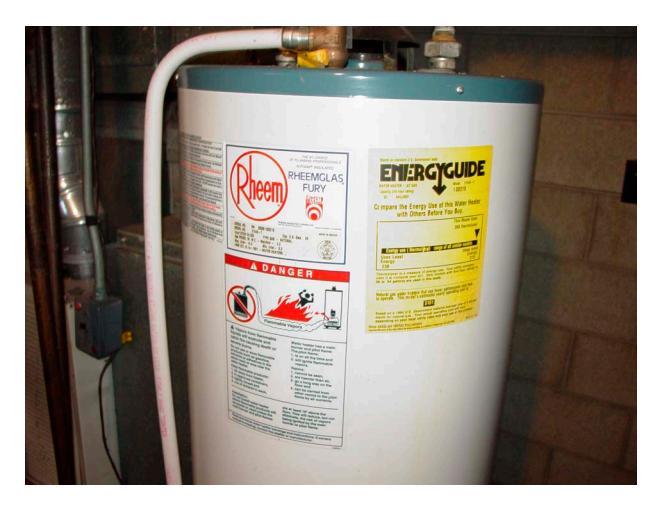
Figure 3. Location of flammable material warning label on side near top of heater

Although the flammable material hazard warning sign was in plain view, its location on the side near the top of this model of hot water heater may not have drawn attention to the dangers posed by using flammable materials in the vicinity because it was not posted near the pilot light. MIFACE recommends that hot water heater manufacturers place the flammable material hazard warning sign near the pilot light in plain view as well as near the top of the unit.

• Gas hot water heater manufacturers should place fire hazard warning labels near the pilot light as well as in another observable location on the unit.

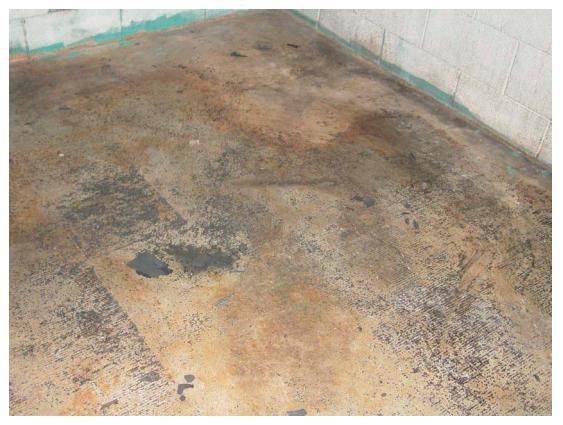
The den floor had remnants of carpet glue that had not been removed when workers had previously removed carpet tiles that had been installed by the previous tenants (Figure 4).

Figure 4. Carpet glue remnants on den concrete floor

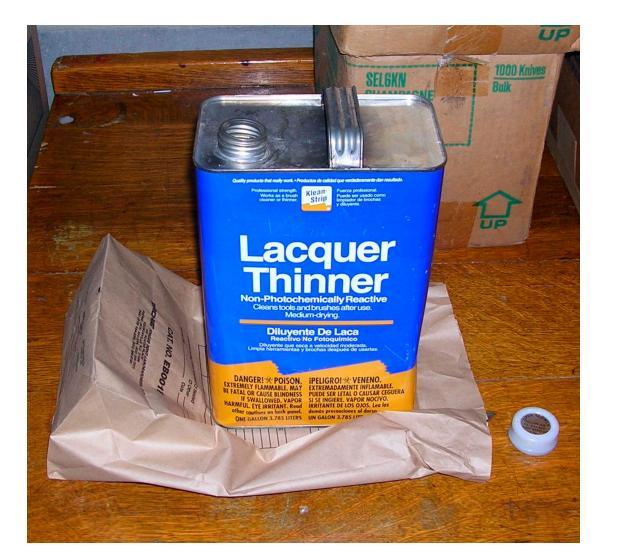
hypothesized that she poured the lacquer thinner (Figure 5) on the floor to soften the glue so she could remove it from the floor. It is unknown what tool she used to remove the glue. A push broom, still smoking from contact with the flames, was found at the scene by firefighters.

Figure 5. Flammable lacquer thinner used by victim to soften glue

• Employers should investigate if substitution of water-based, non-chlorinated cleaning products in place of flammable materials used for cleaning is possible.

Although the flammable lacquer thinner was not formulated for use as a "floor-cleaning agent," the victim used it as a cleaning agent. Many flammable materials, although not formulated for use as a cleaning agent, may be used as such by employees because the flammable material is perceived to be effective. Employers should determine if products, including flammable materials, are being used in a manner not specified by the product manufacturer. Employers should investigate if substitution of water-based, non-chlorinated cleaning products in place of flammable materials used for cleaning purposes is possible.
