MIFACE INVESTIGATION: #05MI123

SUBJECT: Truck Driver Dies When Straw Bales Fall Off Truck and Strike Him.

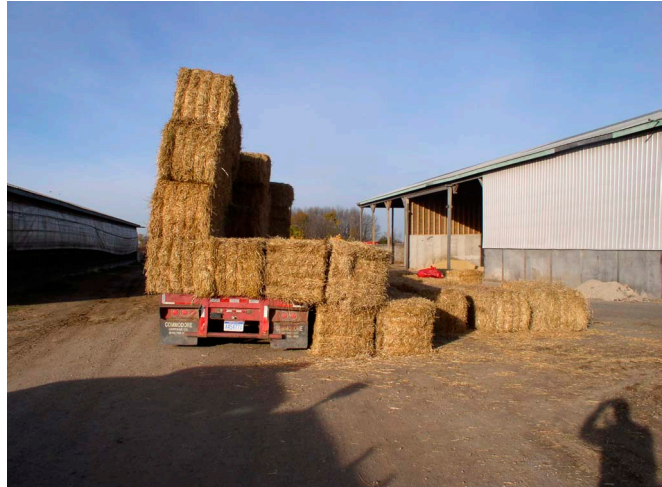
Figure 1. Trailer rear view, bales off trailer

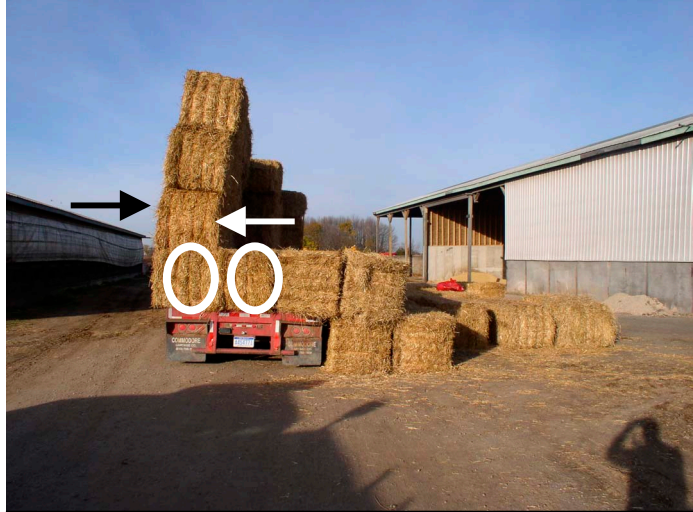
Figure 6. Ovals to demonstrate compression on sides of bale

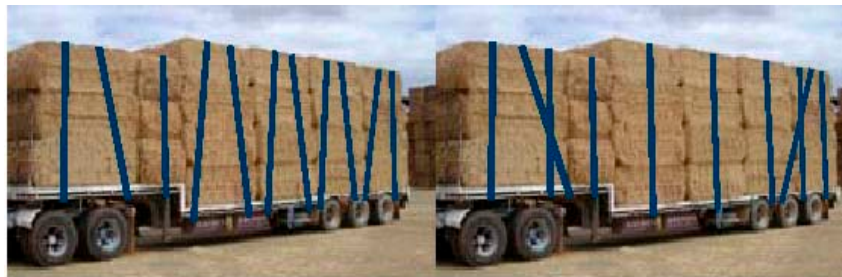
Figure 14 Diagonal bracing recommendations

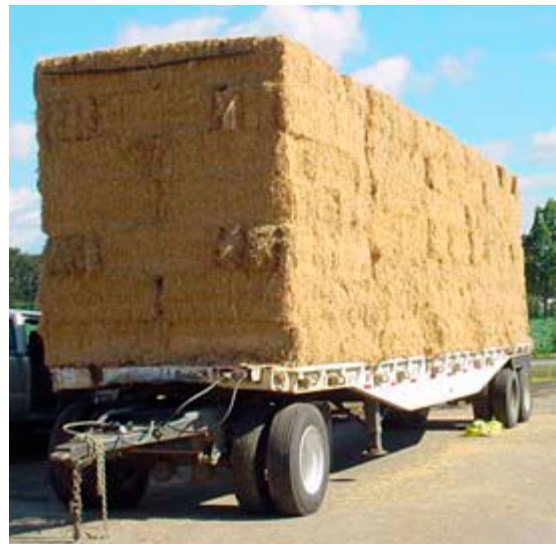
Figure 9. Example of interlocking bales
