## **MIFACE INVESTIGATION #06MI185**

### Subject: Truck Driver Electrocuted When Raised Long-Bed Dump Trailer Contacted 4,800-Volt Overhead Power Line

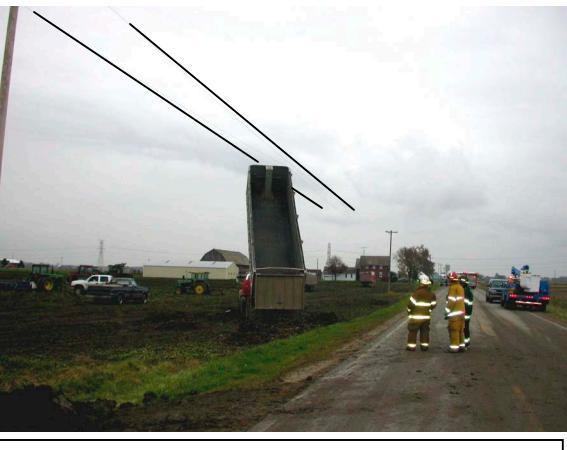
Figure 1. Extended trailer bed touching power lines (lines enhanced for clarity)

The farm owner stated that the decedent knew about the overhead line danger – the farm owner and the decedent discussed the overhead line danger, because this was the only field they would be working in that had overhead power lines. The overhead line support poles were 14 feet away from the road. The poles supported two overhead electrical wires, one of which was energized with 4,800 volts. The other wire was the system neutral.

He drove the truck to his selected location and while in the cab. activated the hydraulics to raise the truck bed. It is unknown if he exited the cab to check on whether he could safely activate the trailer. The event was unwitnessed. Three possible incident scenarios developed were: (a) he was standing/walking by the truck, (b) jumping from or exiting the truck cab, or (c) trying to reenter the cab to halt the rise of the dump body. The farm owner suggested that the decedent exited the cab and walked along the side of the dump trailer as it was rising to

• Farm employers should conduct a field survey prior to fieldwork to determine any hazardous work locations, (such as overhead power lines), determine the work tasks to be performed, and identify safe areas to perform the work away from the hazard.

The employer and the decedent knew that the overhead line was energized. One of the known work procedures was dumping of the tare weight as far away from the plowed field as possible. The field was wet and to minimize entry into the field, the decedent dumped the tar as far away from the plowed field as possible. Unfortunately the location he chose was near the energized overhead lines. Employers should identify areas away from any overhead lines where the task (in this incident, dumping tare weight) can be safely performed. Locating a safe dump area away from the power line would have prevented this incident.

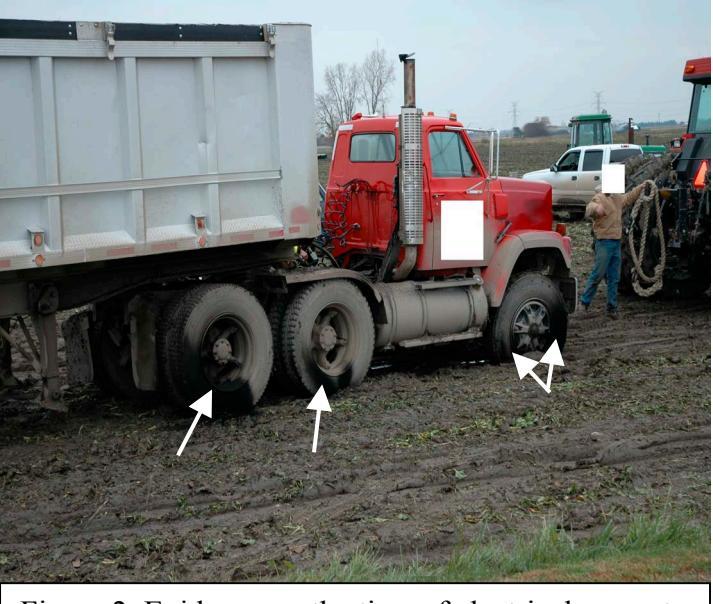
Figure 2. Evidence on the tires of electrical current seeking ground

The farm owner was operating the sugar beet harvester and loading a second truck in another area of the same field in which the decedent had entered with his truck. The driver of the second truck saw a "flash of bright light" and then stated he looked over at decedent's truck and saw fire coming from underneath the truck and the decedent lying on the ground (Figure 2-arrows indicate tire burn). The farm owner, the truck driver and his passenger, a paramedic, ran to victim and began to perform CPR. The decedent was positioned on the ground 5-10 feet from the tractor, on the driver's side. His orientation on the ground is unknown. Since the event was unwitnessed, it is unknown if he was in the truck and attempted to jump clear or if he was outside of the truck when the

It is not known if the decedent was in direct contact with the truck or if he was a casualty of "step" voltage or "step" potential. "Step" voltage or "step" potential is produced when a piece of equipment touches an energized power line, the current flows through the equipment and into the ground, radiating out from the area like ripples in a pool of water. When a person stands with his/her feet in two different voltage level areas, their legs provide another path through which current can flow.
