MIFACE INVESTIGATION REPORT: #07MI024

Subject: Pipefitter/Project Foreman Died When Struck by Ruptured Sewer Pipe/Mechanical Plug

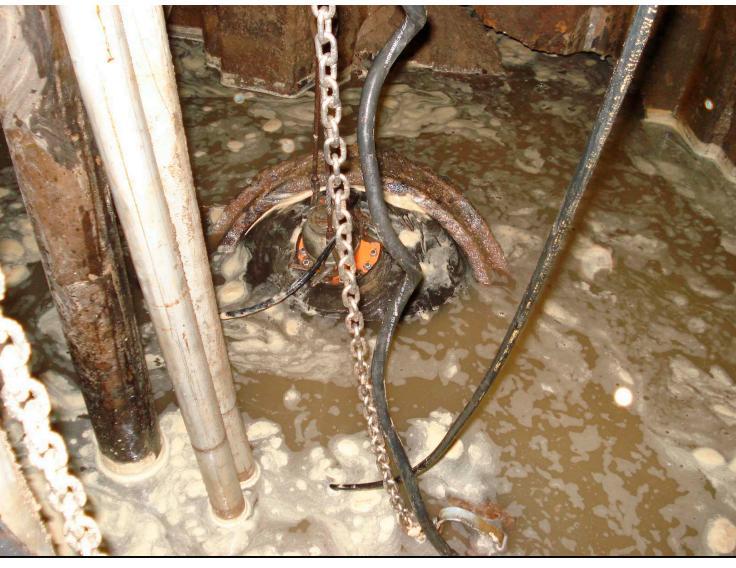
Figure 1. Pipe plug in broken sewer pipe at base of lift station

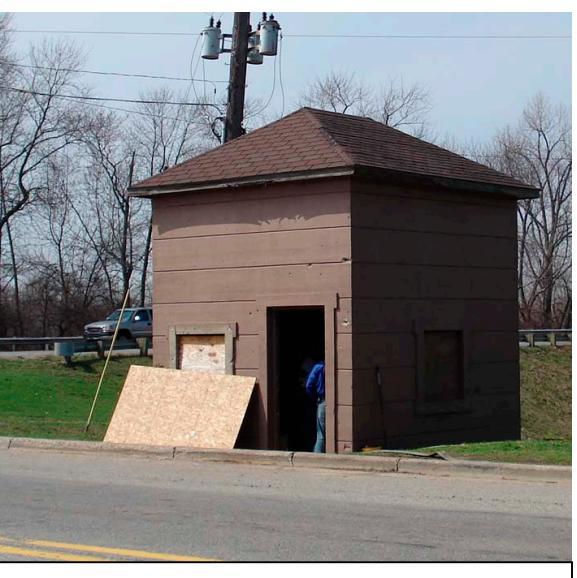
Figure 2. Lift station building

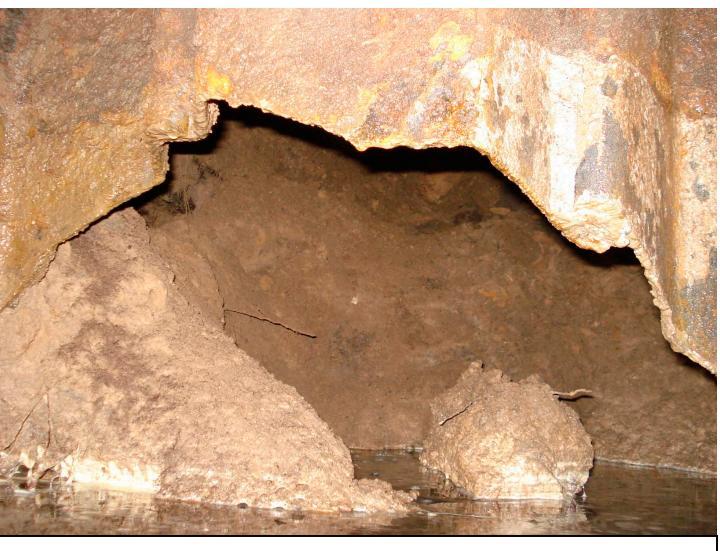
Figure 3. Manhole wall at location of pipe explosion

When Coworker #2 knelt down, he felt air by his face as the force of the explosion picked him up and blew him to the other side of the manhole (Figure 3). Coworker #2 was uncertain if he was knocked unconscious or if so, the length of time he was unconscious. He got up from a fetal position and water in the manhole was chest high. As he came to, he went to the decedent who was visibly injured. Coworker #2 looked up toward the top of the manhole, but it was "raining" air - the air was filled with white powder and dust particles. Coworker #1 could not see the two individuals in the manhole. Coworker #2 yelled to

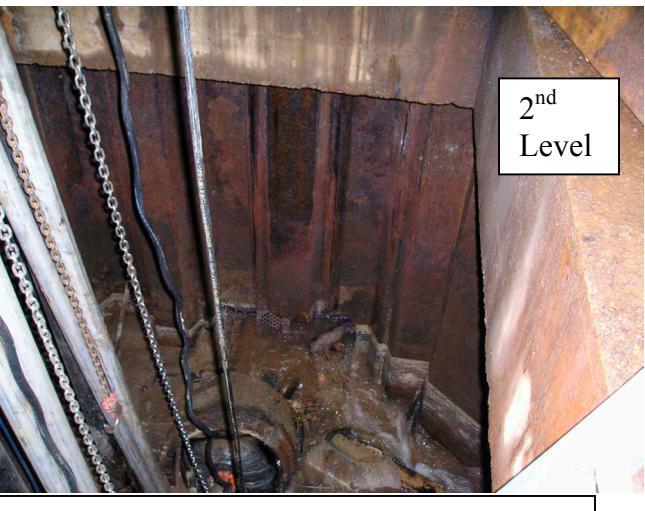
Figure 4. Pipe and plug at base of manhole after water was pumped

water was pumped out, the plug in the pipe could be seen (Figure 4). Part of the concrete pipe was still attached to the plug. The plug was over eight feet long and had metal plugs on both ends (Figure 5). Pictures indicate that the concrete gave way causing the plug to shoot out due to water pressure (Figure 3). The plug had an approximately 16inch cut that appeared to happen when the pipe broke. The cut looked as though it was done by a sharp object and not from blowing under pressure (Figure 6). The entire plug would have been inside of this pipe prior to it blowing out.

The employees indicated that no water was flowing from the pipe after the plug was inflated. This may have placed undue pressure on the pipe, potentially contributing to its failure. Although it is unknown if the plug was over inflated, over inflation will not provide a better seal and the plug may rupture catastrophically and dislodge at high velocity.

• Employers should ensure that workers follow all pneumatic pipe plug manufacturer's safety recommendations and other safety precautions relevant to the safe installation and use of pneumatic pipe plugs.

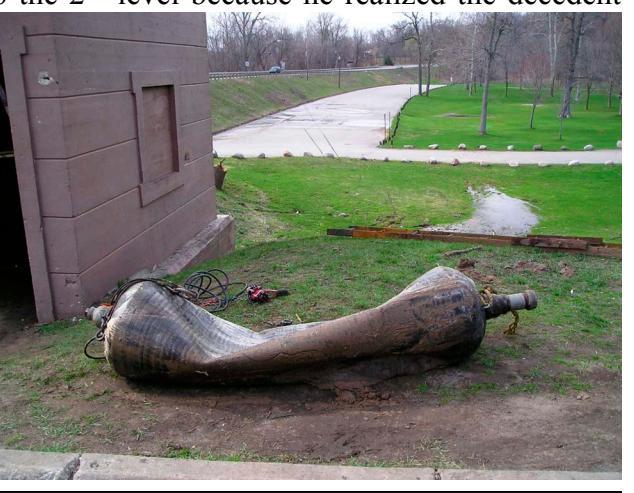
Figure 5. Picture of pipe plug after it was removed from the manhole

The pipe plug was found laying on the floor of the manhole and recovered. When the

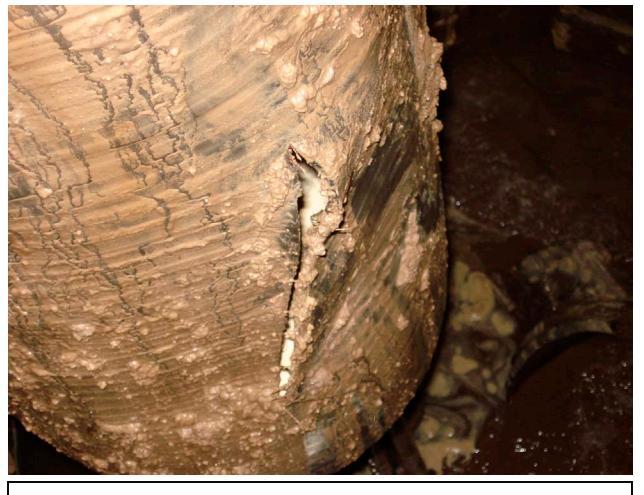
Figure 6. 16-inch cut on pipe plug
