MIFACE Investigation Report #10MI144

Subject: Hispanic Roofer Dies After Falling Through an Improperly Secured Roof Hatch Cover

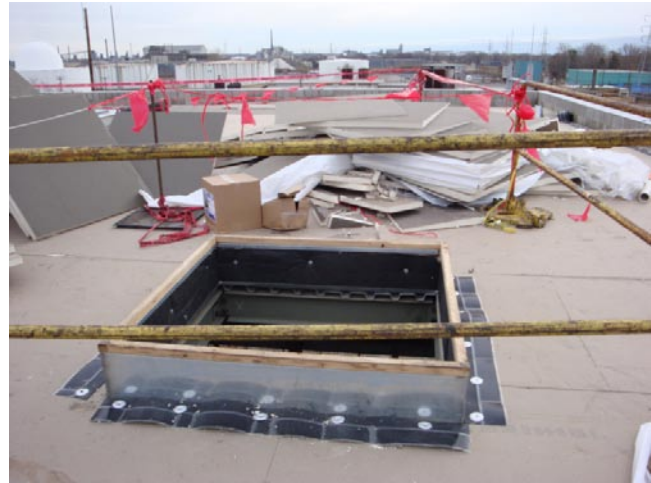
Figure 1. Roof hatch involved in incident. Note nearby pile of insulation sheets.
