REPORT#: 15MI104

REPORT DATE: 1/16/19

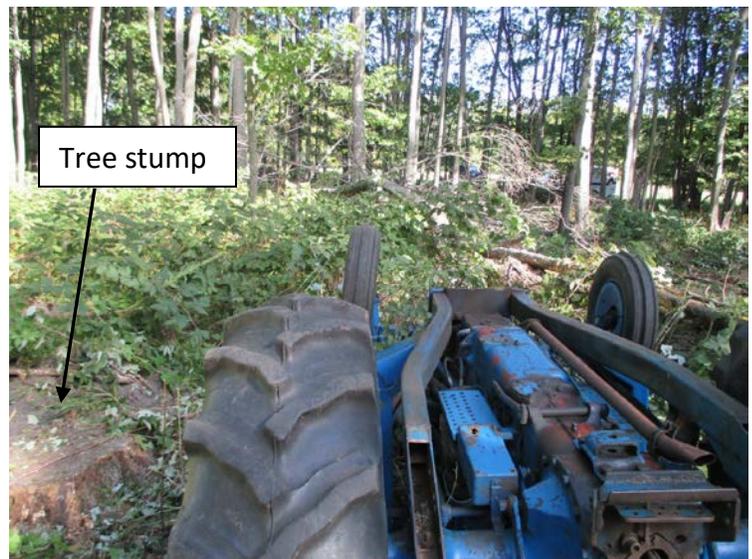
Photo 2. Stump by tractor wheels

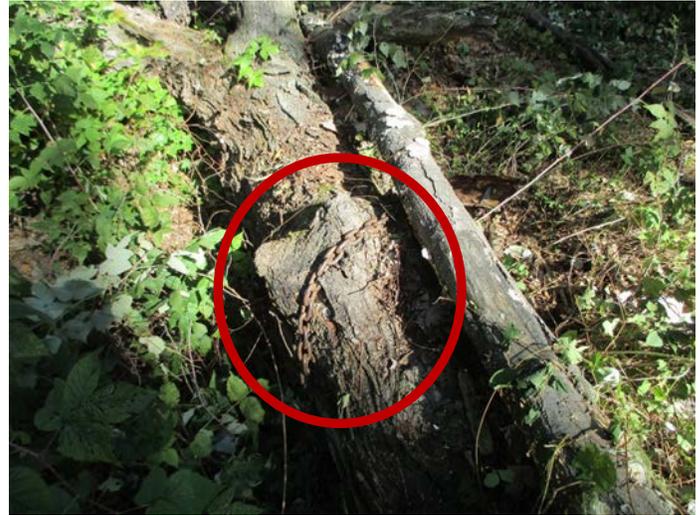
Photo 6. Location of chain on tree

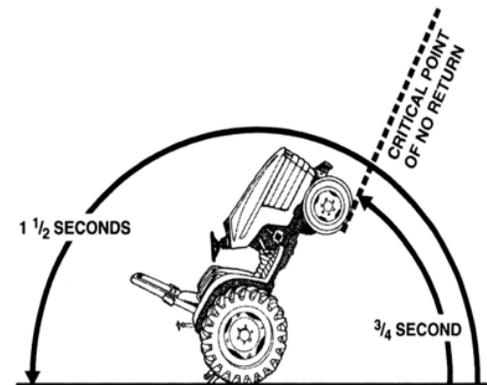
Figure 3. Critical point of no return for tractor overturn to the rear

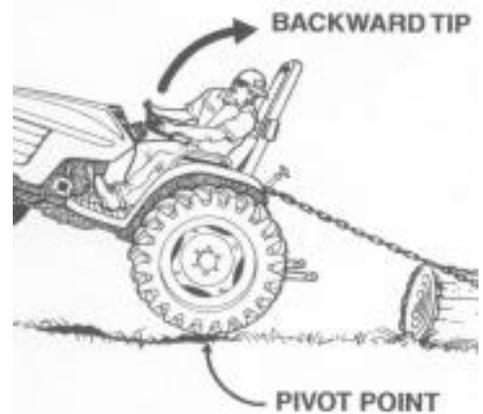
Figure 4. Angle of pull and leverage of load

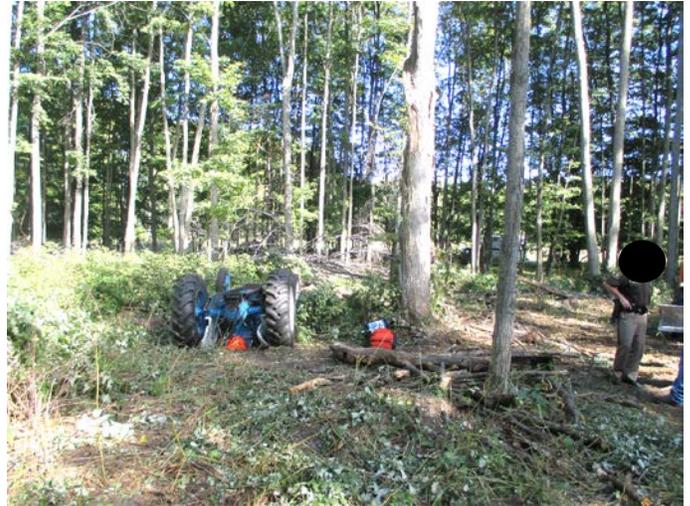
Photo 7. View of incident area, undergrowth, obstructions in path of tractor movement
