REPORT#: 15MI031

REPORT DATE: 10/23/18

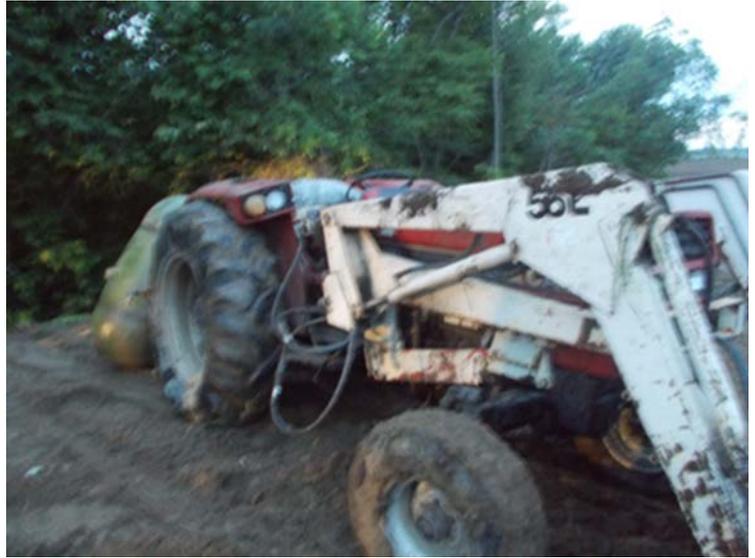
Photo 2. Tractor after removal from ravine. Note height of bucket arms and fiberglass tank positions

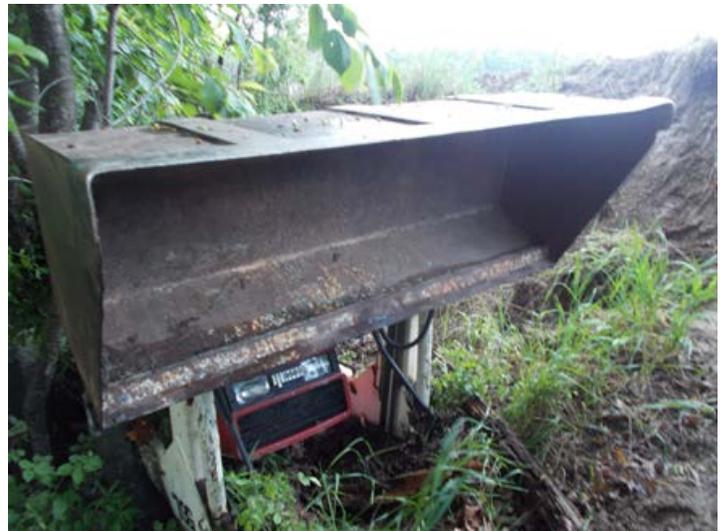
Photo 3. Tractor overturned in ravine. Note steepness of walls and washout

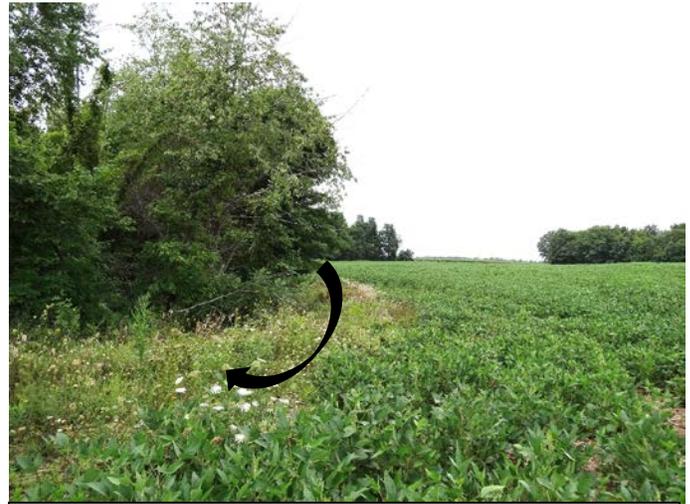
Photo 4. Field edge close to ravine edge. Arrow shows direction of travel
