MIFACE INVESTIGATION #05MI060

SUBJECT: Golf Course Worker Dies After Being Pinned Under an Overturned Tee Box Mower.

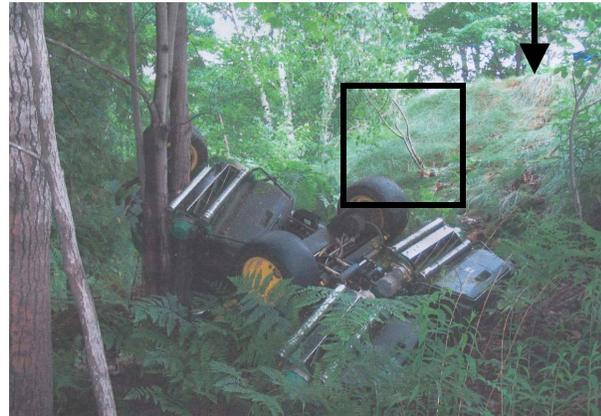
Figure 1. Mower path down slope, tree the mower hit on way down

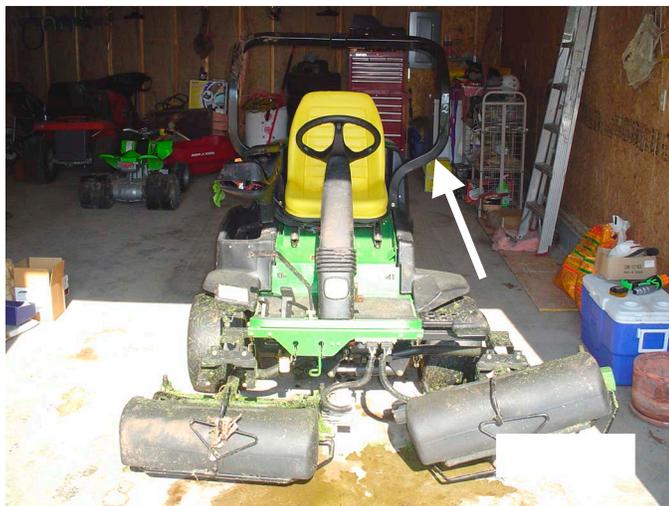
Figure 2. John Deere 2500E Triplex Greens Mower

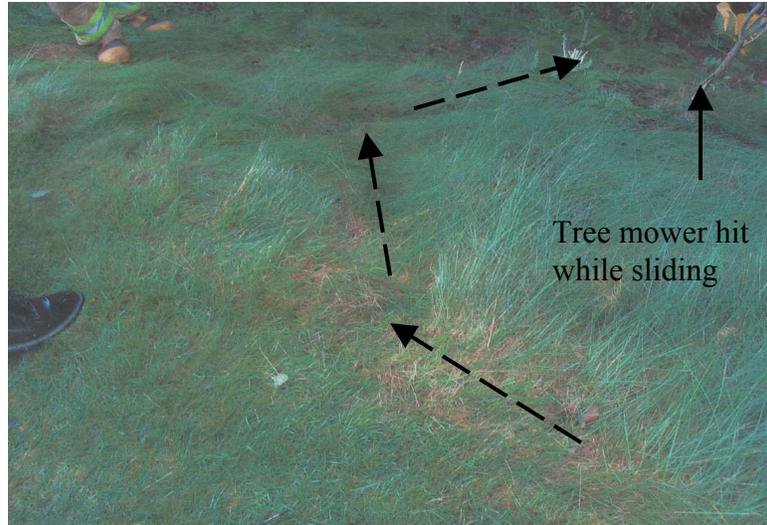
Figure 5. Path of tire down slope
