MIFACE INVESTIGATION #05MI089

SUBJECT: Retired Teacher/Farmer Dies When Pinned Under Overturned Tractor.

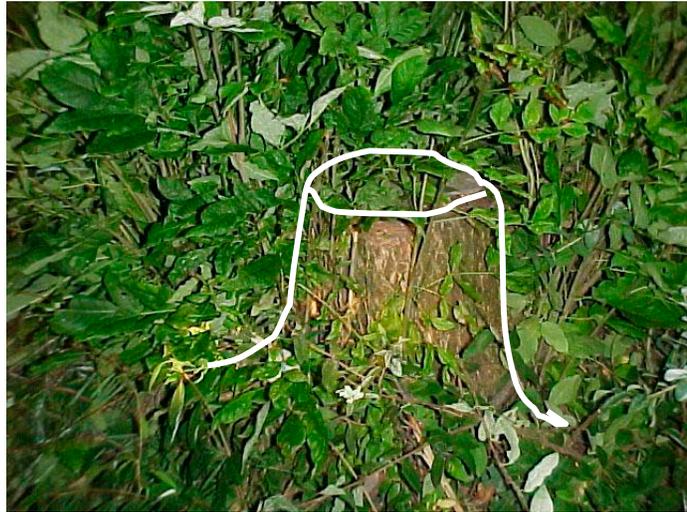
Figure 1. Police Photo of stump that was struck by tractor and/or brush hog

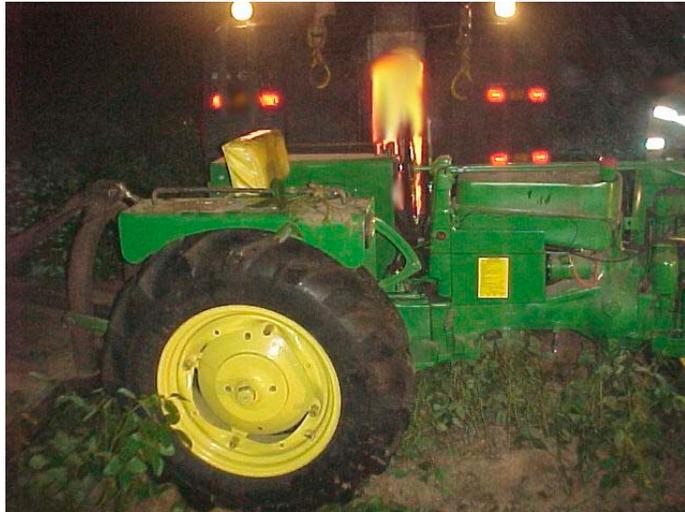
Figure 2. Tractor after being turned upright by tow company

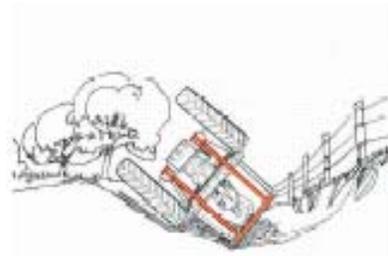
Figure 7. Operator Zone of Protection

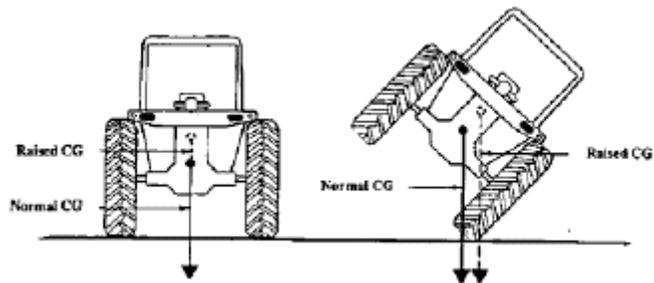
Figure 9. Higher center of gravity allows a side overturn to occur more quickly
