MIFACE INVESTIGATION REPORT: #07MI013

SUBJECT: Construction Foreman Dies from Fall While Climbing the Tower of a Hydromobile Scaffold

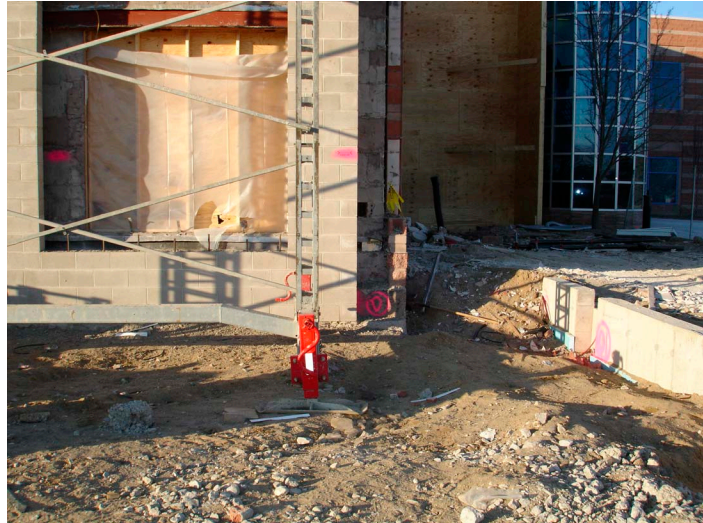
Figure 2. Surface to which the decedent fell.

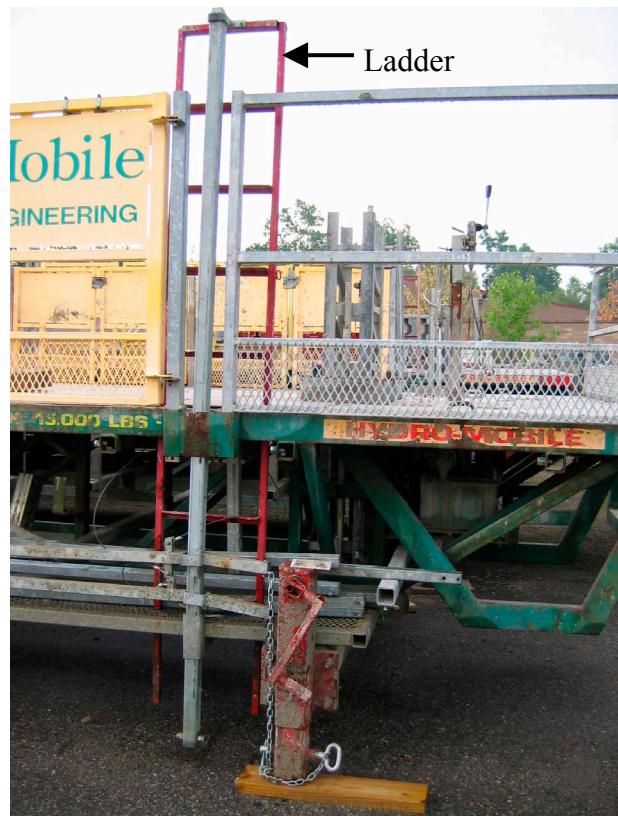
Figure 4. Ladder permanently affixed to the scaffold system.
