MIFACE INVESTIGATION REPORT: #07MI106

SUBJECT: Iron Worker Dies When Struck By Falling Steel Header Beam

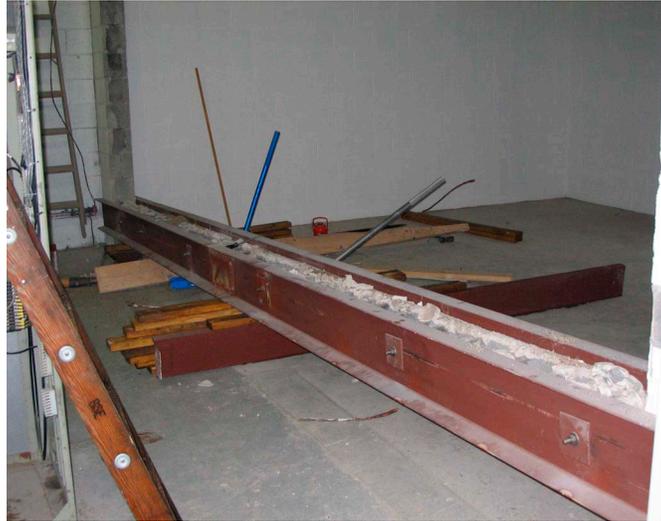
Figure 1. Header beam that fell onto decedent and two jacks used to raise beam from decedent.
