MIFACE INVESTIGATION REPORT: #07MI169

SUBJECT: Supervisor/Foreman Struck By A Pickup Truck While Placing Channelizer Drum in Road

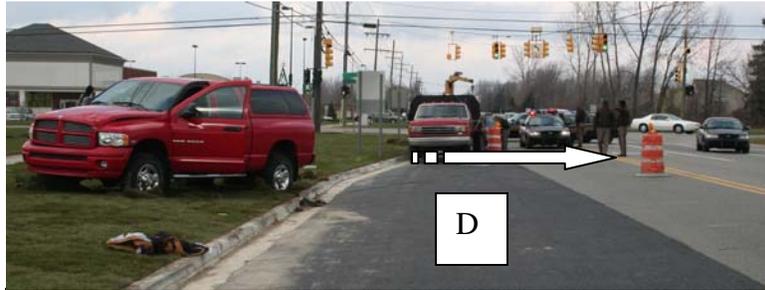
Figure 1. Incident scene showing intersection, ending position of pickup truck and decedent (D), location of channelizer drums, and path of decedent while placing 4th drum.

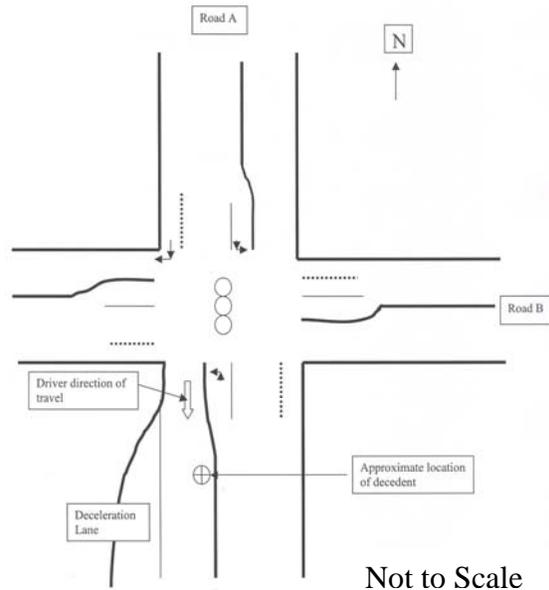
Drawing 1. Line drawing of incident scene

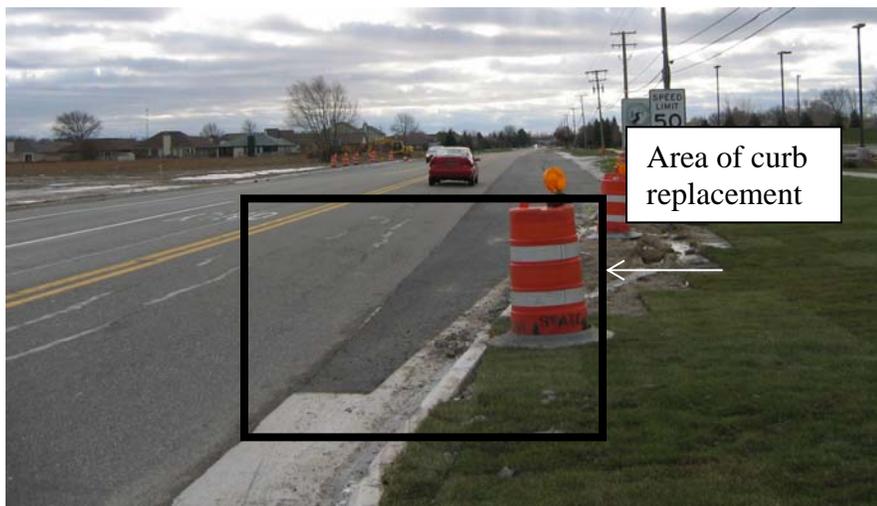
Figure 2. Curb area where water was accumulating and curb replacement was required.

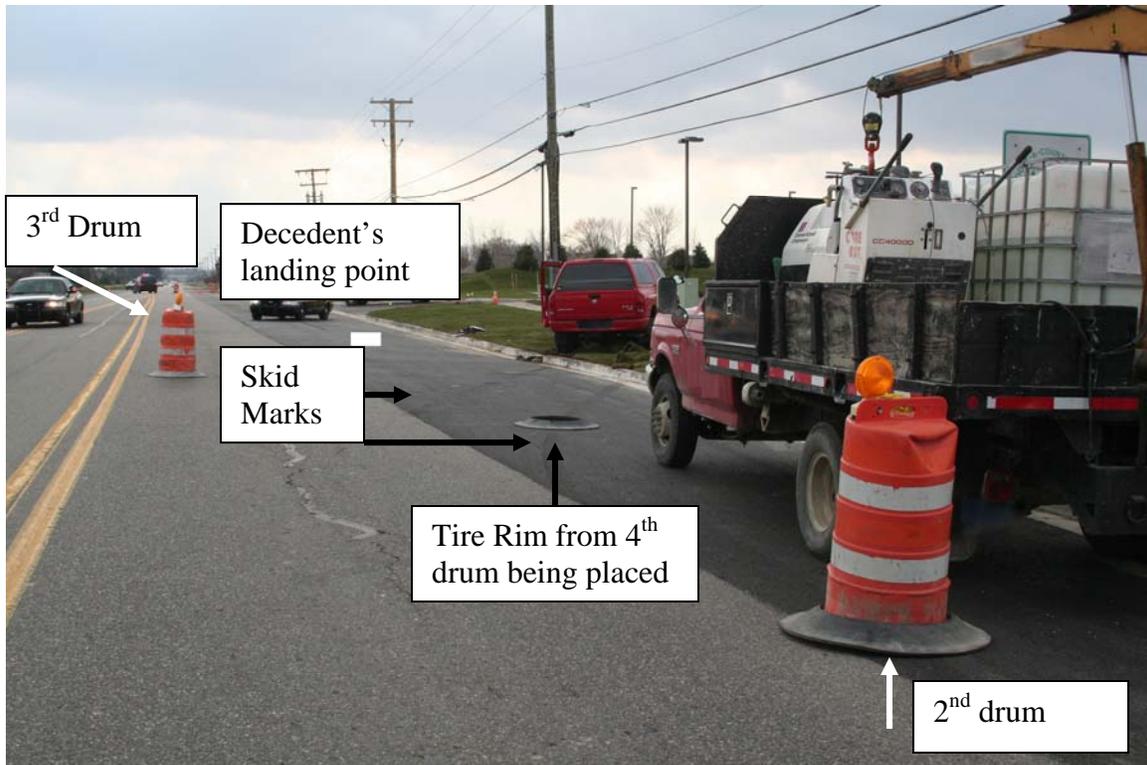
Figure 3. Incident scene showing channelizer drum placement, location where decedent landed after being struck, and skid marks and final position of pickup truck
