# MIFACE INVESTIGATION REPORT: #08MI005

## SUBJECT: Roll-Off Container Truck Driver Electrocuted When Raised Tilt Frame Contacted Overhead Line

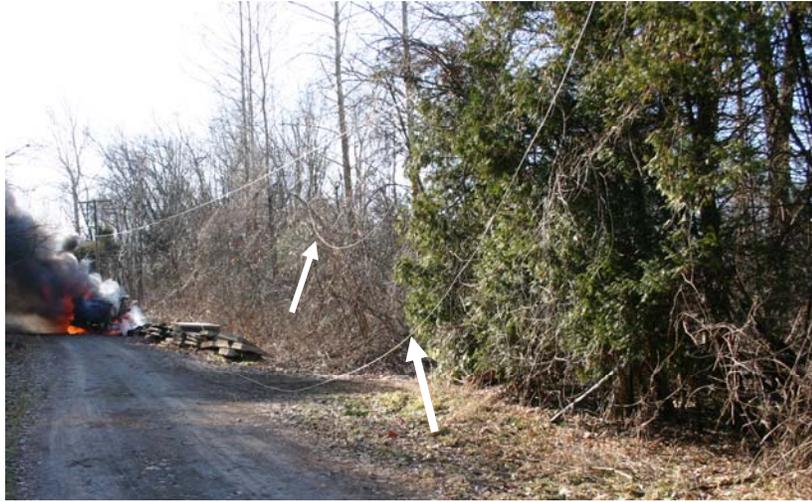
Figure 1. Burning roll-off truck/trailer, melted power lines on ground and in trees

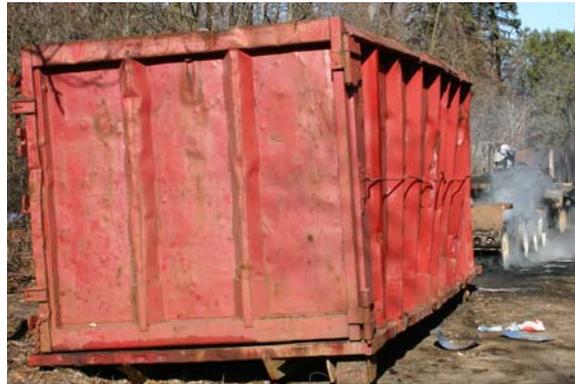
Figure 2. Container involved in incident

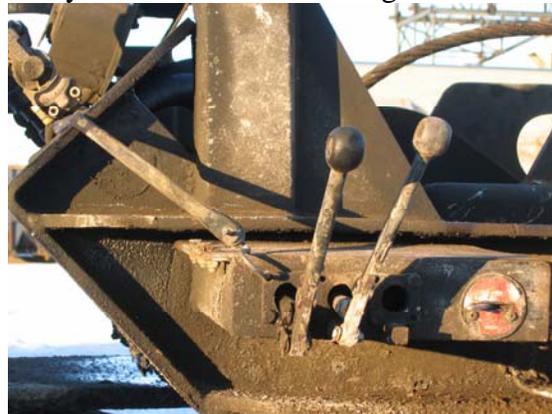
Figure 3. Example of trailer-mounted control levers used to raise/lower tilt frame

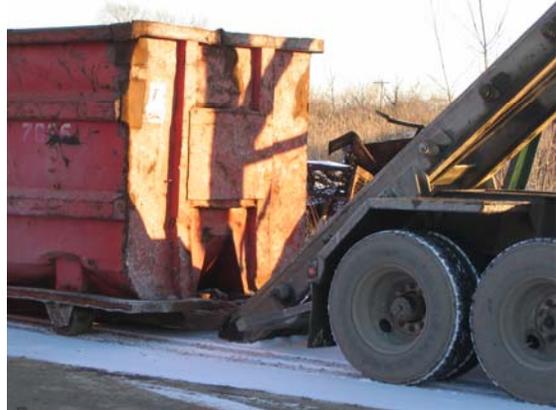
Figure 4. Example of container unloading and tilt frame touching the ground

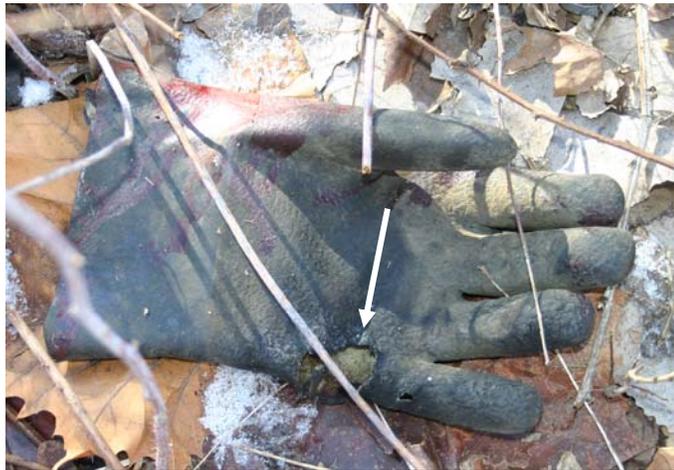
Figure 6. Work glove worn on decedent's left hand, burn mark evident

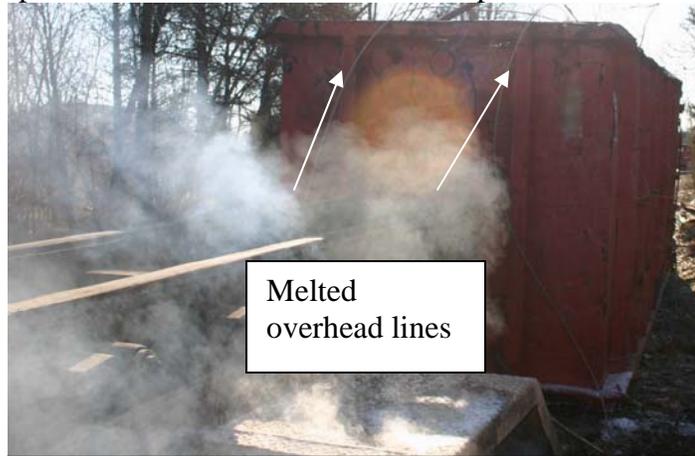
Figure 7. Melted overhead lines lying on container

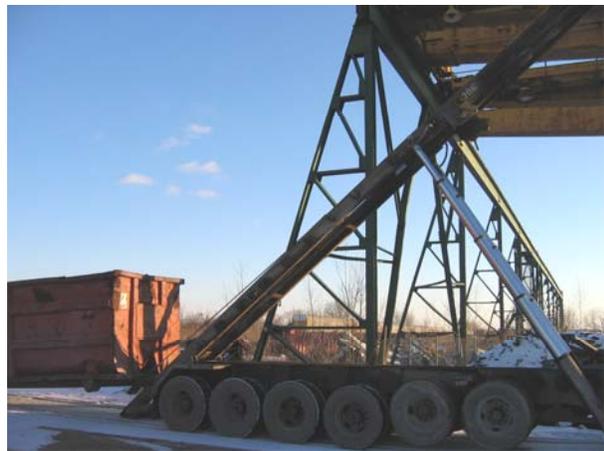
Figure 8. Example of full extension of tilt frame

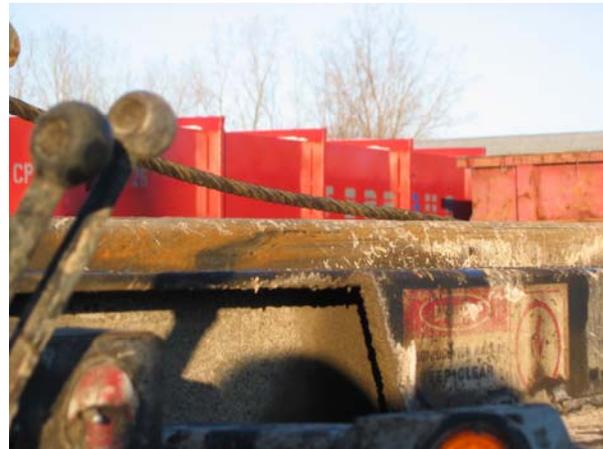
Figure 9. Operator view of faded and worn safety warning sticker on Figure 4 trailer
