MIFACE Investigation Report #08MI015

Subject: Construction Worker Dies From 69-Foot Fall Through Roof Opening

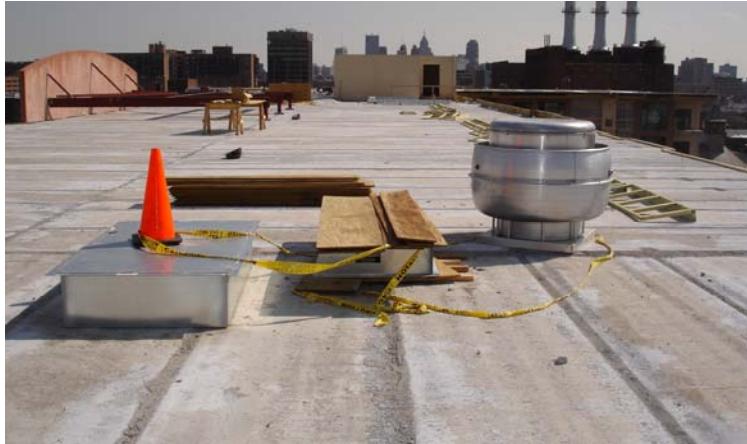
Figure 1. Make-up air roof curb with orange pylon, exhaust fan roof curb with plywood, looking south on roof

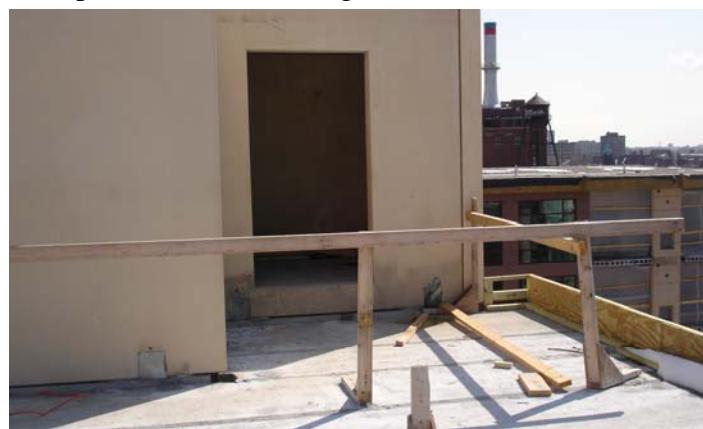
Figure 2. Guardrails at stairwell opening

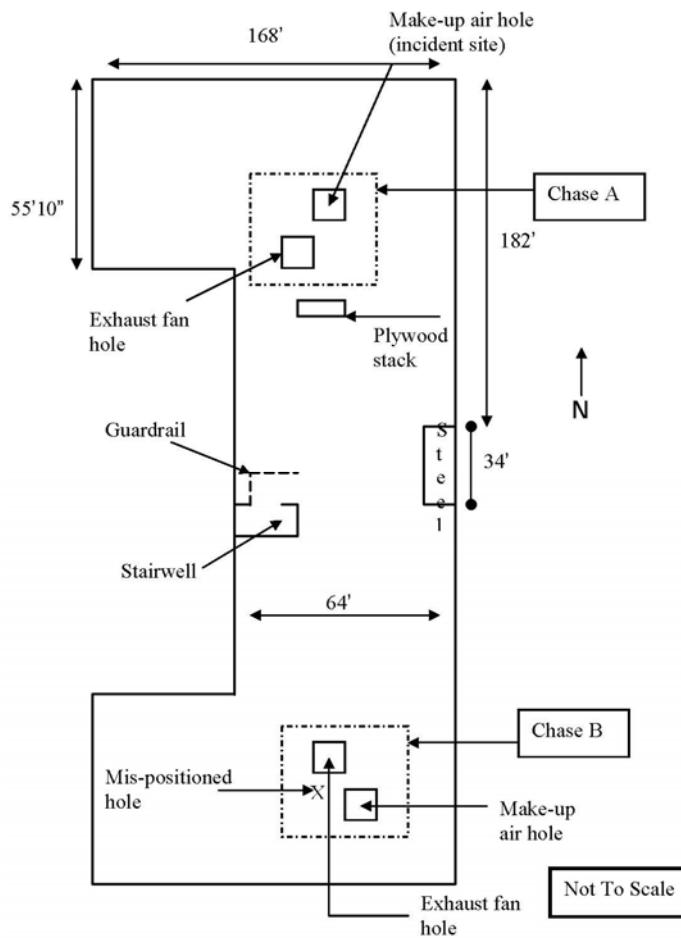
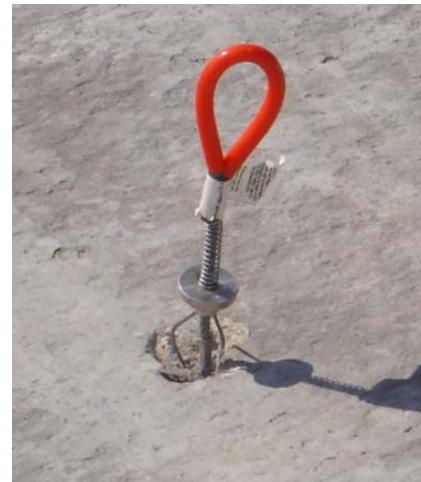
Figure 3. Life line anchor for fall protection lanyard

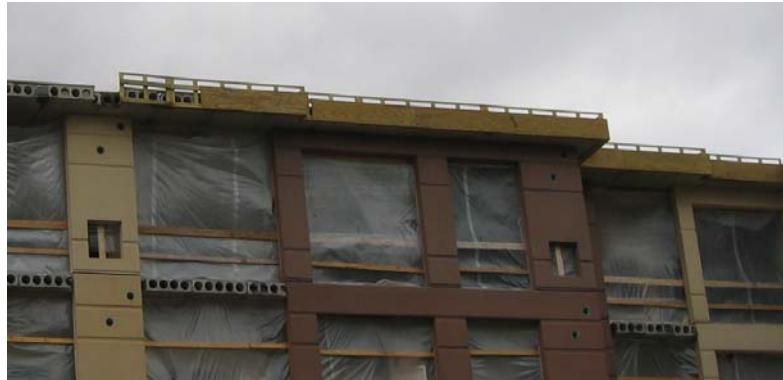
Figure 6. Example of parapet work construction

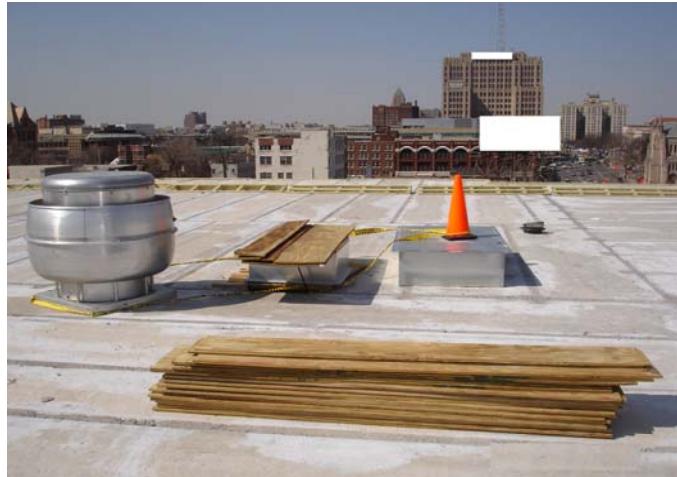
Figure 7. Make-up air roof curb with orange pylon, exhaust fan roof curb with plywood, looking north on roof
