MIFACE INVESTIGATION REPORT: #08MI037

SUBJECT: Lineman Electrocuted When He Contacted 7,200-volt Power Line

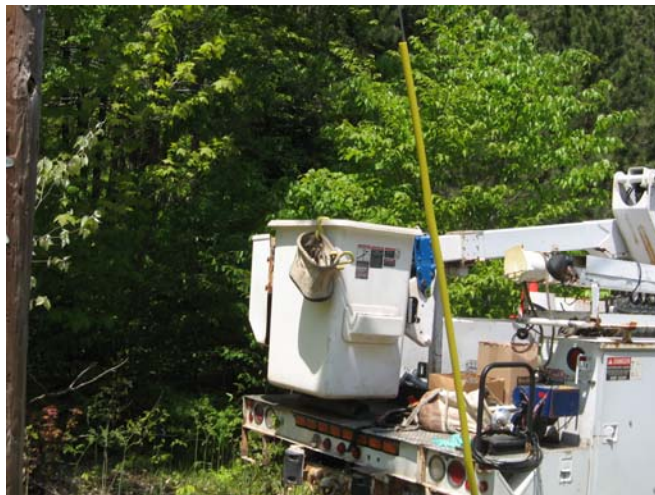
Figure 3. Bucket decedent was working in and glove bag to hang tools

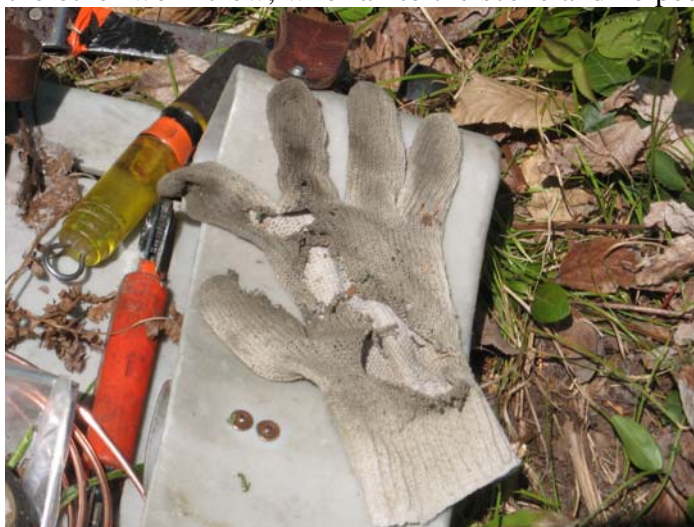
Figure 4. Right hand cotton glove after electrical contact
