MIFACE INVESTIGATION REPORT: #08MI135

SUBJECT: Farmer Drowned While Removing Stop Logs From Water Level Control Structure

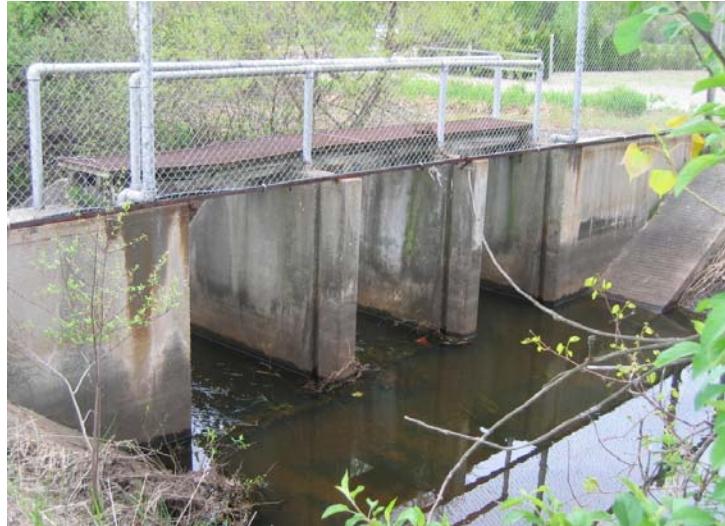
Figure 1. Upstream side of water level control structure looking east

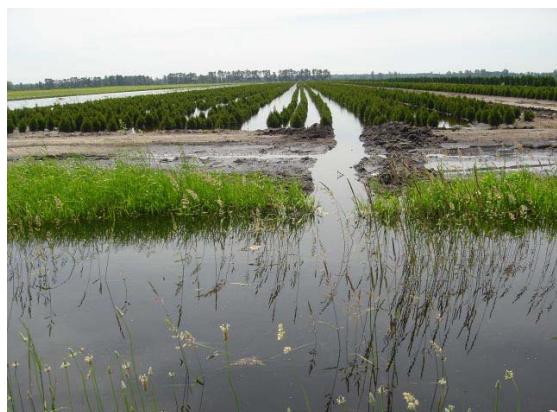
Figure 3. Example of water in fields upstream of drain and height of water in drain

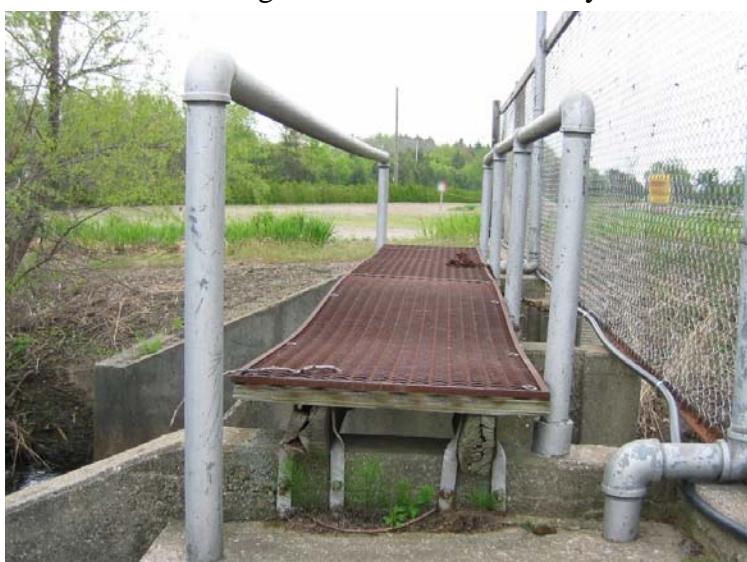
Figure 4. Water level control structure's wood and expanded metal walkway, handrails, and fence, looking south

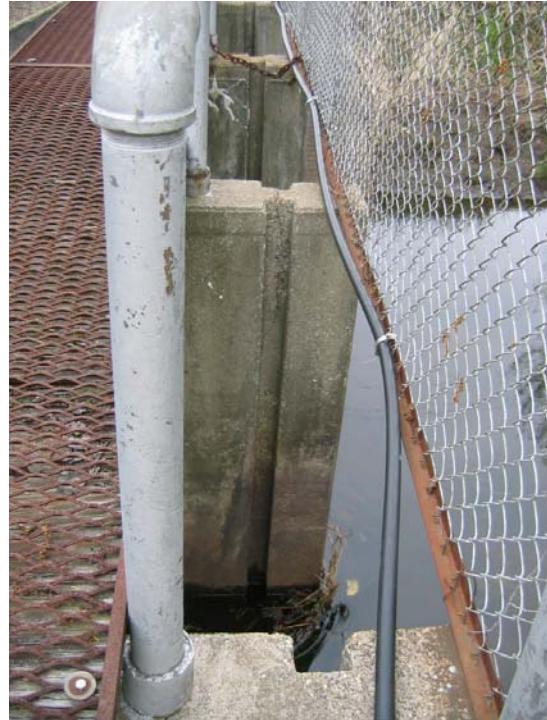
Figure 5. Channels holding stop logs

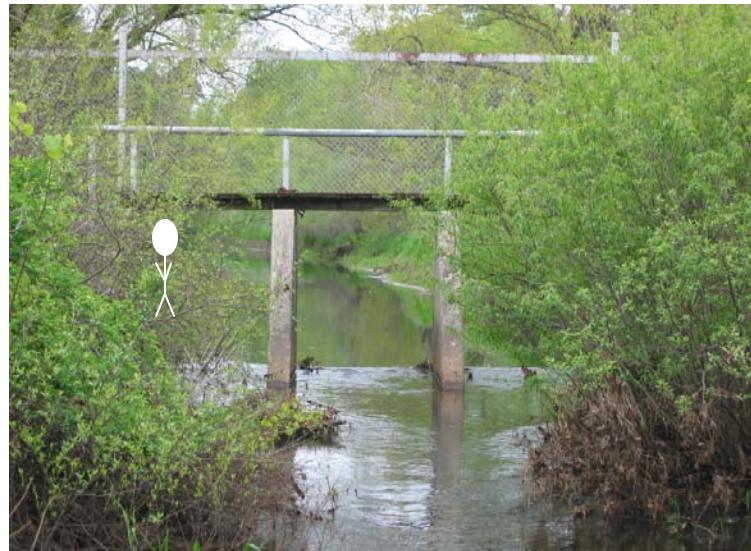
Figure 6. Downstream side of the water level control structure, looking west, showing decedent's location under the structure

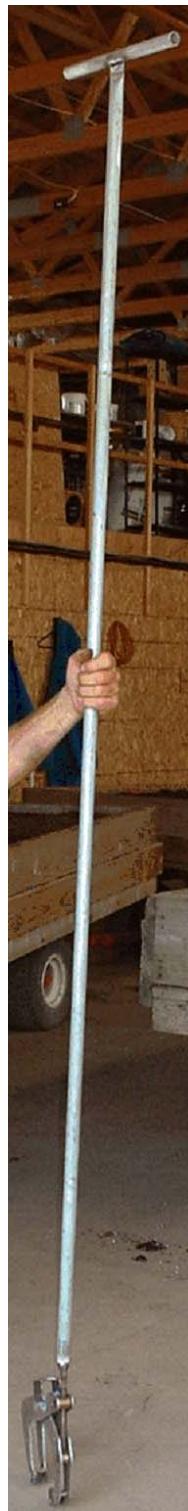
Figure 7. Tool developed to add/remove stop logs
