MIFACE INVESTIGATION REPORT #09MI075

SUBJECT: Semi-Truck Driver Died When Struck by Precast Concrete Panel That Fell From Semi Trailer

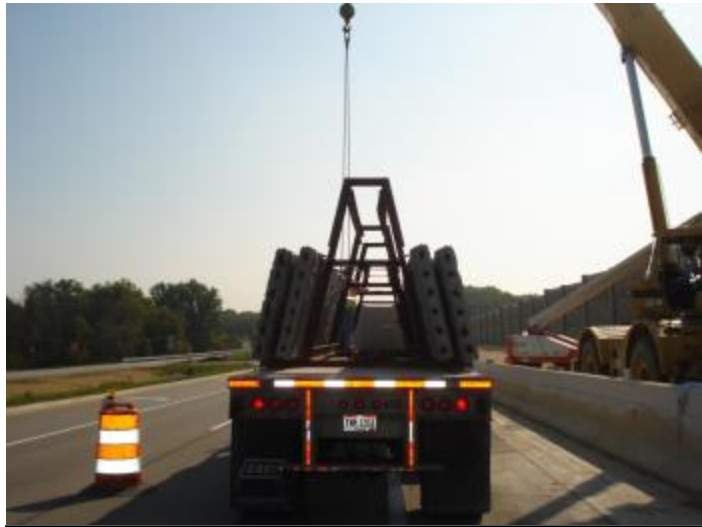
Figure 3. Example of concrete sound panel orientation on A-frames on trailer

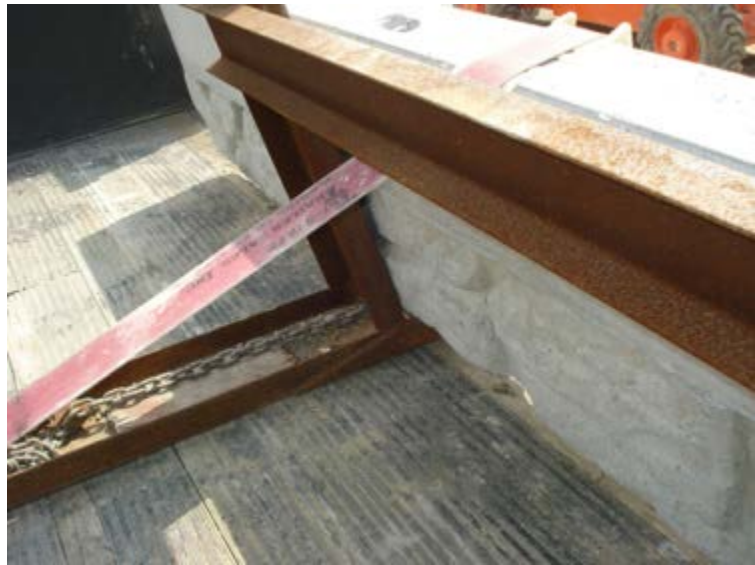
Figure 4. Example of securement method for concrete panel transportation

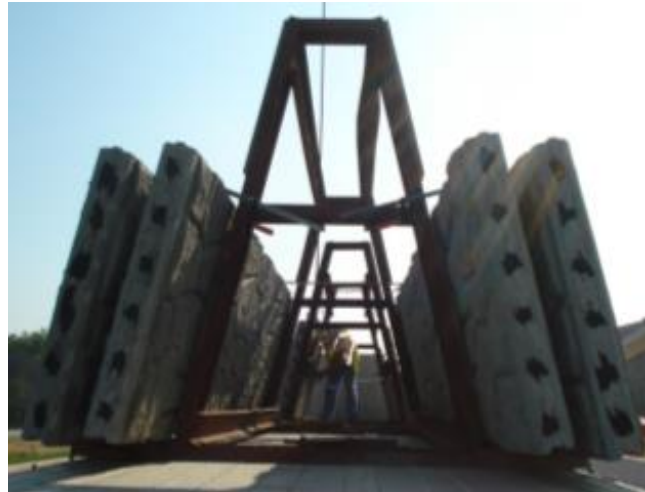
Figure 6. Concrete panel securement with C-clamps, after the incident
