MIFACE INVESTIGATION REPORT: #09MI085

Subject: Truck Driver Struck by Semi-Tractor When Walking in Parking Lot

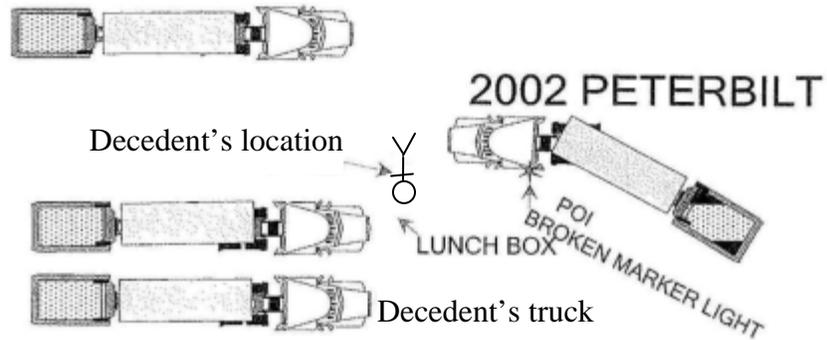
Figure 1. Sheriff report drawing of incident scene. Company and decedent identifiers removed.

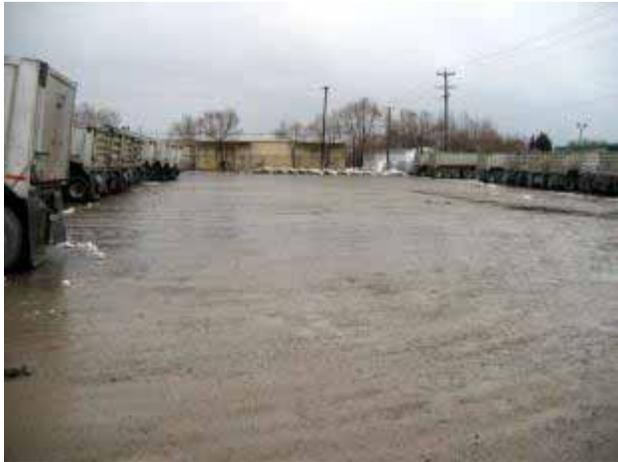
Figure 3. Open area used for turning Peterbilt between two truck rows

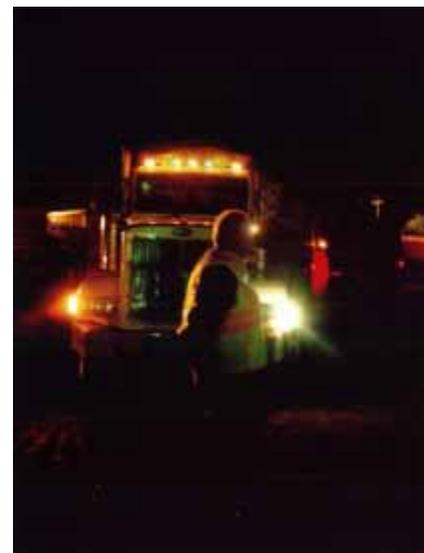
Figure 6. Deputy visibility, vapor light and amber marker lights only

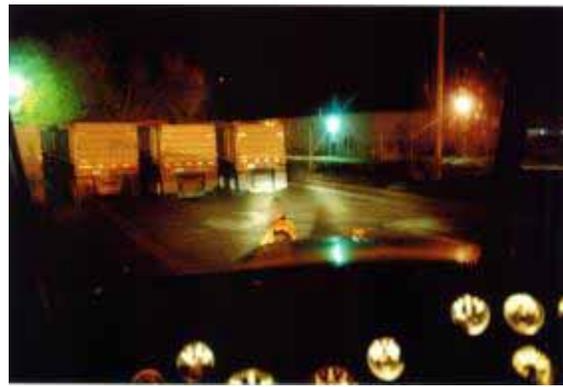
Figure 7. Deputy visibility, vapor light, headlights and amber marker lights
