## **MIFACE Investigation Report: #13MI009**

### **Subject: Assistant Manager at Fertilizer Mixing Facility Dies When Pinned Under Overturned 1972 Tractor Without a ROPS**

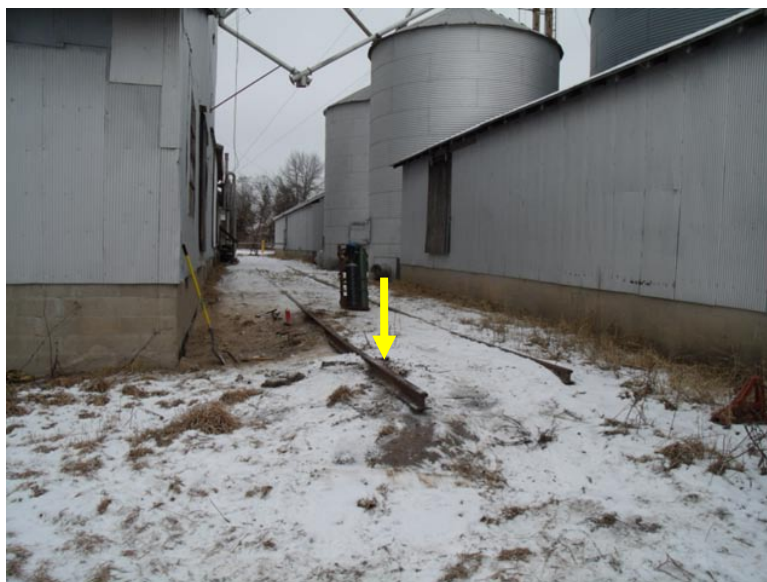
Figure 2. Identification (yellow arrow) and location of railroad spur being removed

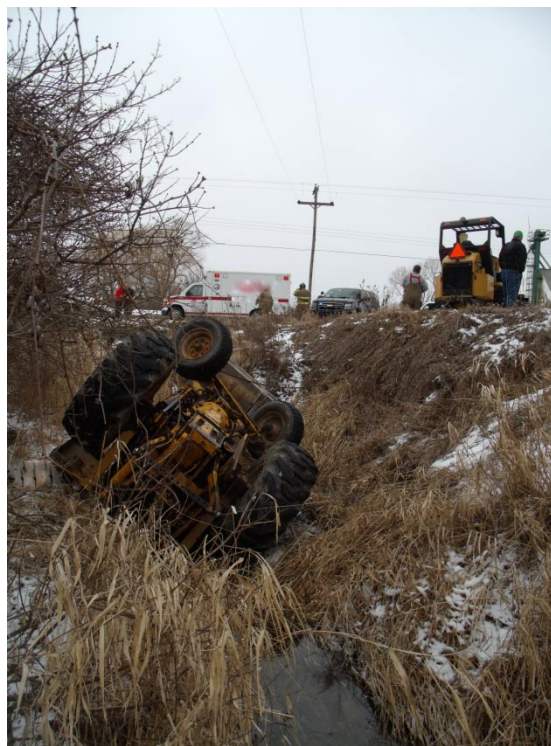
Figure 4. Final resting position of tractor. Note embankment slope.
