## MIFACE Investigation Report: #14MI002

### **Subject: Loader Operator Died When He Fell Into a Railcar Compartment and Was Engulfed by 70,000 Pounds of Yellow Soybeans During Loading.**

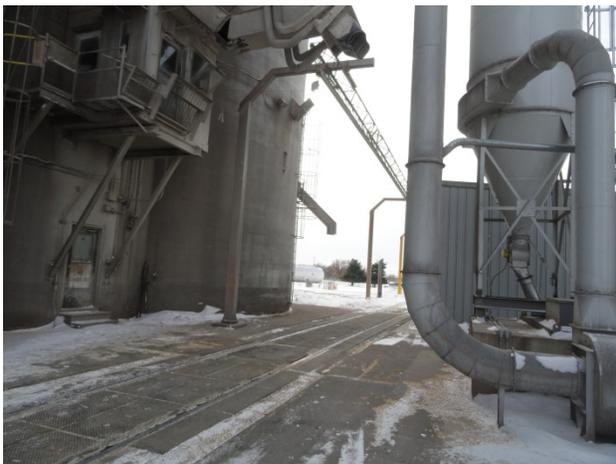
Figure 5. Overview of incident scene. Steps to railcar in retracted position.
