MIFACE INVESTIGATION REPORT #14MI086

SUBJECT: Frozen Custard Store Co-Owner Electrocuted While Servicing an Energized Frozen Custard Machine

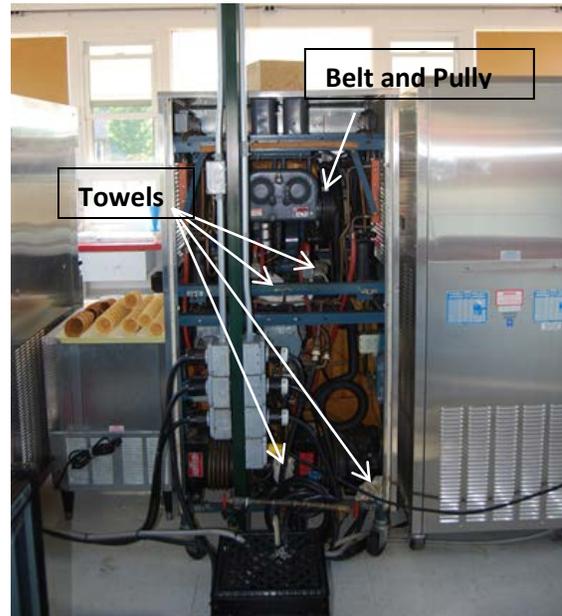
Figure 1. Incident frozen custard machine with back cover removed and plastic crate positioned over drain.

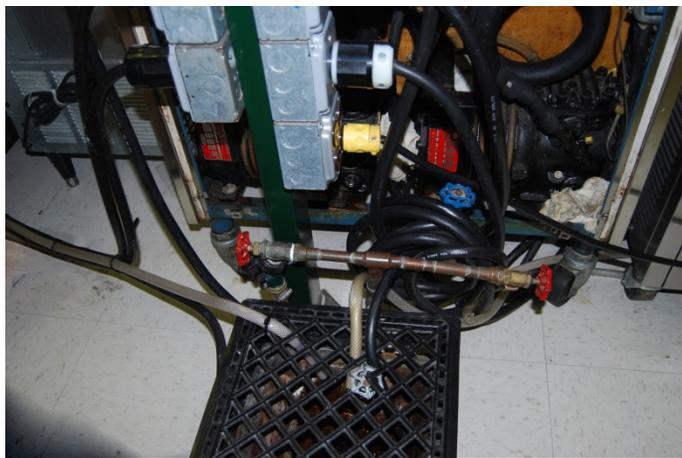
Figure 2. Plastic crate over drain. Note rag in bottom right corner of machine.

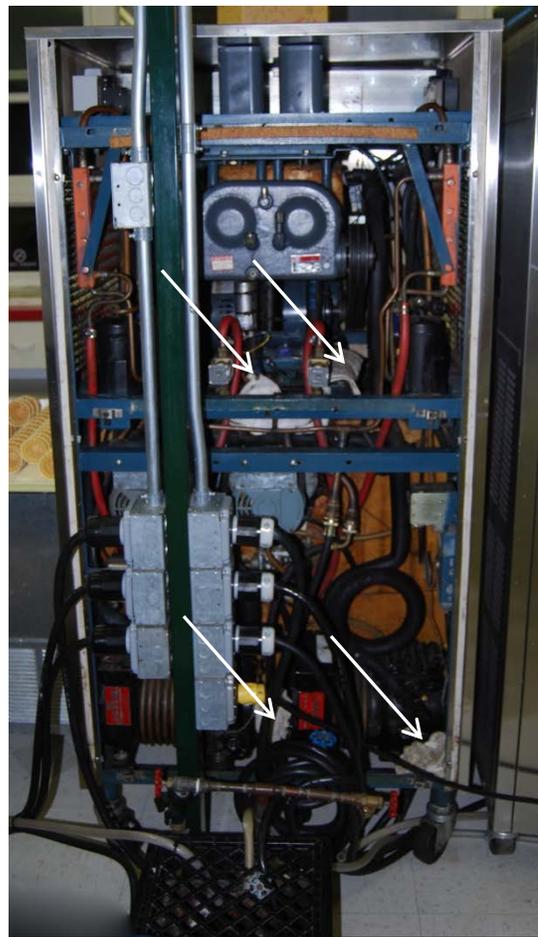
Figure 3. Back of frozen custard machine. Four arrows indicate location of rags placed inside machine.
