REPORT#: 17MI136

REPORT DATE: 9/13/19

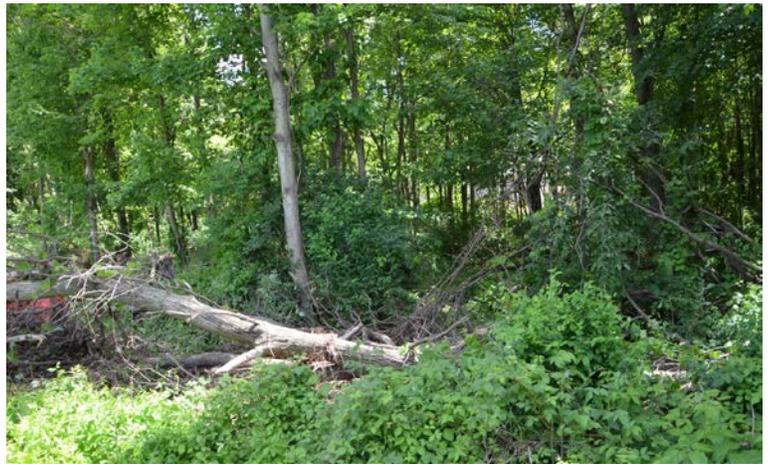
Photo 4. Downed tree location and position near tree line.

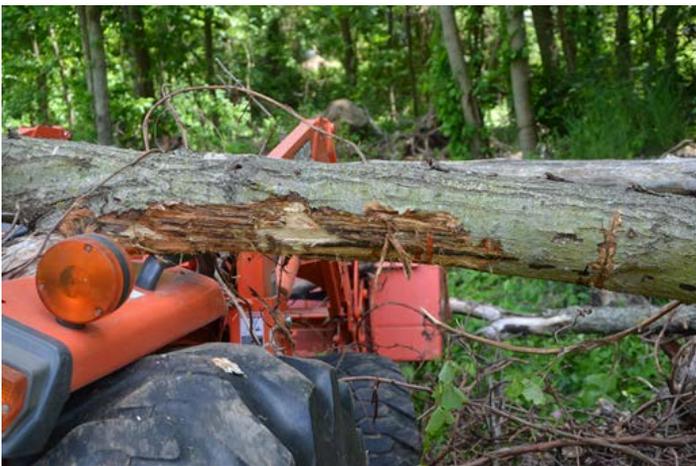
Photo 6. Marks on tree caused by loader bucket and hydraulic arms from multiple attempts to push tree

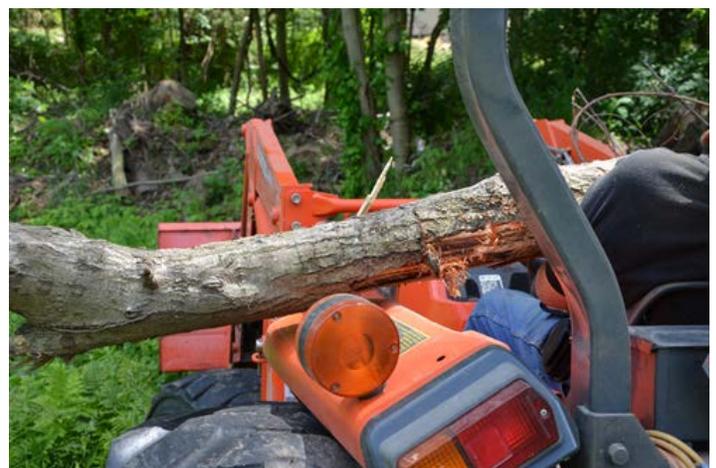
Photo 7. Marks on tree caused by loader bucket and hydraulic arms from multiple attempts to push tree

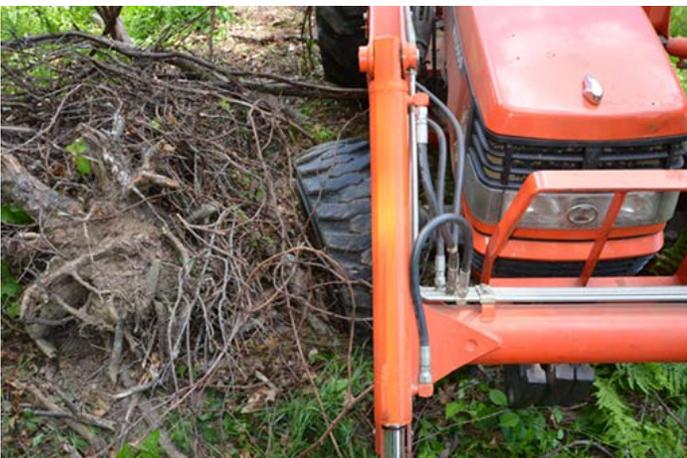
Photo 8. Paint transfer marks on hydraulic arm caused by tree

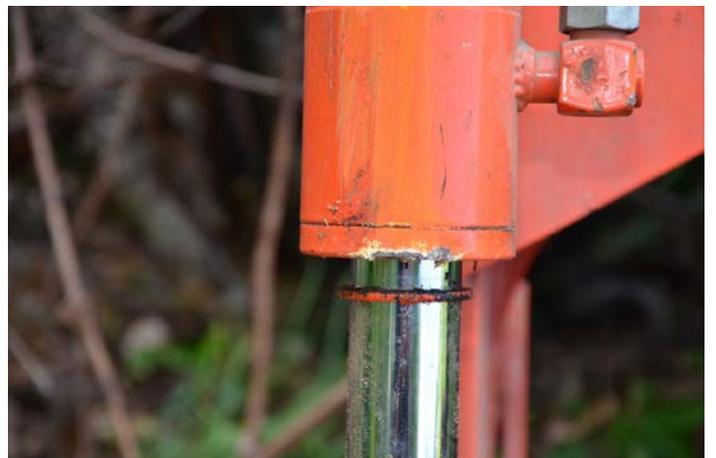
Photo 9. Marks on hydraulic arm/cylinder caused by tree

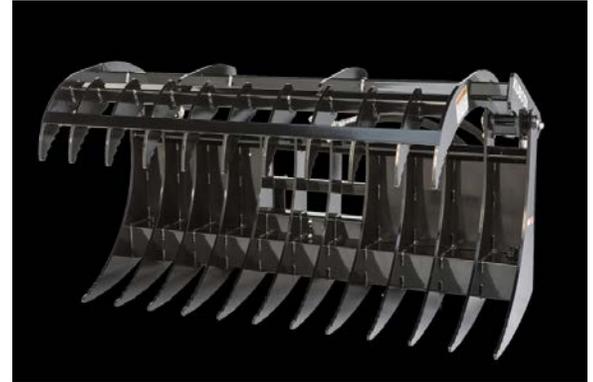
*Photo 10. Photo of grapple attachment.
<https://www.landpride.com/product-search/kubota-ce-attachments>*
