MIFACE INVESTIGATION #03MI005

SUBJECT: Worker Dies As a Result of Being Struck and Pinned Between Two Vehicles While Repairing Potholes

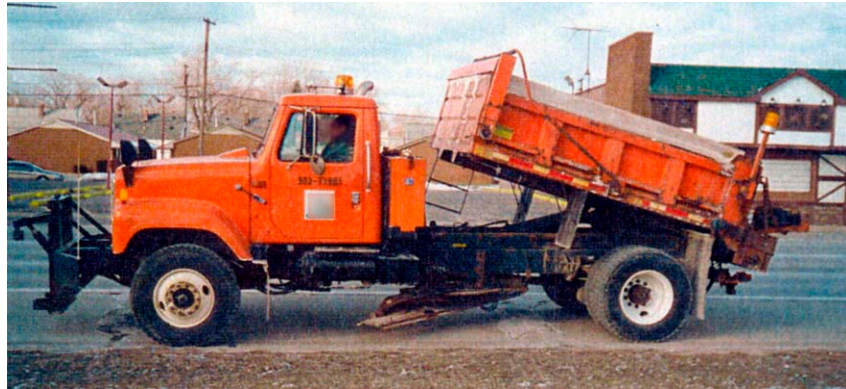
On Monday, January 13, 2003, at approximately 11:40 a.m., a 40-year old male worker repairing a road with cold patch was momentarily pinned between the cold patch truck he was shoveling cold patch from (Figure 1) and the backup vehicle

Figure 1. Cold Patch Truck

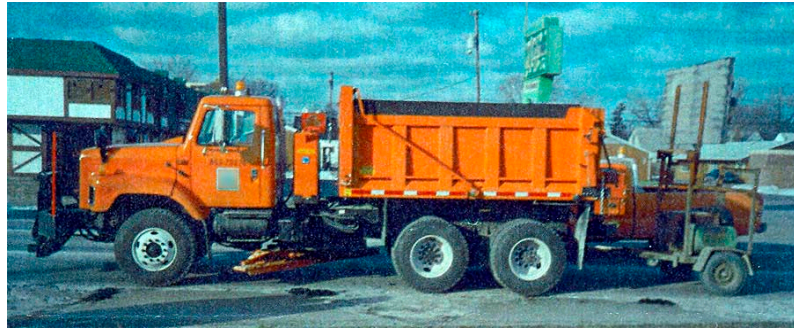
pulling the flasher board warning arrow signaling drivers to stay back from the work crew (Figure 2). He collapsed and died on January 15, 2003, at the hospital where he had been taken after his injury as he was preparing to leave the hospital.

Figure 2. Backup Truck

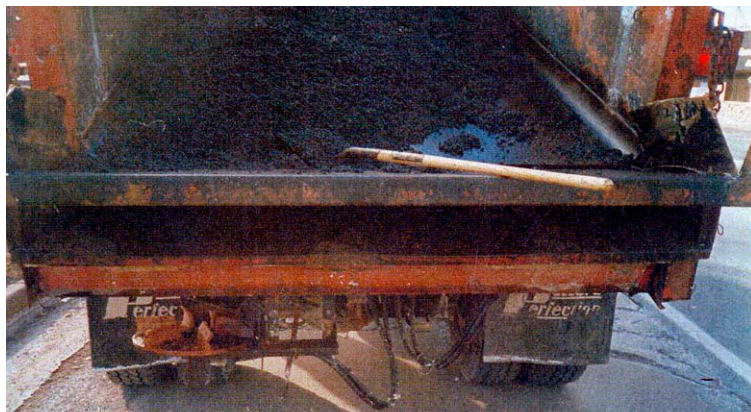
Figure 3. Cold patch in lead truck

The tailgate of the lead truck was lowered and the bed was inclined so the workers could access the cold patch repair material (Figure 3). The trucks were proceeding at the normal pace, approximately three miles per hour. The backup vehicle was expected to stay approximately 50 feet behind the lead vehicle except in intersections where it pulled up closer to prevent cars from slipping between the two work vehicles. The vehicles had just passed an intersection moving southbound, so the backup vehicle was somewhat closer than it would normally have been. The road had six lanes (three northbound and three southbound) plus a median and a left turn lane. The speed limit was 35 miles per hour. The vehicles were in the left of the three southbound lanes next to a left turn lane (Diagram 1).

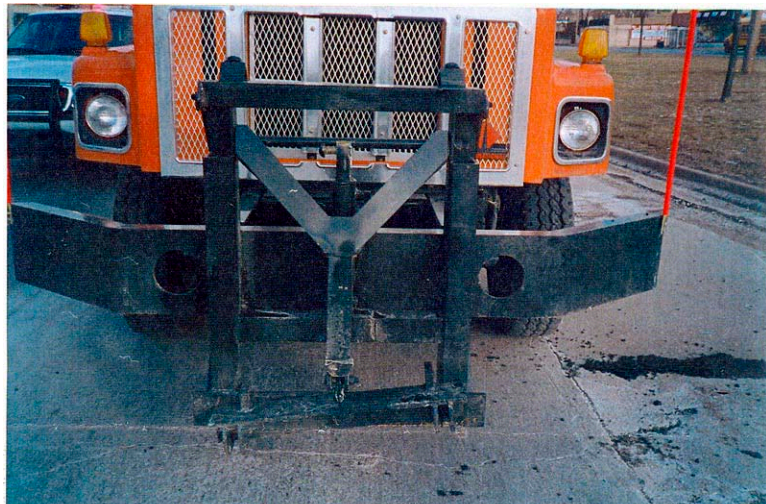
The decedent was walking between the two vehicles filling pot holes with cold patch he shoveled from the back of the lead truck. The backup vehicle (Figure 4) struck the decedent, pushing him into the lead truck for a moment. The driver of the lead truck indicated he was waiting for the decedent to give him a signal to move forward when he felt a small bump. He looked

Figure 4. Front of backup vehicle

- The employer should install after market devices (i.e., camera, radar, and sonar) on construction vehicles and equipment to help monitor the presence of workers on foot in blind areas.

- Employers should ensure that safe work procedures are in place for the use of mobile construction vehicles, a spotter is designated to direct movement of these vehicles, and drivers are in communication with workers on foot.
