# MIFACE INVESTIGATION #05MI051

## **Subject: Carpenter Dies After He Jumped/Lost Balance From An Unsecured Ladder That Fell Due To A Wind Gust.**

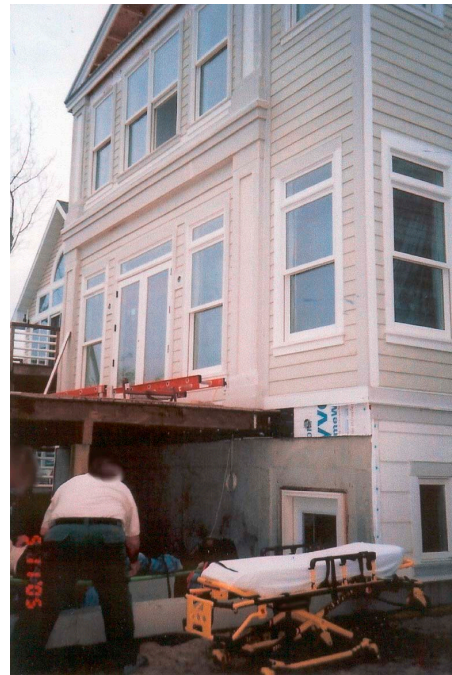
Figure 1. Incident Scene

On Wednesday, May 11, 2005, a 38-year-old male carpenter died after jumping or losing his balance from an unsecured ladder that was falling due to a gust of wind. The company's jobsite foreman instructed the victim and two coworkers to work on the siding on the west side of the house. The victim and one of the coworkers positioned their 30-foot fiberglass extension ladders on a second floor walk out deck. The 16- x 20-foot deck was constructed seven feet above grade and was unguarded on all sides. The victim and his coworker erected their ladders side-by-side and leaned them against the side of the house. Both the victim and his coworker were working approximately 15 feet high on their respective ladders. Both ladders had the ladder feet supported by a piece of plywood adhered to the deck to prevent the ladders from sliding away from the house. At approximately 8:30 a.m., the victim and his coworker were attaching wood nailers for a soffit screen when a gust of wind (~ 45 mph) from an approaching thunderstorm blew the top of the victim's ladder sideways (south) along the fascia board. As the ladder was falling, the victim jumped to the deck approximately 15 feet below and landed at the unguarded deck edge. He then fell ten more feet into a concrete basement well (Figure 1). Coworkers called 911 and the victim was transported to a local hospital where he was pronounced dead.

The coworker and deceased were installing treated lumber for the nailer for the screen soffit inside the soffit. Both workers were working approximately 15 feet high on their ladders. The coworker and deceased had been working approximately one hour. There was a thunderstorm approaching with variable high winds. The deceased had his nailbag on and was handing nails to his coworker when a 45-mile-per-hour gust of wind blew the deceased's ladder sideways along the fascia. The ladder began to fall and the deceased, as he was climbing down the ladder, either jumped from the ladder or lost his balance. The deceased fell between 10 to 15 feet knee-first to the edge of the deck, hit some equipment, and then fell 10 feet face-first into the concrete stairwell below the deck. The ladder landed on the deck.

- Construction employers should consider using scaffolds or other work platforms to work from instead of ladders.
- If a ladder is determined to be the best tool, then supervision should ensure that the ladder is properly secured against displacement, even if the ladder has safety feet.
- Employers should cover ground openings, including basement well openings when work is being performed around the opening.

Although both the deceased's and his coworker's ladders were blocked at the base, the jobsite foreman did not ensure the ladders lashed, per company policy, to prevent displacement. Blocking the ladder at its base did not provide adequate protection from displacement. Lashing a straight ladder as close to an upper support point as possible in addition to blocking will provide more protection against unexpected ladder movement. The employer stated to the MIFACE investigator that employees were instructed to lash the ladder when there was a possibility that the ladder could become displaced. The oncoming storm with the potential high winds raised the possibility that the ladder could become displaced. He stated that training had been given in the correct procedures when erecting and using an extension ladder.

The company was cited under General Rules for the open basement stairwell. The employer did not cover the basement well next to walk-out deck because the well was used as an employee entrance to the home. Although a cover may have been inconvenient, it would have provided protection from a further fall distance when the deceased fell from the deck edge. A MIFACE internet search of options to cover such an opening found transparent solid covers, rectangular grates, and fall arrest netting that could be purchased at a reasonable price to provide worker protection. If the basement well was covered, the deceased would not have fallen the additional distance and the fatality may have been prevented.

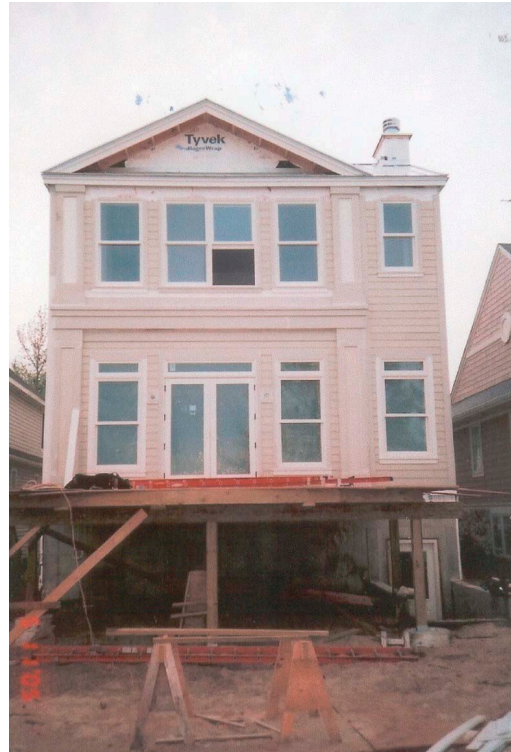
Figure 2. West Side of house

There were four employees on site, three carpenters and one jobsite foreman who had 25 years experience. The company had been working at the site for two months. The three-story home was being built on a 33-foot wide lot, with the west side of the home facing a lake. At the second floor level, there was a 16-foot x 20-foot walkout deck, built 7 feet above grade. The deck had recently been constructed and no guardrails were installed. On the south side of the deck was a basement stairwell entrance. The basement well was 4 feet 8 inches deep by 4 feet wide by 6 feet long. The concrete well floor was approximately 10 feet from the top of deck (Figure 2). There were two entrances for employees to gain access to the interior of the home. One entrance was on the street side and the other entrance was the basement well on the west side.

The victim and a coworker working from another ladder had been working for about a week installing siding. On the day of the incident, the jobsite foreman instructed the deceased and his two coworkers to continue working on the siding on the west side of the house. The deceased and his coworker positioned their 30-foot fiberglass extension ladders side by side on the deck. The third coworker stayed on the ground as a saw man, supplying material to the victim and his coworker. The coworker positioned his ladder that was extended to approximately 16 feet on the north side of the deck (north of the deceased's ladder) against the siding just above the third floor windows. The victim positioned his ladder that was extended to approximately 20 feet against the wood fascia board and drip edge soffit. Plywood "ladder boards" were nailed on the deck to prevent the ladders' safety feet from slipping away from the building. The ladders were not secured at the top. It is unknown if the deceased's ladder complied with the 4 to 1 rule. The 4 to 1 rule recommends that the distance from the bottom of the ladder to the surface it leans against should be a quarter of the ladder's extended height.
