MIFACE INVESTIGATION #07MI007

Subject: Carpenter Dies After Fall From a Ladder That Slipped From Its Base While Positioned on Frozen Sand

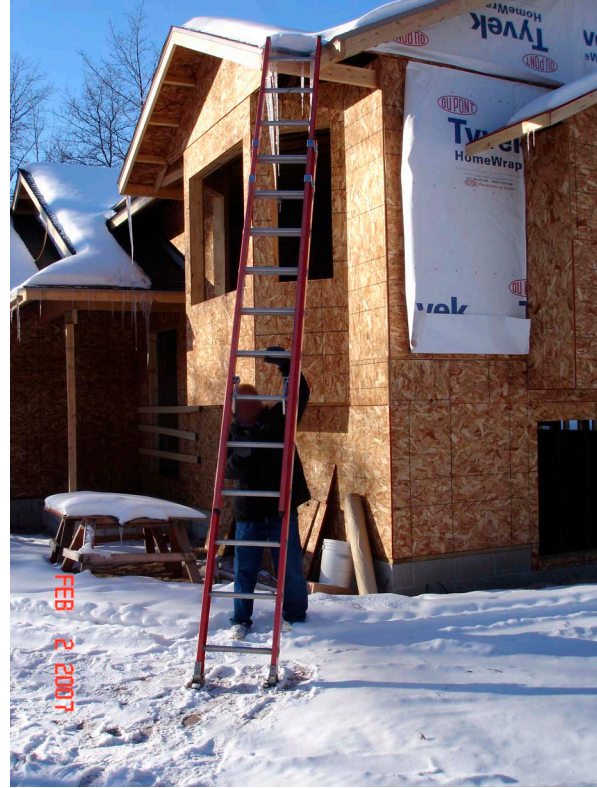
Figure 1. Re-enactment of ladder placement and position of individual holding the ladder

contribute to the fall. The top of the ladder was almost flush with the roof height. The base material was sand, frozen to a depth of approximately four inches. The pitch of the ladder is unknown. The coworker stated to the MIFACE researcher that the ladder's safety feet were in the up position and "dug into" the frozen sand (Figure 2). Figure 1 and Figure 3 were taken at the time of the MIOSHA compliance officer's site inspection and are re-enactments of the ladder position and the position of the coworker under the ladder. The sand was not snow-covered at the time of the incident. Figure 2 shows the sand base and the safety feet in the up position. The coworker also re-enacted the incident scenario for the MIFACE researcher, placing the ladder safety feet in the up position and at a similar pitch as in Figure 1 and Figure 4.

Work Practice	Discussion
Ladder placement against the house may not have been the appropriate pitch.	A portable ladder's safest pitch is when the horizontal projected distance from the top support to the base is not more than 1/4 of the vertical distance between these points. The more the base is moved from this position, the greater the risk that it will slip outwards and fall.
Ladder was diagonally placed against inside corner of the roof.	The ladder's stability was most likely compromised when the side rails were placed on a diagonal against the inside corner of the roof to protect the drip edge.
Ladder placed on potentially unstable base material (frozen sand).	Although the sand was frozen, it may not have provided a substantial and stable base as required. The safety feet may not have been dug deep enough and may have been anchored into loose sand on the frozen sand surface. One method to ensure the ladder's safety feet were embedded deeply enough in the sand would have been to use a claw hammer to dig two to three inches deep into the surface and then place the safety feet into the hole.

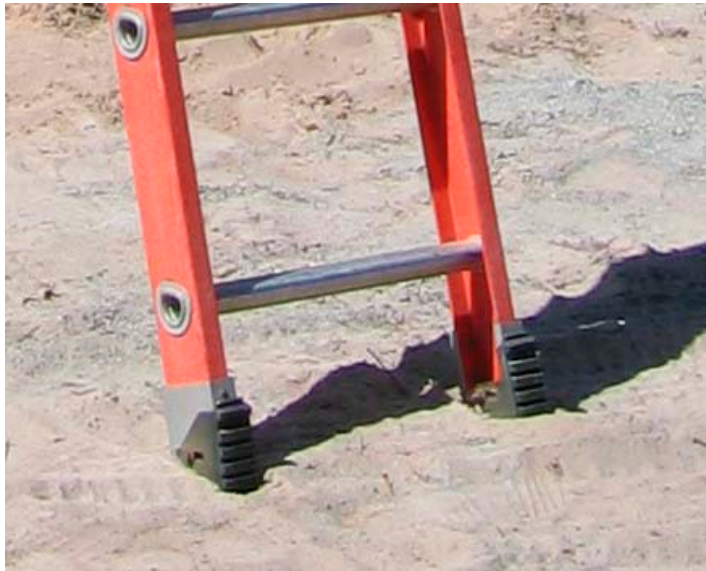
Figure 2. Ladder safety feet in the up position

The decedent had 25 years experience as a carpenter. The coworker stated that the decedent's specialty was truss work. The coworker and decedent would "correct" each other when they noted someone working unsafely. The coworker stated that if an extension ladder was to be used for more than a short period of time, the decedent would place the ladder with the safety feet up and run spikes between the ladder and the safety feet to anchor the ladder to the ground.

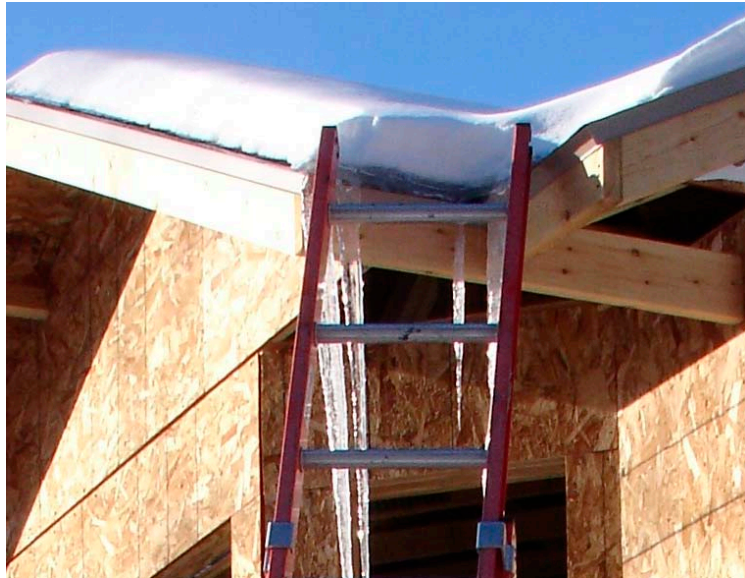
While his coworker was changing the knife blade on his utility knife to a hook blade so he could cut shingles for the ridge cap, the decedent set the Type IA fiberglass extension ladder diagonally across the inside corner of the roof to secure a 2-inch by 4-inch piece of wood to the fascia under the drip edge to protect the drip edge (Figure 3). In this incident, the ladder was clean and free of defects that might

Figure 3. Ladder placed diagonally across inside corner

Ladder not lashed or held in position.	Ladders should be lashed/secured by attaching ropes or straps to the ladder side rails, not the rungs, onto a stable, fixed object. The base of the ladder could be secured by securing ropes/straps from the ladder side rails to stakes in the ground, using fixed blocks or sandbags, or using ladder stabilizers.
Ladder not extended three feet past the roofline.	Because the extension ladder length was long enough, the ladder side rails should have been at least three feet or more above the roofline.
Individual supporting the ladder standing under the ladder.	The position of the coworker made it difficult to control ladder movement. A better position for an individual to provide ladder support would be to stand in front of the ladder, hold both side rails, and place one foot on the bottom rung of the ladder.

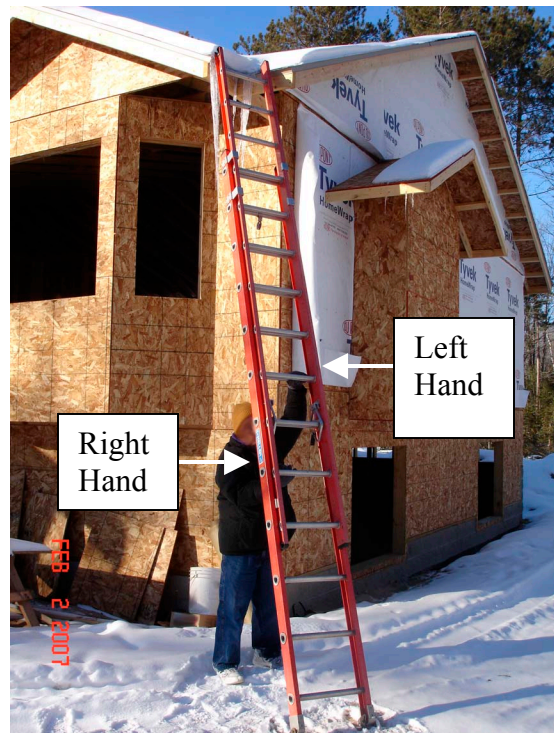
Figure 3. Re-enactment of the position of the coworker under ladder

been done in the past, the coworker stood under the ladder with his back facing the house and placed his left hand on the rung #7 and his right hand on rung #5 (Figure 4). The decedent, who was wearing his tool belt and carrying the 2-inch by 4-inch piece of wood, ascended the ladder. As the decedent climbed passed his coworker, the coworker turned his head so he would not get sand from the decedent's shoes in his face. The decedent was above the coworker when the coworker felt a "pressure on his hands." As the decedent passed him, the coworker sensed the decedent's weight on the ladder and called out to the decedent that it was too heavy for him. As he called out to the decedent, the ladder base kicked out away from the home and the coworker lost his grip. As the ladder fell, it struck the coworker on his left shoulder and arm and knocked him to the ground. The decedent, perhaps to avoid landing on his coworker, jumped/fell in the opposite direction landing on his back approximately seven feet from the ladder. The wood the decedent was carrying landed near the home. The ladder's final resting spot was several feet from the home.
