MIFACE Investigation Report #10MI021

Subject: Farmer Grading Field Pinned Under Overturned Tractor

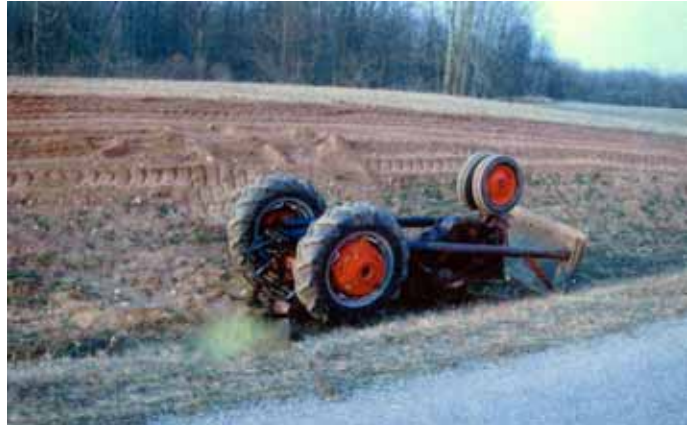
Figure 1. Incident scene.

Evidence suggests that the decedent encountered difficulty maintaining directional control of the tractor and push blade as he made a pass along the sloped edge of the field. While he was attempting to regain control, the tractor became unstable and overturned into the ditch. The decedent was unable to jump off or free himself before the tractor came to rest on top of him. When the neighbor drove the same road back to her home 15 minutes later, she

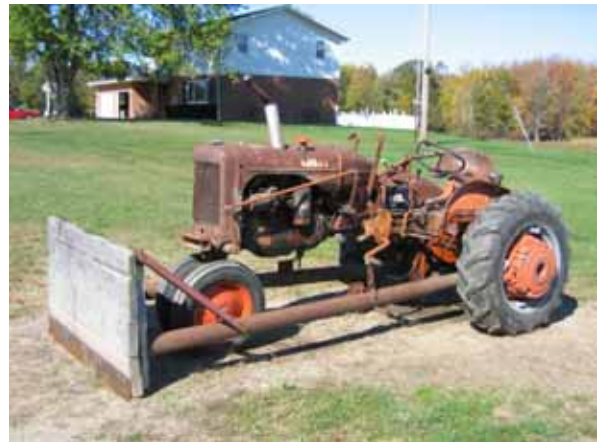
The decedent was operating a 1940s Allis Chalmers, tricycle tractor equipped with a home-made push blade attachment. The 5-foot long by 2 feet 8 inch high wooden blade had a 5-inch metal piece at its base. The blade was connected via a piece of channel iron on each end of the blade to 4-inch diameter metal pipes. On each pipe was a bracket that was attached to a chain, which was attached to a gear mechanism that raised and lowered the pipe and blade. The piping was welded to a metal bar attached to the back of the tractor. (See Figures 2 - 4). The decedent had attached two metal weights to the rear of the tractor (Figure 5). The two weights may have acted as counterweights to balance the additional weight the blade placed on the front of the tractor, or to balance the weight of the hoist mechanism for easier lifting of the blade. The attachment location of these weights was unknown. These weights became detached during the overturn.

Figure 2. Incident tractor showing home-made push blade attachment

Older tractors have limited ability to attach implements, other than what they were originally designed and intended to be used for. The decedent's tractor did not have a 3-point hitch, so a rear-mounted blade was not possible. Using a front mounted blade on a tricycle tractor to push soil contains risk and may be a misuse of the manufacturer's intended use of this tractor. Additionally, the use of farm built implements on agricultural tractors could contain unknown risks to the user due to engineering and other factors. The home-made push plow involved adding a great deal of weight to the front and sides of the tractor, which could have affected the stability of the tractor significantly.

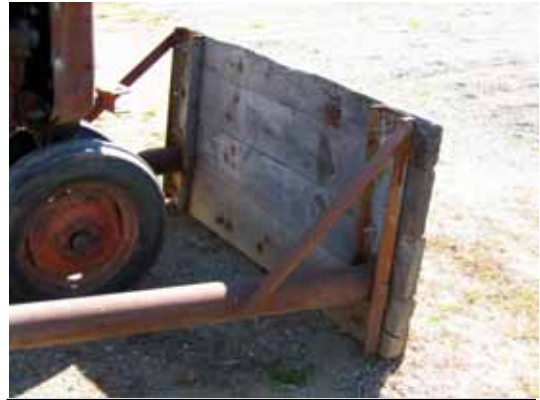
Figure 3. Close view of incident tractor showing home-made push blade attachment

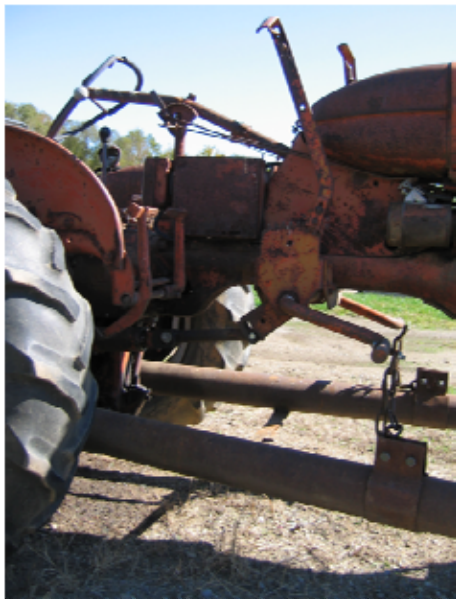
Figure 4. Attachment and hoist mechanism for raising and lowering blade

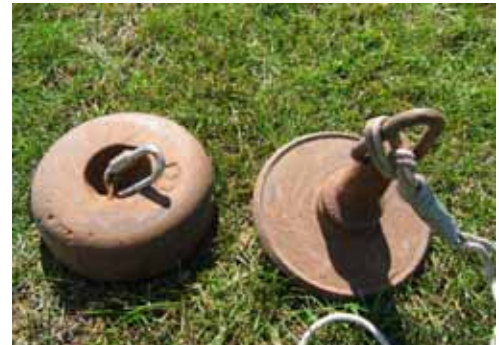
Figure 5. Weights attached to rear of tractor

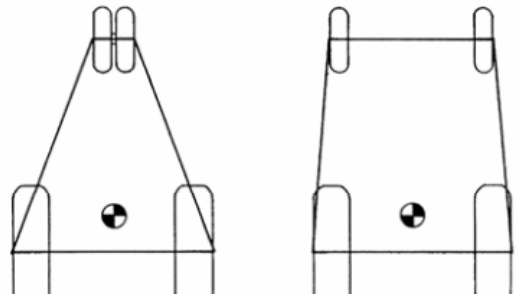
Tricycle-configured tractors, with the narrow-front wheel design are inherently less stable than tractors with a wide-wheel configuration. Tricycle tractors also have stability baselines which leave little room for error (Figure 7). The stability baseline of a tractor is made up of imaginary lines drawn between the points where the tractor tires contact the ground. Front, rear, and side stability baselines are established.

Figure 7. Stability baselines for tricycle and wide-front tractors

A tractor's center of gravity is the point where all parts balance one another. To avoid turnover, the center of gravity must stay within the tractor's stability baseline. Factors that may change the location of the center of gravity for the tractor or its relationship with the stability baselines are:

- Added weight from attachments and items being hauled will shift the center of gravity to the front or rear of the tractor depending upon weight of load and location of attachment,
- Driving on a slope shifts the center of gravity toward the load,
- Lifting a load shifts the center of gravity toward the load),
- When turning, the center of gravity shifts within the stability baseline toward the outside of the turn. Turning too fast may cause the shift to occur so quickly that dynamic forces overturn the tractor.

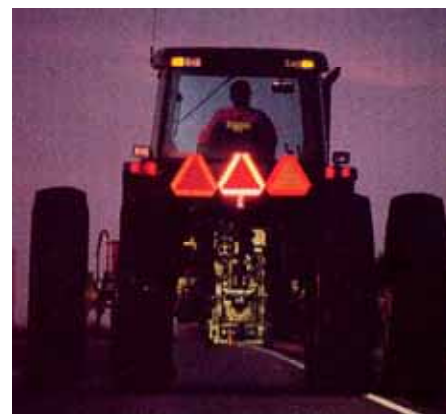
The new SMV emblems have fluorescent material aiding daytime visibility and reflective material aiding nighttime visibility (Figure 8). Replacing worn SMV emblems is important because the orange fluorescent center portion of the SMV emblem fades and turns color over time, changing from orange to yellow, pink or white. This portion is the most vulnerable to light and moisture degradation because fluorescent dyes decompose.

Retro-reflective material as found in the outer border of the SMV emblem reflects the headlights of vehicles approaching from the rear at night. Retro-reflective material lasts longer than fluorescent material. The retro-reflective readings on SMV emblems meeting the new ASAE standard are over ten times greater than most of the readings on SMV emblems currently in use. Figure 8 shows a comparison of older and newer SMV emblems. The SMV on the left is a new sign under the old standard, the SMV sign in the middle is the sign under the new standard, and the SMV on the right is an old sign under the old standard.

Figure 8. Center SMV emblem equipped with ASAE 276.6 recommendations
