MIFACE INVESTIGATION REPORT: #10MI067

Subject: Volunteer Mowing Grass Pinned by Overturned Tractor

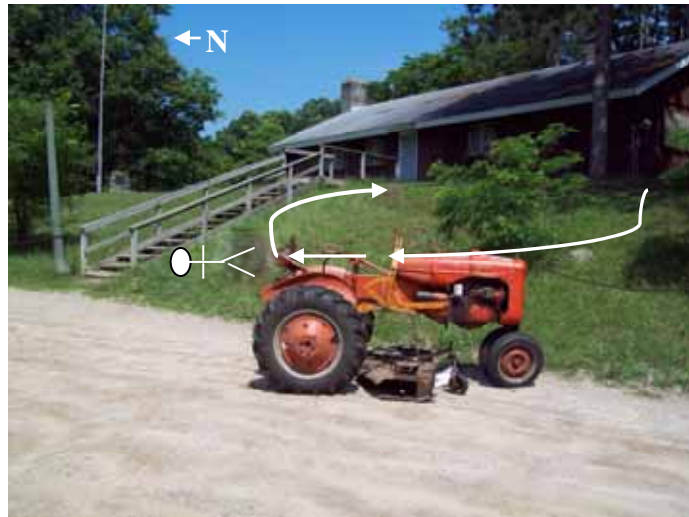
Figure 1. Overview of incident scene showing mowing path and position of decedent on hill. Tractor had been removed from decedent by emergency response.

The decedent was found face down on the side of the hill with the tractor seat pinning his right shoulder blade to the ground. His head was pointed in a northern direction and the nose of the tractor was pointed in a southeastern direction (tractor direction as shown in Figure 1). Emergency response arrived and rendered aid. The decedent was declared dead at the scene.

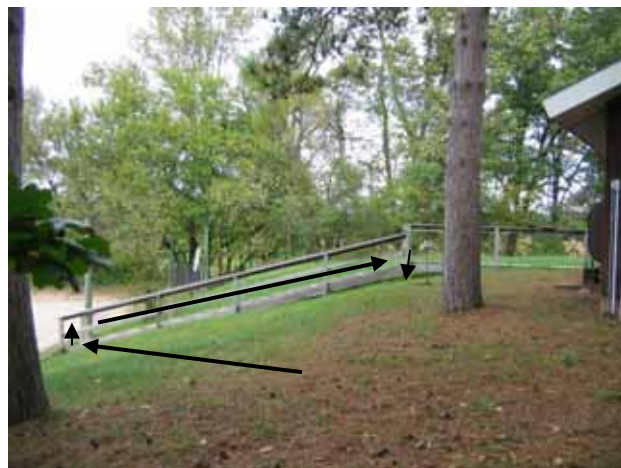
The camp was located at the end of a road on the east side of a cul-de-sac. The camp building was five feet away from the nearest tree. There was 16 feet 6 inches between the two trees shown in Figure 2. The ground was fairly level approximately 16 feet from the building and then the slope of the hill commenced. The hill undulates and there was a knoll approximately 10 to 12 feet from the edge of the road. The decedent had mowed this property for over 30 years.

Figure 2. At top of hill, facing north looking through two trees near the building.

Using the police photos indicating the pattern of the mowed grass, the following scenario has been developed. The decedent arrived at the camp and drove the tractor to the top of the hill behind the building. Starting from the top of the hill, he drove the tractor downhill between the two trees and then turned north toward the bottom stairs leading to the building. He then ascended the 30-degree hill and as he was turning the tractor southbound at the top of the hill, the outside wheel lost its traction and the tractor overturned to the side (Figure 2). His tractor, according to his family members was in first gear. His tractor speed was unknown.

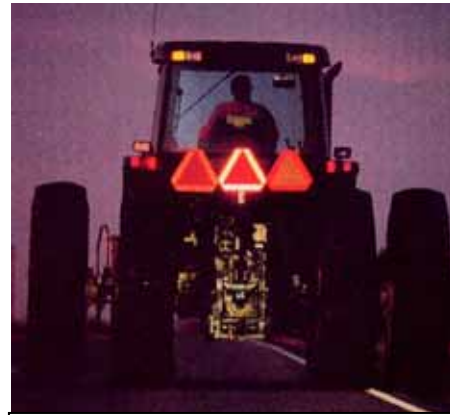
The new SMV emblems have fluorescent material aiding daytime visibility and reflective material aiding nighttime visibility (Figure 5). Replacing worn SMV emblems is important because the orange fluorescent center portion of the SMV emblem fades and turns color over time, changing from orange to yellow, pink or white. This portion is the most vulnerable to light and moisture degradation because fluorescent dyes decompose.

Figure 5. Center SMV emblem equipped with ASAE 276.6 recommendations

Retro-reflective material as found in the outer border of the SMV emblem reflects the headlights of vehicles approaching from the rear at night. Retro-reflective material holds up longer than fluorescent material. The retro-reflective readings on SMV emblems meeting the new ASAE standard are over ten times greater than most of the readings on SMV emblems currently in use. Figure shows a comparison of older and newer SMV emblems. The SMV on the left is a new sign under the old standard, the SMV in the middle is a new sign under the new standard, and the SMV on the right is an old sign under the old standard.
