MIFACE INVESTIGATION REPORT #12MI218

SUBJECT: Horse Breeder Falls 11-12 Feet From Hayloft When Throwing Hay Bale

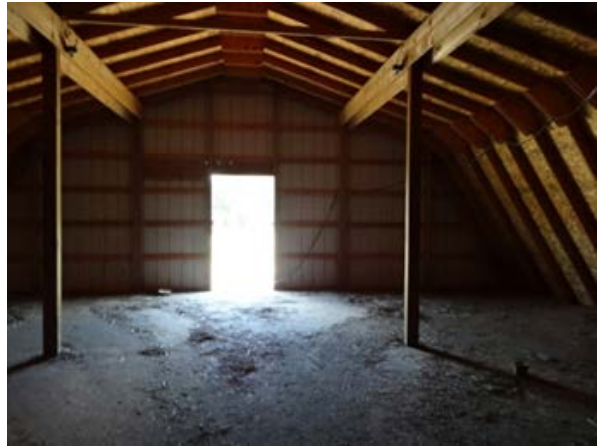
The hayloft could be accessed by stairs. Four lights were in the loft, two by each opening. Openings were located on each end of the hayloft by a sliding door. The door opening dimensions were 3 feet 9 inches wide by 7 feet high. The loft area was approximately 36 feet wide by 40 feet long. The door openings were approximately 12 feet above the ground.

Figure 2. Standing in loft area, loft opening through which decedent fell

- Install removable guardrail(s) across the loft door when the loft doors are open.

Although the doors are normally kept closed when individuals are not in the loft, they may be open while work is being performed due to time of day, limited lighting in the loft, and work being performed. When the door is slid open and kept open for lighting or work purposes, MIFACE recommends that a removable guardrail be placed across/in front of the opening to prevent an unintended fall.

- Wear a fall protection harness with appropriate anchor points to safely access each loft door.

Whenever work is performed at an elevation where the potential for a fall exists, fall protection equipment should be used. The decedent was working without using any type of fall protection at an elevation where the potential for a fall of more than 6 feet existed.
