MIFACE Investigation Report: #13MI019

Subject: Bus Driver Died While Attempting To Open Bus Doors While Bus Was Moving

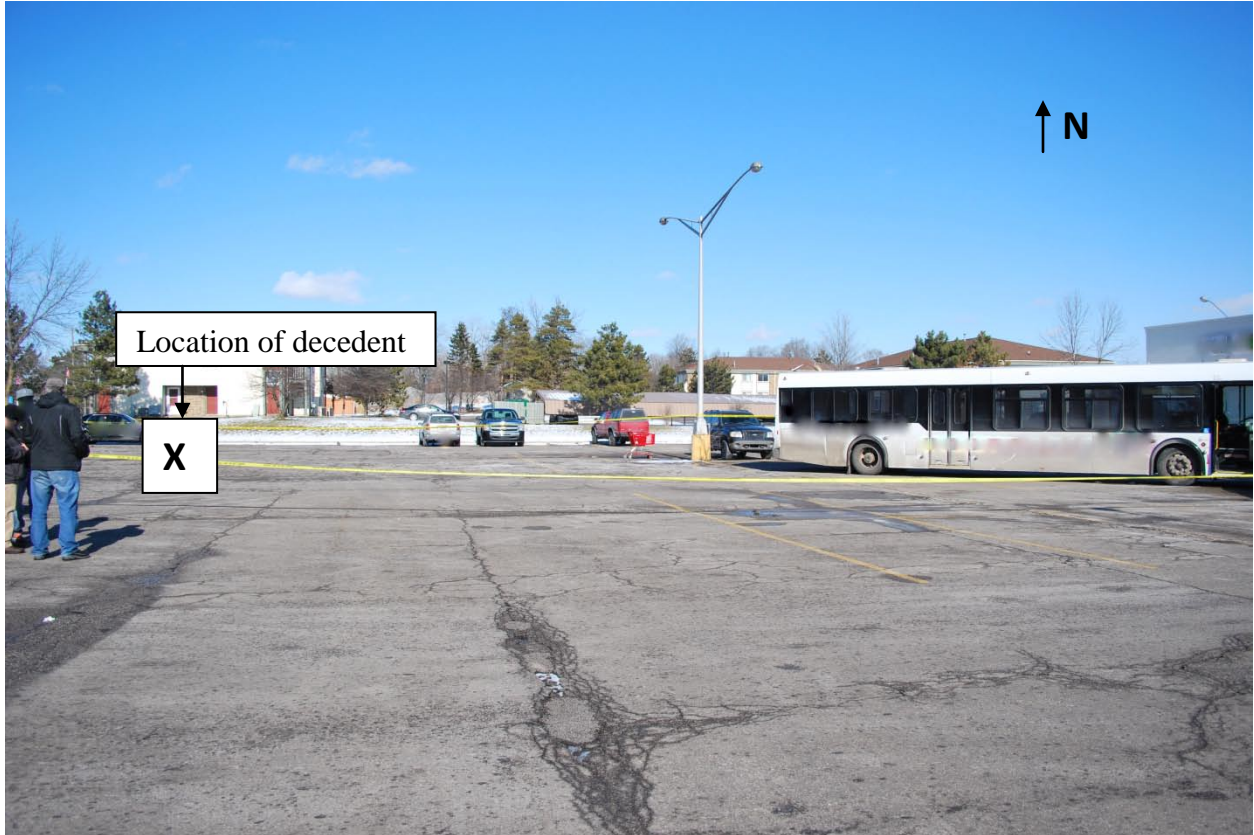
Figure 1. Overview of Incident Scene

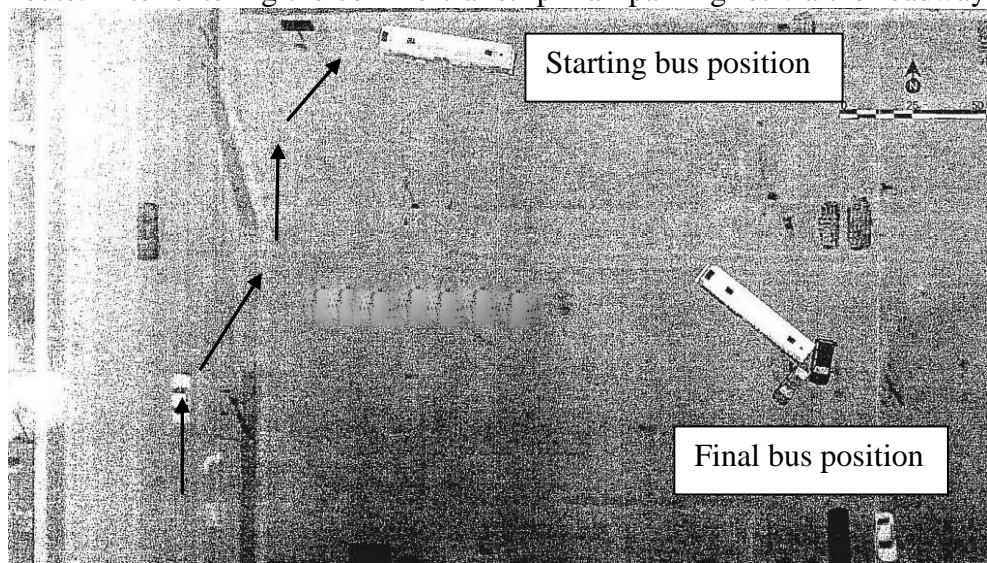
Figure 2. Police report overhead of incident scene

The bus was situated so it faced east and was positioned near the top of a slight downward slope in the parking lot. The bus wheels were turned slightly to the right, toward the center of the parking lot.

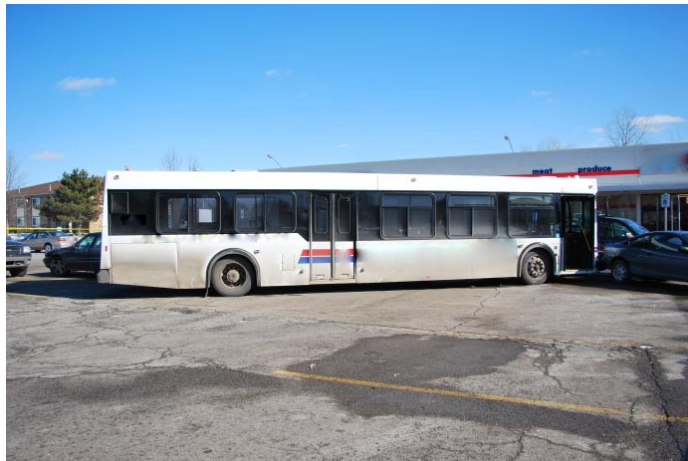
Emergency response was called. The bus continued across the parking lot and collided with two unoccupied parked vehicles, stopping its forward momentum. The police department was first on scene. After parking his vehicle and quickly surveying the incident scene, the police officer attempted to contact Central Communications by portable radio to advise them there was a subject down at the scene and to have medical personnel “step it up” due to the decedent’s medical issues. Due to the volume of radio traffic on the air, the officer was not able to get through to Central Communications. The officer noticed an ambulance traveling on a nearby roadway and flagged it down. Ambulance personnel responded and took over patient care. The officer then went to his patrol car and contacted Central Communications by radio, advised them of the incident

Figure 3. Final resting position of bus against parked cars

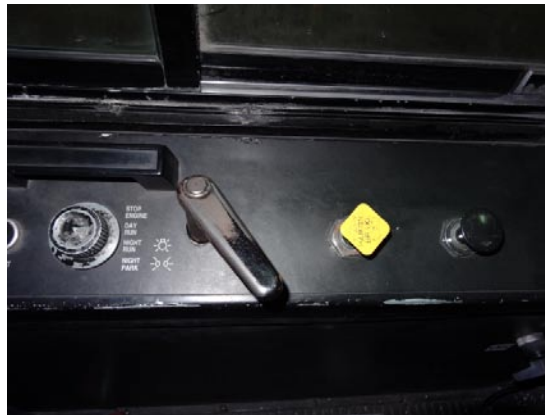
The bus door controller positions were unlabeled, possibly contributing to the complacency of the driver as she left the bus. If the controller positions were labeled, it would be easy for the driver to see what position the controller is in and potentially trigger an awareness of the bus securement procedure.

Figure 4. Unlabeled Door Controller Lever

- Transit authorities should label door controller positions for clarity.
