MIFACE INVESTIGATION REPORT: #07MI172

SUBJECT: Roofer Dies From Fall Off Residential Roof

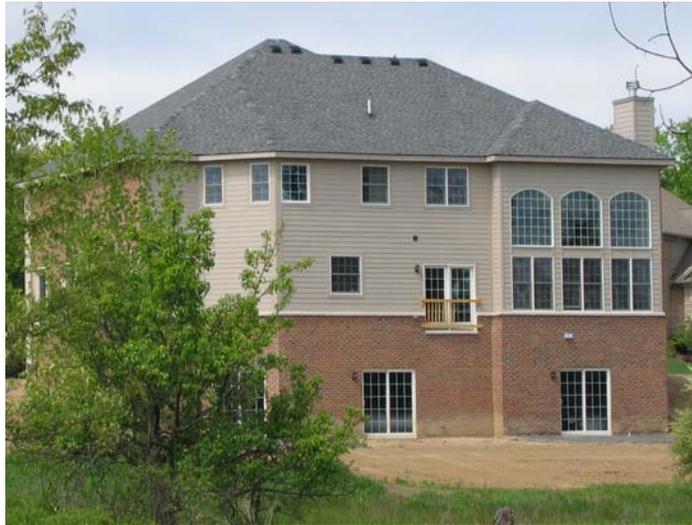
Figure 1. View of rear of residence under construction

The decedent's employer was on the "other side of the roof." When the decedent fell, he most likely landed on packed dirt. MIFACE cannot confirm this scenario because neither the decedent's employer nor the fire department emergency response personnel responded to MIFACE inquiries. (See Figures 1, 2, and 3)

- Roofers and employers conducting work activities on a roof should utilize fall protection measures when required.

Self-employed roofers and employers conducting work activities on a roof should ensure that adequate fall protection means are used. At some time during the sheathing process, the roof becomes stable enough and conventional fall protection systems are to be used. Once the first couple courses of sheathing go on, the system can be anchored at the roof peak and workers can move horizontally, moving their anchor point with them. MIFACE conducted an Internet search and found many providers of personal fall arrest systems that included the anchorage connector, body wear and connecting device, many were less than \$150.00.

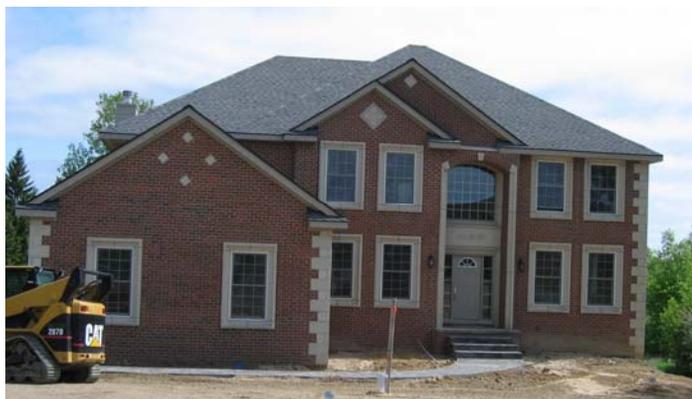
Figure 2. Front view of home under construction

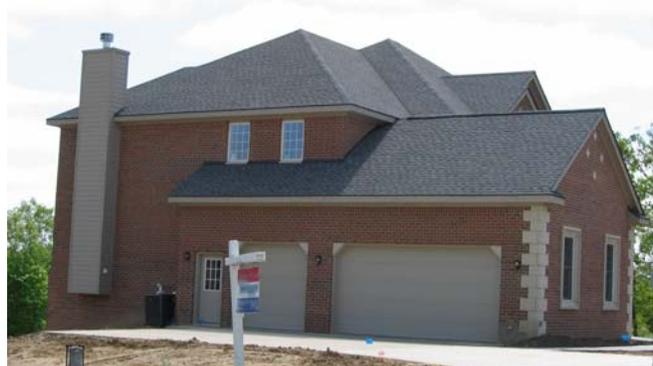
Figure 3. Side view of home under construction

In this incident, the decedent's employer could not use the exception and develop an alternative fall protection plan for the work site. The roof slopes were at 8 in 12 or less, but the roof due to roof heights would not satisfy the fall distance requirement of 25 feet or less. Conventional fall protection (guardrail, safety net systems or personal fall arrest systems) or alternative fall protection measures (other measures described under 1926.501(b) that could be used instead of
