MICHIGAN HAZARD ALERT

WORKERS FATALLY STRUCK BY VICTAULIC END CAPS DURING PRESSURE TESTING

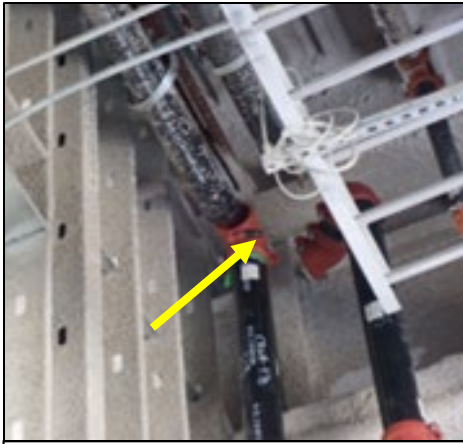
View of elbow (red) where end cap dislodged under pressure. Case 23MI139.

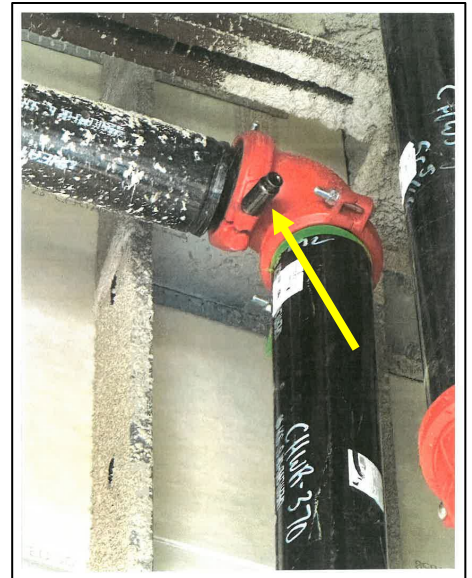
View of grooved pipe end separated to insert end cap into elbow to isolate for pressure testing. The socket remained on the coupling bolt being loosened (yellow arrow). The end cap ejected under 150 psi compressed air pressure. Case 23MI139
