## INCIDENT FACTS

**INVESTIGATION #:**  
22MI061

## Truck Driver Struck By Backing Bulldozer While Standing Near Rear of Dump Trailer

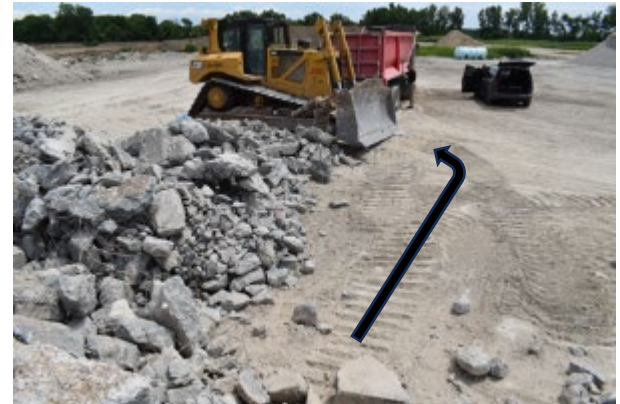
Police photo. The black arrow shows the path of the bulldozer.

Another company on site owned the bulldozer. The bulldozer operator and the site foreman were employed by the company owning the bulldozer. The 80+-ton bulldozer's rear window was 9 feet 8 inches above the ground. A cooler was situated on the rear shelf inside the bulldozer cab which may have added to the operator's blind area behind the bulldozer. The bulldozer's backup alarm was functional.

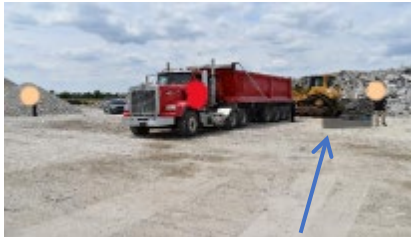
The decedent backed the tractor/trailer to the designated dump area and unloaded his concrete. He pulled forward several feet and stayed in the cab for several minutes. He exited the cab and walked behind the tandem dump truck to clear the bumper of concrete debris. He was not wearing the required company-issued high visibility vest or a hard hat. He was wearing yellow and grey gloves. The incident was unwitnessed.

Police Photo. Incident scene. Location of decedent indicated by blue arrow

- Develop, implement, enforce, and train workers regarding standard operating procedures that include, but are not limited to, minimizing work performed near vehicles and equipment. **NOTE:** The decedent had room to pull further away from the dump area to provide safe clearance for him to work.

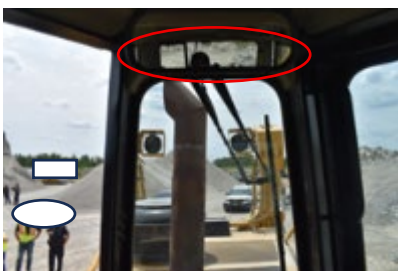
Police Photo. Rear view mirror field of view from operator seat.

- Utilize the National Institutes of Occupational Safety and Health (NIOSH) equipment blind-area diagrams available on the [NIOSH Construction Equipment Visibility](#) webpage to train both heavy equipment operators as well as workers on foot about the line-of-sight limitations (blind areas) for heavy equipment operators. **NOTE:** The decedent became a worker on foot when he exited the cab to clean the tailgate area of the truck. A similar bulldozer (Cat D7R) to the one involved in the incident is shown at right. The blind areas in the 1500 mm plane corresponding to the height of a 4' 11" person are the shaded areas. **NOTE:** The blind area for the bulldozer operator extends more than 8 meters (26 or more feet) behind the bulldozer.
