## INCIDENT FACTS

22MI115

## Roofer Dies after Contact with Power Line Causes Fall

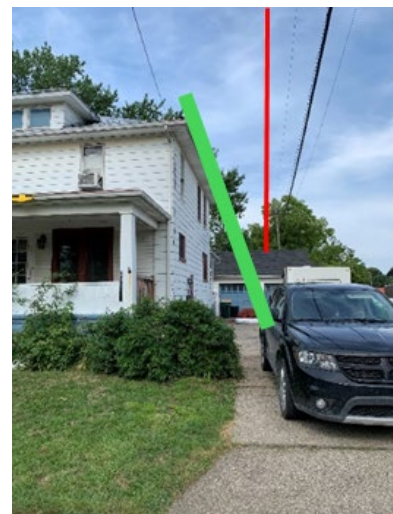
Incident scene: ladder placement (in green) and overhead line location (in red).

At some point during the day, the decedent set the aluminum extension ladder against the home. MIOSHA measured the 2<sup>nd</sup> story roof height at 20 feet and police measured the base of the ladder 9 feet 9 inches from the home. The MIOSHA investigation found the distance between the home and the high voltage overhead line to be approximately 10 feet.

The major contributing factor to this incident was the decedent's selection and placement of the ladder. Rather than access the roof in an area that was not adjacent to overhead lines, the ladder was placed near these lines and, especially given the 10-foot-long metal trim he was carrying, increased the likelihood of electrical contact. Additionally, the selection of a ladder that conducts electricity rather than a non-conductive ladder contributed to the electricity running to ground. When working near electricity, a non-conductive ladder should be selected.

Possibly contributory was the angle at which the ladder was placed. The ladder placement did not follow the required 4:1 rule so the ladder did not meet the required 75.5° angle; the approximate ladder angle was 64.8°. The ladder base should have been positioned approximately 5 feet from the home rather than 9 feet 9 inches. The ladder angle coupled with the length of the metal trim as the decedent climbed the ladder may have placed the trim close enough to contact the overhead line.

Non-contributory to the fall included that the top of the ladder did not extend at least 3 feet above the upper 2<sup>nd</sup> story roof, was not secured, and was not equipped with safety feet.
