22MI112

## Owner Suffers Fatal Fall While Changing a Lightbulb

### SUMMARY

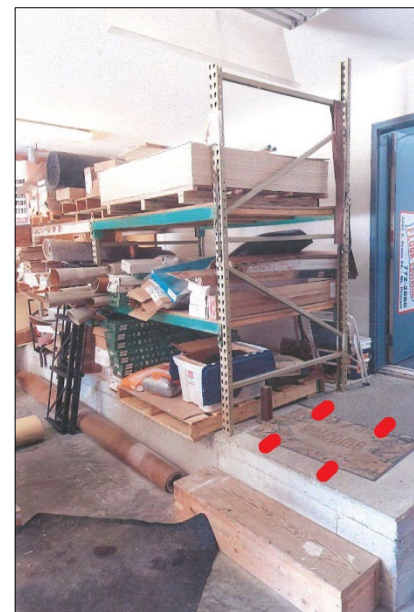
On the day of the incident, he was working alone to replace the overhead fluorescent bulbs at the showroom entrance from the shop/warehouse. A nearby wooden step from the floor up to the landing was 8-10 inches high. He utilized a well-maintained 4-foot Werner fiberglass stepladder with a 225-pound capacity to reach the ceiling level lightbulbs positioned 87 inches (7.25 feet) above the landing. The rated load of the ladder was adequate for the weight of the victim, tools, and equipment. Additionally, the step ladder had a maximum reach distance of 8 feet. While working overhead, he fell off the ladder, striking his head on the cement floor below. A bystander found the owner unconscious, and there were no witnesses to the fall. It is hypothesized that the decedent may have overreached on the ladder while changing the bulb, or that he may have placed the feet of his ladder too close to the edge of the concrete landing leading to the outside door. It also may be a combination of these factors.

Overview of work area. The approximate location of the feet of the stepladder at the time of the incident is represented by red markings.

- Training and Hazard Recognition
  - Ensure thorough training for employees on ladder safety, emphasizing the selection of the appropriate ladder for the task, regular inspection, and recognition of hazards. Train workers to maintain stability, avoid leaning or reaching away from the ladder, and always maintain three points of contact while ascending or descending.
- Ladder Selection and Inspection
  - Prioritize the selection of ladders suitable for the task and ensure they are inspected before each use. Verify that the ladder's weight capacity is adequate and that all components, including spreaders, are in good condition. Inspect the surrounding area for obstructions and ensure the ladder is placed on a firm, level surface.

- Work Environment Preparation
  - Create a clutter-free work environment around the ladder and ensure it is positioned away from any potential hazards or obstructions. Consider the use of a work partner to hold and steady the ladder during tasks.
- Utilization of Fall Protection and Equipment
  - Provide appropriate fall protection equipment and select the right tools for the job, including ladders, scaffolds, etc. Consider alternative equipment such as mobile work platforms with guardrails for tasks requiring overhead work, ensuring workers can maintain stability and use both hands effectively.
- Compliance with Standards
  - Adhere to relevant regulatory standards such as 1910.23 for ladder use in General Industry and 408.41112 for Construction. Adhere to provisions regarding ladder stability, maximum height, and limitations on standing positions.

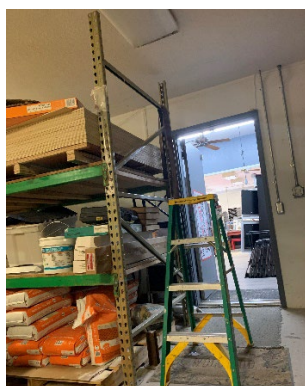
Stepladder position.
