**REPORT #:**  
25MI025

## CONSTRUCTION FATALITY NARRATIVE

### Residential Roofer Falls 25 Feet Removing Tarp

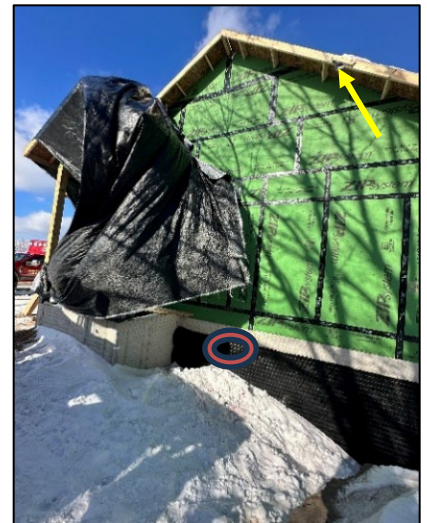
At around 9:49 am a 29-year-old roofer fell 20-25 feet to the ground on the side of a residential home sustaining fatal cranial and cervical fractures. The roof was a steep roof with 8 in 12 pitch (vertical to horizontal). The plywood roof sheathing was fully tarped and had some snow on it. The ground was frozen and snow-covered. Historical weather data at the time of the fall shows the outside temperature was 20 degrees F and wind speed 10 mph (Source Weather Underground). The victim went on the roof to cut and remove the tarp and sweep off the snow so that the crew could install a shingle roof. The tarp was held on to the roof using 2x4 pieces of scrap wood attached to the side edges of the roof. While cutting off the last part of the tarp near the roof edge, a wind gust reportedly caught the tarp, and the victim fell 20-25 feet onto their head. It was not clear if the fall was witnessed. Other employees heard a scream. The victim was found wearing a body harness but was not connected to a lanyard or lifeline. Co-workers pounded on the homeowner's truck window attempting to get his assistance, as the company owner was not on site. The homeowner followed the workers to where the victim was lying, and initiated CPR after calling 911. CPR was taken over by a fire department ambulance crew, but the victim was pronounced deceased at the worksite. The cause of death was multiple blunt force injuries, and manner of death was accidental. A drug and alcohol panel was negative for all substances. The homeowner spoke only English. The roofing company owner spoke English and Spanish but had left the site. The workers including the victim spoke only Spanish. The owner of the company supplied body harnesses but did not verify use.

The tarp involved and victim's impact location (red circle) located on the right side of the house when facing the front. The yellow arrow indicates 2x4 sections used to attach and hold tarp on. Photo source: police photos.

- Always ensure employees in construction are protected by a fall protection system when exposed to fall hazards including roof edges or openings or at any heights more than 6 feet from a lower level.

- Identify all job steps that involve fall exposure. Ensure the protection system is in place before work begins.
- Seek assistance from an equipment manufacturer's technical representative or safety professional if needed to help choose the correct fall protection system.

- Develop work rules for when fall protection is required and communicate them to employees.
- Ensure all fall protection components including anchors and connections are installed according to manufacturer requirements before roofing work begins.

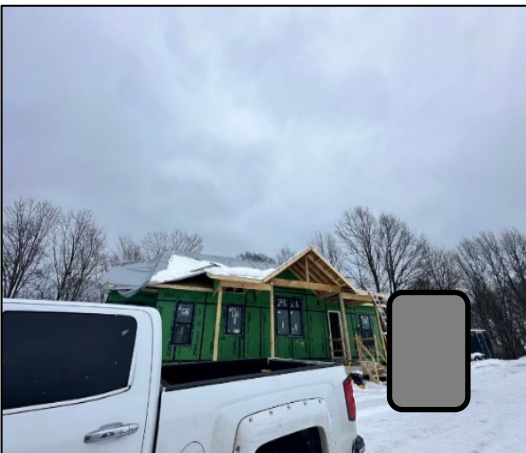
Front of house before tarp removal began. The tarp had to be cut at roof edge where scrap 2x4 was attached and holding it. The grey block excludes employees. Photo source: police photos.
