MIFACE INVESTIGATION #01MI047

SUBJECT: Corrections Officer Dies When He Falls Off Ladder While Supervising Prison Work Crew

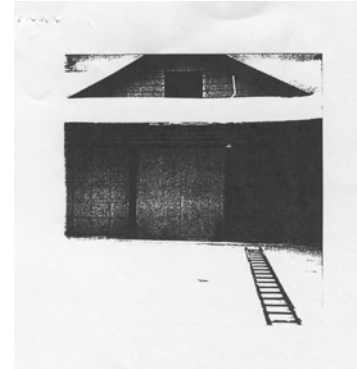
Police Department Photograph

The work crew was contracted to clear the snow off of a building roof. To accomplish this, they were going to use shovels to push the snow off of the roof. The 17-rung, 18-foot wood straight ladder used to gain access to the roof was stored inside of one of the project agency's buildings. The ladder rungs were not snow covered. However, the ladder did not have safety feet. Safety feet as defined by MIOSHA means a safety device placed on the foot of the side rails to reduce the likelihood of the base slipping. Safety feet can be flat pads covered with a non-slip material, pointed metal projections, or spur wheels. The ladder was placed against the building. The asphalt had been shoveled, but was icy. The deputy warden stated that most of the time, inmates are elevated using a pallet on a Hi-Lo to gain access to the roofs to clear snow.

The snow clearing operation began with one inmate climbing the ladder to the roof. The correction officer was supposed to stay on the ground during the snow clearing operation. The inmate on the roof called out to the correction officer. It is unknown what the inmate said that caused the correction officer to climb the ladder. The other inmate held the ladder to steady it as the victim climbed up to the roof. The victim was wearing appropriate winter clothing and work boots. It is unknown if the victim knocked the snow off of his boots prior to ascending the ladder. Snow on the boot soles could affect traction on the ladder rungs. The officer was not carrying any piece of equipment to the roof surface.

The sequence of events leading to the fall from the ladder is unknown. One possible scenario is that as the victim began to transfer his weight from the ladder to the roof, the ladder slipped and the victim's foot became entangled, he lost his balance and fell backward toward the asphalt with his foot still entangled in the ladder. Another possible scenario is as the victim neared the roofline, the victim's foot became entangled between the ladder rungs causing the ladder to slip on the icy surface. The inmate holding the ladder stated that the victim's foot was entangled in the ladder when he struck the ground. The inmate holding the ladder contacted the property owners, and emergency response was requested. The emergency responders stabilized the victim and transported him to a local hospital. He was released from the hospital and returned home with outpatient treatment. He began having seizures at home, was re-hospitalized, and later died.

The correctional officer had not received ladder safety training. Ladder safety training would include information about ladder inspection and the requirement for a ladder to have safety feet. Training should also include safety measures a person should take prior to ascending the ladder, i.e. making sure boots are free from grease, oil and contaminants to minimize slipping on the rungs. It is unknown if the ladder was appropriately labeled and if victim knew that safety feet were required on the ladder. It is also unknown if the victim asked the project agency for another ladder. Following the incident, MIOSHA provided a ladder safety class to work crew supervisors.

The ladder was also used on an icy surface; the area was shoveled, but not de-iced. The icy surface may have been a factor in this fatal incident. By not de-icing the surface, the ladder base was unstable. A ladder should not be directly placed on a slippery surface; a non-slip mat or other surface should be provided. A ladder should have non-skid feet or spurs to prevent slipping.

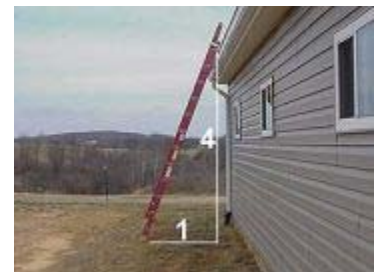
It is also unknown if the straight ladder was correctly set using the “4 to 1 rule”; set the ladder’s base 1 foot from the wall for each 4 feet of ladder length. Rungs are generally one foot apart, so an estimate of the distance of the base from the wall can be done on-site.

Part 4, Rule 443 requires that ladders must be inspected before its use as well as after it has fallen or been involved in an accident to determine if it needs repair or replacement. Rule 443 specifies the ladder conditions that require a ladder to be repaired or replaced. Ladder inspection should include at least: condition of rung, cleats, steps, side rails and safety feet (no cracks, bends, breaks, free of oil and grease, etc.), hardware and fittings secure and undamaged, and moveable parts operate freely. There are many examples of ladder checklists (and safe ladder procedures) on the Internet that can be tailored for site-specific use.

Ladder safe use procedures should be developed and implemented. As part of the procedure, prior to ladder use, the ladder checklist should be completed to ensure the ladder is properly maintained and safe for use.
