## MIFACE INVESTIGATION: #01MI056

**SUBJECT:** Grader Operator Run Over by Rear Tire While Jumpstarting Grader

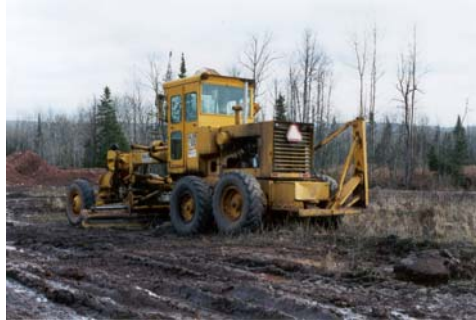
On July 30, 2001, a 63-year old male died from injuries sustained when he was run over by the rear wheel of a grader. A coworker driving a bulldozer was spreading gravel and the grader was following the bulldozer leveling the gravel. The grader stalled and would not restart. The bulldozer drove behind the grader, and pushed the grader to a location where the bulldozer could be used to jumpstart the grader. The victim attempted to jumpstart the grader with jumpstart cables but was unsuccessful because the grader was in 1<sup>st</sup> gear. The victim left the cab. He stood between the rear tires and used pliers to jumpstart across the solenoid. When the engine started, the grader moved forward, running over the victim with the rear tire. The coworker shut down the grader after the blade struck a bank of dirt and stopped moving. The coworker ran to the highway and flagged down a car to call for emergency assistance. The motorist's cell phone could not get a signal. While the coworker was using the motorist's cell phone, another company employee arrived with a load of gravel. The truck driver drove to another area on the road, contacted the office. The office called for an ambulance service (911 emergency service is not available). The ambulance personnel arrived 15 minutes after being notified of the incident. The victim was declared dead at the scene.

- Employers should discourage jumpstarting equipment; if absolutely necessary, jumpstarting a piece of equipment should be allowed only from the battery while the operator is in the equipment cab.
- Company policy should prohibit use of equipment if not in proper working order, remove from service all equipment in need of repair until repairs are made, strictly enforce employee reporting of defective equipment.
- Equipment owners should ensure that an owner and/or operator manual is available on the equipment and for use in service/maintenance procedures.
- Employers must ensure that a person with a valid certificate in first aid training is present at the worksite to provide first aid.
- Company management should consider developing a joint health and safety committee.
- Employers should provide all field personnel a means for emergency communication in case of injury.

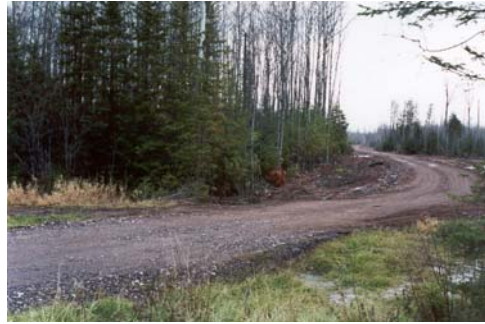
The company had purchased land and was putting in a road back to an area where there was future home construction. The road construction operation had been going on for approximately 3 months. The road was dirt covered, and the two employees working at the site were laying gravel/rock on the road surface. A dump truck had previously delivered a load of gravel. The bulldozer was distributing the gravel, and the grader was leveling the gravel on the road. It had been raining that morning. The ground was muddy.

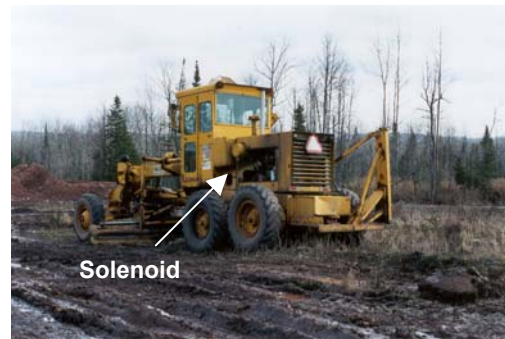
The victim usually used this grader when he performed work at the company. The grader was at a different location in the morning of the incident. The grader was jumpstarted in the morning with a pickup truck, and driven on the road by the victim to the incident location. While spreading the gravel behind the bulldozer, the grader stalled. The victim exited the grader cab. The grader location would not allow the bulldozer to get close enough to use the bulldozer battery to jumpstart the grader. The bulldozer drove around to the back of the grader, and pushed the grader forward to place it in a position to be jumpstarted by the bulldozer. The grader operator retrieved jumper cables from his truck while the dozer operator came along side next to the grader, approximately 5 feet away. The grader was facing west, the bulldozer operator was facing east.

It is unknown if the victim kept the grader in 1<sup>st</sup> gear or placed the grader in neutral while being moved into the position by the bulldozer. Because the grader was in gear during the jumpstart, a safety switch prevented the engine from starting. The safety switch allows the grader to be started only when the gear is in neutral; if in gear, the grader will not start. The key was in the "on" position. The cover is left off in the summer to assist in cooling the compartment; it had not been replaced when the grader was observed in the winter.

The victim placed the jumpers on the bulldozer battery and the positive jumper lead on the grader solenoid, and the negative on the grader frame. The victim did not use the battery to jumpstart the grader; he hooked directly to the solenoid. The solenoid regulates the power from the battery to the starter. This was the first time the dozer operator saw the victim jumpstart directly from the solenoid. The victim climbed inside the grader cab and attempted to start the grader. With the bulldozer running, it was probable he could not hear if the engine was turning over.

The company does not discourage jumpstarting equipment, only that an operator must be in the cab during the procedure. MIFACE recommends that the company discourage jumpstarting a machine. If the machine requires a jumpstart, it is likely that the machine is in need of service, and should be taken out of service and returned to the shop. MIFACE also recommends jumpstarting should be authorized only when necessary to return the machine to the shop, and only the equipment battery should be used to jumpstart the machine.

The company tagged the equipment with a safety alert warning tag which alerts the employee to the dangers of jumpstarting at the starter and starting the equipment while standing on the ground. The tag recommends keeping the starting system in repair, and keeping the starter solenoid cover in place. The company had not placed a solenoid cover on the solenoid. Jumpstarting from the solenoid bypasses all safety switches; the equipment battery should be used to perform the jumpstart.

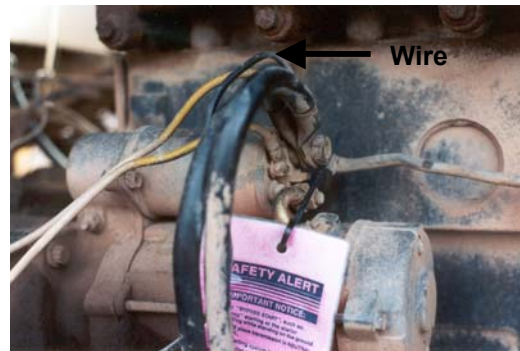
Figure 2

The job was finished the next day using a bulldozer to spread the gravel. When the grader was removed from the location, the grader required several jumpstarts while being loaded on a trailer for transport back to the company office. The grader operator who removed the grader from the incident site determined the cause of the repeated stalling of the grader. He noticed that when the grader fan was blowing, it would pick up the wire (Figure 2) that feeds power from the battery to the ignition inside the operator cab. This lost wire connection from the solenoid caused the grader to stall, and made it appear that there was a dead battery.
