## **MIFACE INVESTIGATION: #01MI058**

### **SUBJECT: Farmer Run Over by a Tractor and/or Manure Spreader**

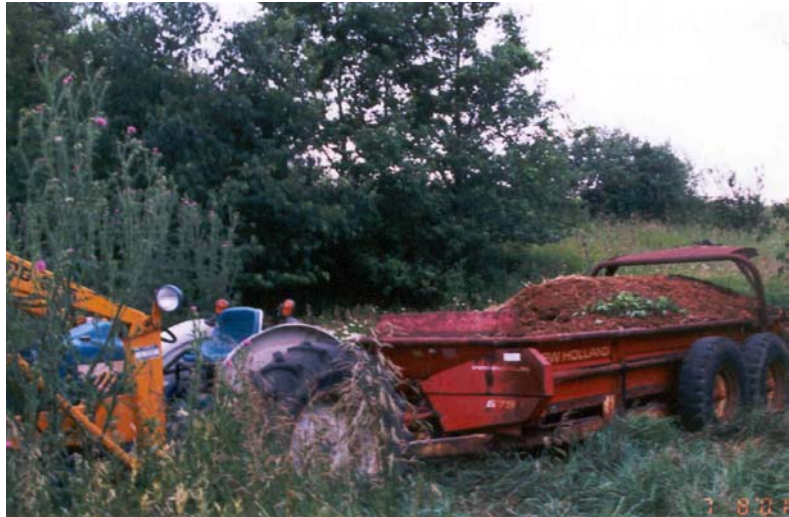
Figure 1- Police Photograph

On July 7, 2001, a 58-year old male part-time farmer died from injuries sustained while spreading manure in a nearby vacant open field with rolling hills. It appears that just after cresting a hill with a full manure spreader, he stopped the tractor, perhaps to retrieve his hat that had blown off of his head. Leaving the tractor running, the front-end loader bucket in the raised position, he dismounted from the tractor. After the victim dismounted, the tractor began to roll down the hill. The sequence of events leading to the fatal injury is unknown. It appears that the victim was run over first by the rear tractor tire and subsequently the manure spreader. The victim's hat was located approximately 57 feet from where the victim was found, in the direction of the wind. No one saw the incident. When the victim did not return home, his wife went to look for him. When found, 911 was called. He was pronounced dead at the scene.

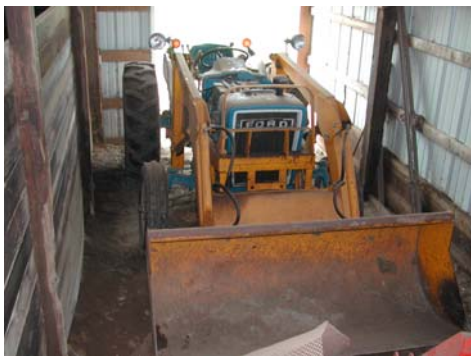
Figure 2

The tractor was a Series 3000, Ford model CA 223C, built in 1975. He bought the tractor used. The victim did not have an operator's manual. He had been having trouble with the tractor. The tractor had stalled in a field behind the house a few days before the fatal incident. The victim changed the plugs and points on the tractor and the tractor worked as desired for the next two

The tractor did not have a PTO master shield. The tractor was equipped with a Ford Model 335 front-end loader. See Figure 2. The victim filled the New Holland Model 679 tandem axle manure spreader (Figure 3) with manure the night before the incident. The tractor horsepower recommended by dealer and manufacturer information for the manure spreader was 80-85 horsepower.

The victim did not lower the loader attachment on the tractor to the ground, which may have placed additional stress on the brakes/transmission's ability to keep the tractor in place on the slope. The victim appeared to have placed the transmission in the neutral or park position with the engine running. It is unknown if he set the parking brake. He may have assumed he was protected from the tractor's movement down the hill by placing the tractor in neutral. Even if the brakes were set and the transmission in neutral, the brakes may not have been able to "hold" the loaded manure spreader on the slope of the hill.

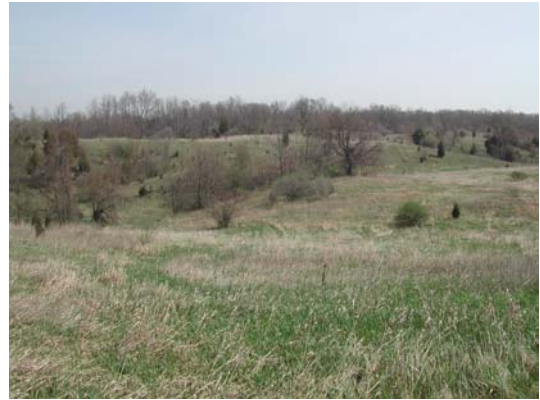
Figure 4

The field was acreage of vacant property. It was rolling, and had a few mature trees and some scrub-type trees. The property was covered by tall grass approximately 2-3 feet high. He normally spread the manure in this field. He entered the field, crested the first major hill, and began to go down that hill. (Figure 4 – View from top of hill). Barely past the top of the hill, the police found his baseball cap. It is unknown why the victim got off of the tractor. When the victim dismounted from the tractor, he left the loader in a raised position, the tractor engine running, and the transmission placed in Neutral. Based on the position and injuries sustained by the victim and the marks on the victim's clothing, it is probable that he was first run over by the rear tractor wheel, and as the tractor continued down the hill, the manure spreader wheel. It is unknown if the parking brakes were set.

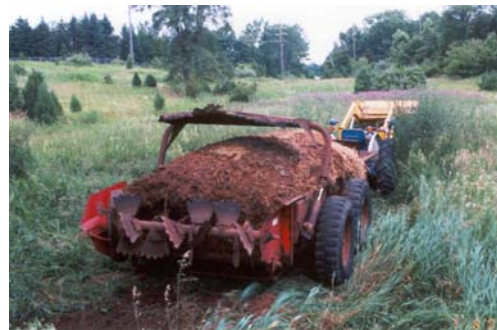
Figure 5 – Police Photograph

The victim spread the manure approximately every 2 months. It normally would take him approximately an hour round trip from his home to spread the manure at this location. When a couple of hours passed and the victim had not returned his wife attempted to reach him by cell phone. Unable to reach him, she went to the field to look for him. She found the tractor, still running with the manure spreader at a low point in the field (Figure 5). Police pictures taken at the scene indicate that the manure spreader was operating as the tractor and spreader proceeded to the base of the hill.

Upon finding the tractor, she shut off the tractor using the keys in the ignition. She searched the field while calling out to her husband. She could not find him and there was no answer to her calls. Unsure of what happened to her husband (maybe walked home via another route, possible heart attack), she returned home and called some friends to help her find her husband. The friends and the victim's wife returned to the field to search for him. Walking along the path of matted weeds made by the tractor as it descended down from the top of the hill, she found her husband, approximately 200 feet from the final resting position of the tractor. 911 was called and emergency personnel declared the victim dead at the scene. The police report indicated that the tractor had two shift levers; one appeared to be engaged while the second shift lever was in the neutral position. The key was in the off position and the engine was off.
