MIFACE INVESTIGATION: #02MI028

SUBJECT: Rigger Killed When Equipment Being Unloaded From A Semi-Trailer Fell From the High-Lift Fork Truck and Landed on Him

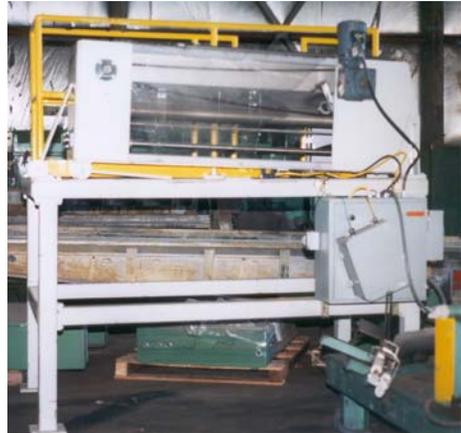
On March 1, 2002, a 52-year old rigger died while he was assisting in the removal of a piece of metal framework weighing 1500-2500 pounds. The framework was located in the middle of an enclosed trailer bed. Approximately ½ of the trailer load was material on pallets and had been unloaded from the trailer with a high lift fork truck. The metal framework involved in this incident was free-standing, not on a pallet. The handrail side of the framework was facing the open end of the trailer; the opposite side of the framework had a hopper and the equipment motor and was facing the truck cab. To remove the framework, a chain was wrapped around the bottom rails and the framework was pulled to the end of the trailer bed by the forklift.

While pulling the framework toward the end of the truck, the framework became “cocked” to one side and lodged or caught on something in the trailer and would not continue to move. The forklift was positioned so the forks were placed under the lower framework cross beams and the handrail side placed against the backrest. The victim climbed into the trailer, went under the framework and knelt on the bed floor while under the framework to see what the framework was caught on and to guide the forklift operator. The forklift operator lifted the framework a short distance from the trailer bed floor. As it was being lifted, the framework became dislodged. The sudden movement allowed it to lurch off of the forks toward the hopper/motor side. The victim attempted, but was unable to get out of the way of the falling framework. The hopper landed on the victim’s back pinning him to the trailer bed floor. The semi-truck driver called 911 and emergency responders arrived. The victim was declared dead at the scene.

- Employers should ensure that powered industrial truck operators properly position and secure all loads before lifting and prohibit employees from working under raised loads.
- Employers should develop and implement a comprehensive safety and health program that includes a powered industrial truck safety program and employee training.
- Employers should conduct a job safety analysis for each individual rigging job.
- Employers should develop and implement a health and safety committee that includes representatives from both management and labor.
- The company should develop a written disciplinary procedure for safety and health policy violations.

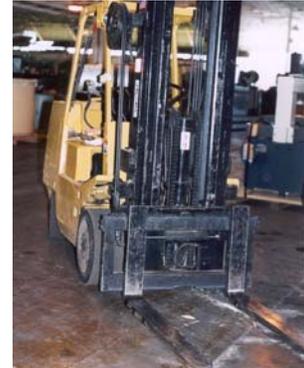
Figure A

MIOSHA General Industry Safety Standard Part 21, Powered Industrial Trucks defines a powered industrial truck as a “mobile, power driven vehicle used to carry, push, pull, lift, stack, or tier material”. The powered industrial truck used to unload the trailer was a TCM solid tire propane gas-driven high-lift fork truck (herein after referred to as forklift). The forklift tines were 4 feet long and spaced 43 inches apart. The load center was 30 inches and the lifting capacity was 3900 pounds. The forklift used during unloading is shown in Figure A. There was another forklift nearby that had longer tines and a greater load capacity.

The forklift used to attempt to free the framework was capable of safely lifting the framework, but the length of the tines did not completely support the beam cross member on the side of the machine with the most weight. It is unknown if the forks were positioned as far apart as possible prior to trying to free the framework. The forks had been in a position to handle pallets, and to provide more support for the framework, the forks should have been placed a greater distance apart to aid in stabilizing the load.

Although the fork length was 2/3 of the load's width, the side with the most weight was not completely supported. When the equipment jumped off the forks, there was not enough fork length for the equipment to fall on and the equipment rolled off of the tines. Another forklift in the area had longer tines and would have provided more support for the framework side that carried the most weight.

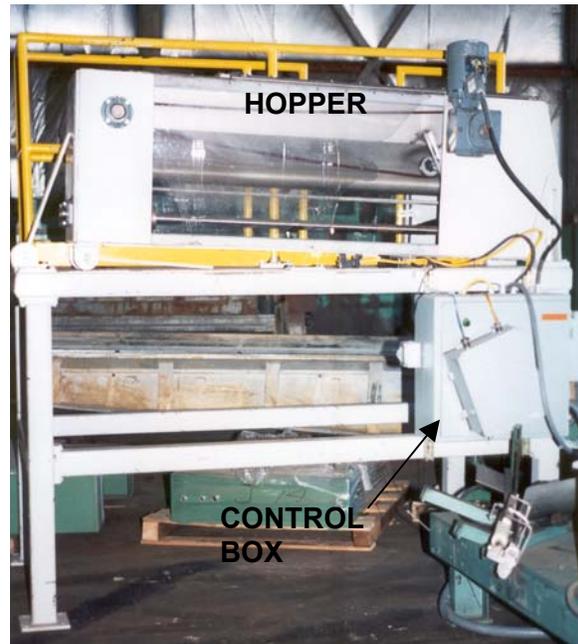
The framework was hollow steel and weighed between 1500-2500 pounds. The 8x8 inch steel plates (1) on the base of the 4x4 inch legs permitted the equipment to be freestanding. The framework was 97 inches long from the outside edges of the steel floor plates and the width from the outside edges of the legs was 53 inches. The bottom horizontal support was 33 ½ inches from the ground; the framework height was 58 inches tall. The hopper setting on a steel plate on top of the framework was 32 inches high. The equipment control box was 11 inches wide, 34 inches long and 23½ inches high. The metal guardrail on top of the framework was 41 inches high. The total height of the equipment was 99 inches. According to the company owner, the equipment was “top-heavy” and the side with the hopper and control box had more weight associated with it.

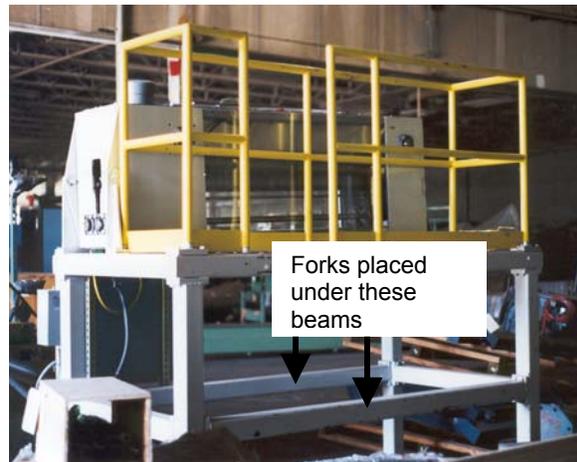
The forklift operator placed the forks under the horizontal beams. Due to the 53-inch width of the framework, the 4 foot forks did not reach under both of the horizontal cross beams. The side of the framework with the hopper and control box were unsupported by the forklift tines. The forklift driver tried to raise the framework up slightly while the victim

guided the maneuver. The victim had placed himself under the framework, kneeling on the trailer bed to try to see what was caught. MIFACE postulates that the framework steel floor plates, when lifted off the trailer bed, were caught on the scuff rail were placed under tension. When they “broke free” of the scuff rail, the sudden movement allowed the framework to move on the forks. Since the side with the most weight was unsupported, the framework began to tip in that direction. The victim could not get out of the way fast enough, and the framework landed on his back.

- Employers should ensure that powered industrial truck operators properly position and secure all loads before lifting and prohibit employees from working under raised loads.

The incident occurred after the forklift operator tried to lift a load that was top-heavy, had its weight concentrated on one side, and was off-center of the forks. Due to the construction of the framework, the center of gravity, i.e., the point on an object at which all of the object's weight is concentrated, was toward the side of the framework with the hopper and motor. The framework was on a slight angle in the trailer, so the forks were not positioned in a straight manner and the framework was not sitting straight against the load backrest.

The framework was not secured to the forklift prior to the lift to prevent the framework from falling off the forks. As he was lifting the load that was caught on something inside the trailer, he was applying vertical forces to the framework cross members. The uneven weight distribution when placed under vertical stress, caused the load, when it broke free of the obstruction, to move off the tips of the forks and fall forward. The victim crawled over the framework crossbeams and was underneath the load during the lift when he was directing the forklift operator. Workers should be prohibited from working under raised loads so that they are not in the path of a falling load.

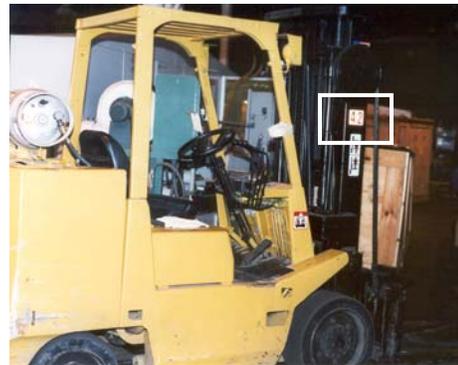
Part 21 requires formal classroom and hands-on training for the operators and must be specific to the worksite and equipment used. To assist in training the operators concerning specific forklift equipment, the company applies numbers to the equipment to alert the employee as to the weight capacity the forklift can safely lift. Figure B is another view of the forklift used in the incident. A number in the forties (in this case, 42) indicates that the forklift can be used to lift loads under 4,000 pounds.
