MIFACE INVESTIGATION: #02MI152

SUBJECT: Guardrail Post Pounder Operator Electrocuted When Hammer Boom Contacts Energized Overhead Electrical Line

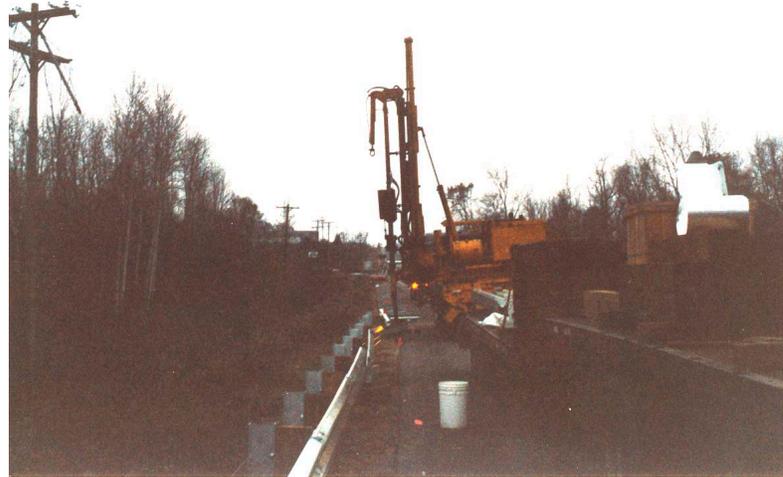
Figure 1. Guardrail Post Pounder Truck at Incident Site

The hydraulically powered guardrail post pounder was mounted on a stake truck. It had a gravity drop hammer and turntable. The boom had a working height of 22 feet. The truck was referred to as the “post pounder” (See Figure 1). The operator (victim) could remotely drive the truck while walking on the ground alongside the truck by activating control levers at the operator station. The victim had approximately 8 months experience operating the post pounder; he operated it on a daily basis when placing rails. The victim was required to wear a hard hat while operating the post pounder. He was not required to wear other personal protective equipment.

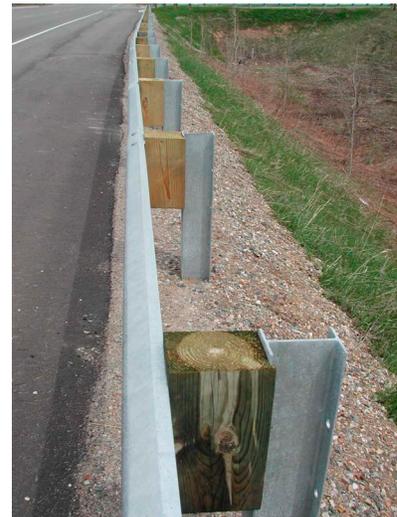
Figure 3. Installed guardrail

The job crew consisted of one foreman, one post punch operator (the victim) and 4 laborers. The crew worked 10- hour days, 5 days a week. The company was contracted to place guardrails on the east/west shoulders of a state highway as well as installation of guardrail on the south shoulder of an intersecting road. The company had been at the job site for 2-3 weeks. To construct a guardrail, the victim would position a steel H-beam approximately 6 feet in length in a vertical position into the post pounder boom below a cable operated hammer device. The victim, standing on the ground at the operator controls, would activate levers to drive the beam into the ground along the road shoulder. After setting the beam, he walked alongside the truck, moving it to the next location to set the next steel beam. Other company employees would follow him and install the guardrail onto the newly set steel beams. (See Figure 3)

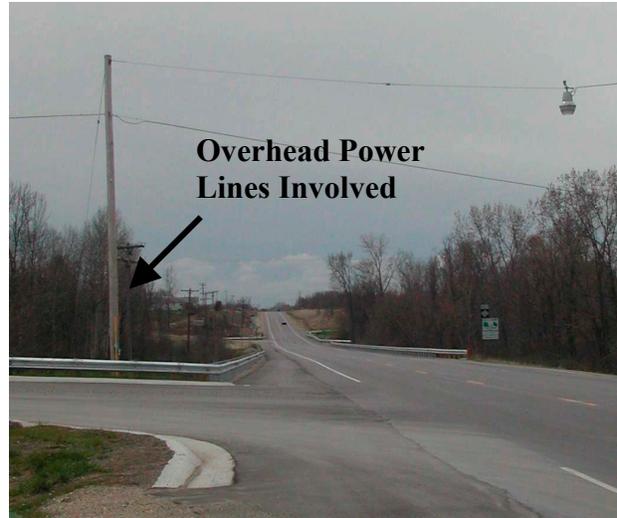
Figure 4. Incident Site, Facing South

Prior to beginning work, the company had contacted MISS DIG and all underground lines were marked. The company did not indicate to MISS DIG that overhead power lines were in the area. The electrical lines contacted were oriented in an east/west direction and traveled across the highway.

The company had completed installation of the guardrail on the west side of the highway; the section of guardrail on the west side did not extend underneath the overhead lines. (See Figure 4). The ground was icy and snow covered. It was a windy on the day of the incident, and the emergency responders noted that the overhead line was moving back and forth in the wind. The victim was setting the steel beams along the east shoulder. He had set beams approximately 150-200 feet, moving the post pounder in a southerly direction. The post pounder truck cab was facing south.

The location of the machine (directly below the power line) and the weather conditions (overcast and windy) may have interfered with the operator's perception of distance to the power line. Where applicable, a person should be designated to observe clearance of the equipment and give timely warning for operations where it is difficult for the operator to maintain desired clearances by visual means.

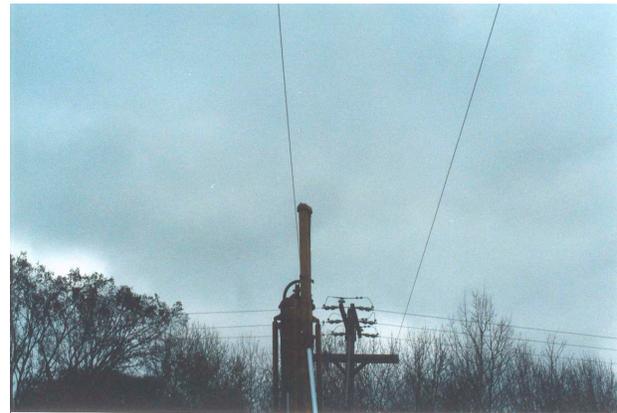
Figure 5. Extended boom and power line

The boom was extended upward when it contacted the overhead power line. It is unknown if the victim was walking alongside the post pounder or if he was setting a beam when the overhead power line contacted the boom. The boom extended approximately one foot above the wire and approximately 4-6 inches from the wire. (See Figure 5)

There were burn marks on the boom on the side toward the cab. Before the truck was moved to a safe area, the electrical company was contacted and their employees insulated the wire.

- Companies working in the vicinity of overhead power lines should verify that a minimum of 10 feet is maintained between the equipment and the power line. If a 10-foot clearance cannot be guaranteed, the employer should indicate to the MISS DIG system that they would be working with equipment that could contact these lines.

requires that an employer may not work or be closer than 10 feet to an energized electrical lines, gears or equipment if the voltage is less than or equal to 50 kv.

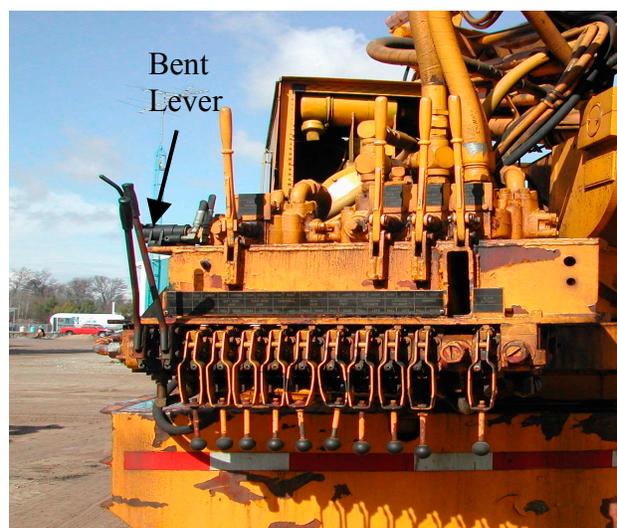
Figure 6. Bent control lever on post pounder

When the energized wire touched the raised boom, electric current arced into the post pounder. The victim was holding the left control lever with his left hand when the electrical current struck him; he acted as a path to ground. The left lever control was bent from the impact of his reaction to the electricity. (See Figure 6). He fell to the ground, landing under the truck, breaking contact with the electricity. His coworkers, working on a separate task at the time of the incident, did not witness the electrocution. They heard a “crackling” sound and looked over and saw the victim on the ground by the rear of the truck. A coworker pulled him from under the energized truck and began CPR. Another employee ran to the foreman who was approximately 1/4 mile away to get help. Emergency assistance arrived and transported him to the nearest hospital where he was dead on arrival.

- Operating controls for boomed vehicles, when designed for use from ground level, should insulate the operator from the vehicle.

Regulations concerning boomed machinery and overhead power lines provide operator protection when followed; however boomed equipment, when operated from ground level should have electrically insulated operating controls. The post pounder is used may be operated in areas both with and without an overhead electrical hazard, as was true in this incident The control levers should have an insulating material placed on them as well as the operator wearing insulating gloves when working within the vicinity of electrical power lines to provide operator protection at all times. MIOSHA Construction Safety Standard, Part 6, Personal Protective Equipment, Rule 641, Rubber protective equipment; certification; use and storage, details the requirements for insulating equipment, such as gloves, matting, blankets, covers, line hose and sleeves.
