MIFACE INVESTIGATION: #04MI066

SUBJECT: Landscaper Died When the Arms of a Skid-Steer Loader Crushed His Upper Body and Head.

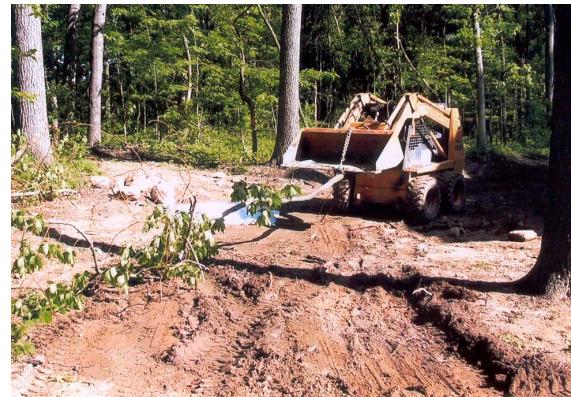
On May 27, 2004, a 27-year-old male landscape supervisor was killed when the lowering arms of a skid-steer loader crushed his head and upper body. See Figure 1. The victim and his crew were clearing the back yard and uprooting small diameter trees and tree stumps for a newly constructed house. The victim was operating a Case brand model 1845C skid-steer loader equipped with a 73-inch bucket to uproot small diameter (one to two inches) trees and tree stumps. Although this was an unwitnessed incident, the following scenario has been developed based on routine work practices as indicated by company personnel. To uproot the tree involved in this incident, he wrapped a 16-foot 3/8-inch binder chain around the base of the tree and wrapped the other end of the chain around the bucket's stabilizing bar. He placed the skid steer in reverse. As he was backing up, he raised the bucket to lift the tree roots from the ground. After removing the tree and with the bucket in the air, he raised the skid steer's safety bar and exited the cab. Standing on the ground under the raised bucket, he attempted to unwrap the chain from the tree. He was unable to remove the chain because of the tension on the chain caused by the raised bucket. He reached into the cab, lowered the safety bar, and began to operate the controls to lower the bucket. As the bucket lowered, he was unable to remove himself from beneath the raised arms of the skid steer and he was crushed between the skid-steer loader's arms and frame. A fellow worker heard a sound, turned around and saw the victim. He notified another worker, who ran to the residence where the crew was working. The homeowner called 9-1-1. His fellow workers raised the skid-steer loader arms and began CPR. Emergency response arrived and declared the victim dead at the scene.

Figure 1. Skid-steer loader at scene

- Construction employers should develop, implement, and enforce a comprehensive accident prevention program that includes, but is not limited to, training in hazard recognition and avoidance.
- Operators of skid-steer loaders should be trained in and follow the manufacturer's recommended procedures to safely operate, service, maintain, and exit the skid-steer loader.

- Employers should ensure that skid-steer loader operators follow the procedures for which they have been trained, including prohibiting them from working underneath raised lift arms if an approved lift arm support is not available.
- Company management should consider developing a joint health and safety committee.
- Employers should establish and enforce a thorough vehicle maintenance and inspection program.

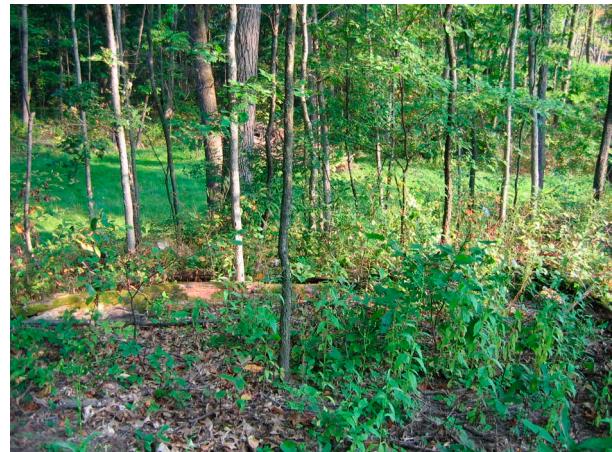
Figure 2. Wooded area behind home at time of MIFACE visit

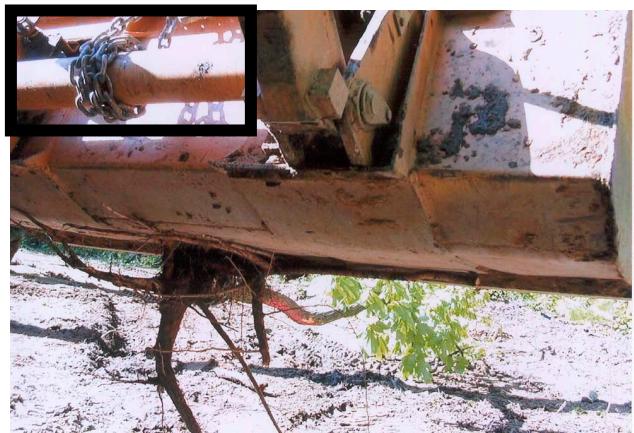
Figure 3. Chain wrapped around tree and bucket stabilizing bar

exited the cab while the skid steer was still running and the bucket still raised above the ground. He attempted to loosen the chain from the tree so he could unwrap the chain from around the tree. He was unable to remove the chain because of the tension on the chain caused by the raised bucket. While standing on the ground under the raised bucket, he reached into the cab and lowered the safety lap bar. He was positioned on the operator's right side of the cab. The operating controls for raising and lowering the bucket were located on the operator's left side of the cab. He reached into and across the cab to lower the bucket and the bucket arm came down, crushing him. His fellow workers heard a noise and turned around and saw the victim. One of the employees who was chopping trees in the vicinity of the victim notified another employee who went to the residence for help. The employee who originally saw the victim attempted to reach Emergency Response with his cell phone but was unsuccessful. The homeowner called 9-1-1. The employee who went to the home to notify the homeowner to call 9-1-1 entered the cab, lifted the safety bar and sat on the seat, lowered the safety bar and raised the bucket from the ground. This employee stated to the police that the skid steer front tires were off of the ground when he entered the cab. When he raised the bucket from the ground, the skid steer rolled back approximately two to three feet. Employees performed CPR until Emergency Response arrived. Emergency Response declared the victim dead at the scene.

A hazard analysis may have identified the potential problem of chain tension on the tree when the bucket was in a raised position. A copy of the OSHA Job Hazard Analysis publication is included with this report as Attachment A. This document may also be found and downloaded from the OSHA website: www.osha.gov/. Click on the Newsroom Publications link, and scroll down the OSHA publications until the "Job Hazard Analysis" document is found.

An approved lift arm support is required by the manufacturer to work under raised lift arms. If an employer does not have available an approved lift arm support, the employer's safety program should strictly prohibit employees from working underneath the raised lift arms of a skid-steer loader.
