MIFACE INVESTIGATION: #04MI093

SUBJECT: Farmer Died When Run Over by Tractor's Rear Wheel and Chopper

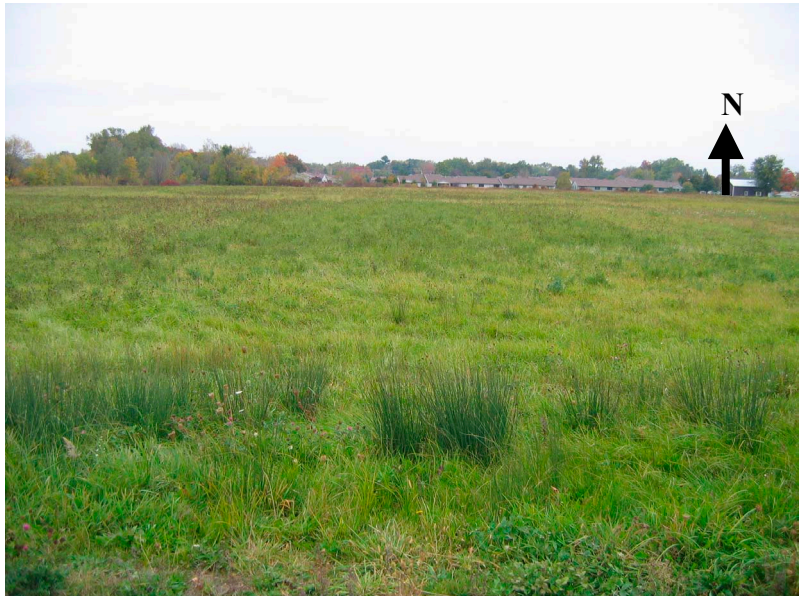
Figure 1. Rutted field where victim was cutting at time of incident.

The victim was driving a wide-front, diesel powered, 1950's model Farmall 400 tractor. He had attached both a chopper and a forage box wagon to the rear of the tractor. His family member reported the tractor was in good operating condition. The victim was cutting a 40-50 acre hay field that was flat but had fairly rutted terrain.

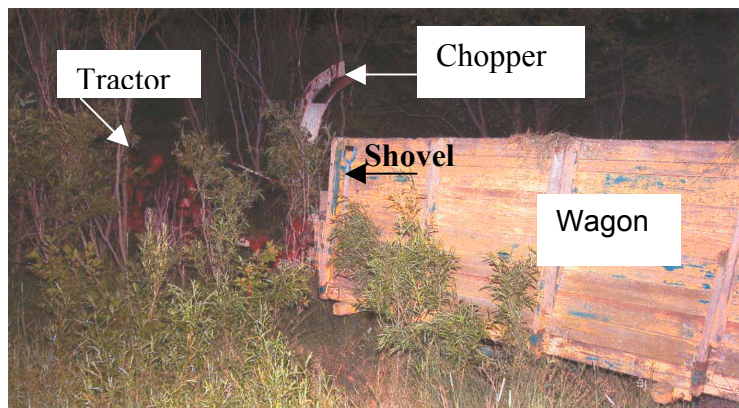
Figure 2. Tractor, chopper, trailer wagon stalled in tree line next to field

The victim had not returned home as expected so his family and friends went to look for him. They found the tractor in first gear in a tree line near the field. The tractor had stalled but the radio that was sitting on the right fender of the tractor was still operating. Because the tractor and chopper had continued to operate after the victim was run over, the family members walked along the cut hay path from the tractor location at the tree line until they found the victim. He was found lying on his back with his arms extended over his head. The rear tractor tire ran over his arm and the right side of his body sustained injury from the chopper and chopper blade. The family called 9-1-1. Emergency response personnel declared him dead at the scene. His ball cap was discovered approximately 100 feet south of where the victim was found and his cell phone was found approximately 75 feet south of the baseball cap.

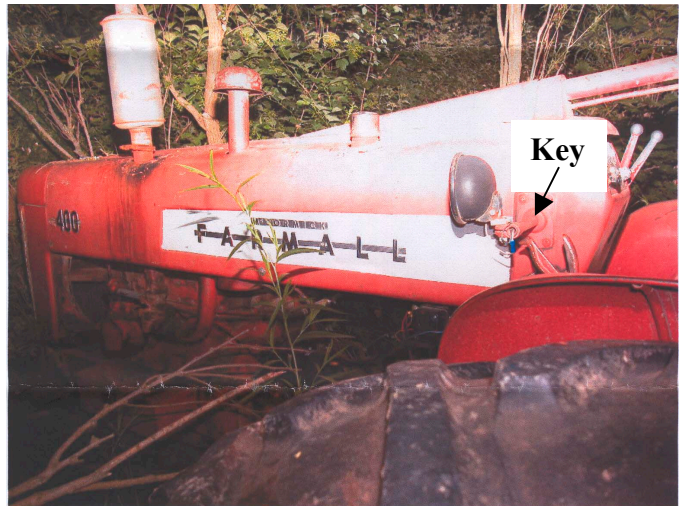
Figure 3. Farmall Tractor and key location

Scenario Six: The victim may have dismounted from the tractor to either retrieve his cell phone, ball cap, check the chopping equipment operation, or to use the shovel hanging on the wagon (See Figure 3) to redistribute the hay in the trailer wagon. It is unknown whether he dismounted with the tractor running. He did not set the parking brake. If he had turned the tractor off prior to dismounting, he may have left the tractor in gear. Prior to mounting the tractor and while standing on the ground, he may have turned the key to start the tractor. (See Figure 4) Since the tractor was in gear, it began its forward movement upon starting. He was unable to get out of the way and was run over by the tractor and chopper.
