# MIFACE INVESTIGATION REPORT: #05MI026

## SUBJECT: Tow Truck Operator Pinned Under Sport Utility Vehicle When Working Under It

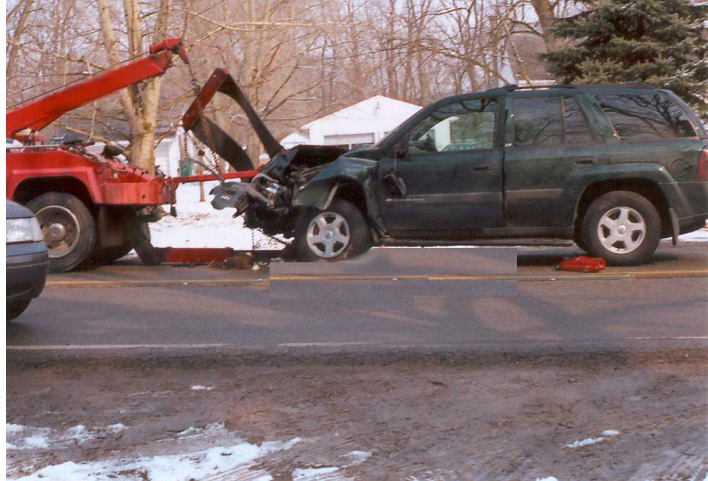
Figure 1. Position of truck and vehicle at the time of incident

- Towing and recovery industry employers should instruct and ensure employees use a secondary means of support when placing any part of their body under a raised vehicle.
- Tow truck operators should review the Automobile Association of America (AAA) Towing and Service Manual, AAA towing service bulletins, or the vehicle owner's manual prior to towing the vehicle to determine the proper towing method.

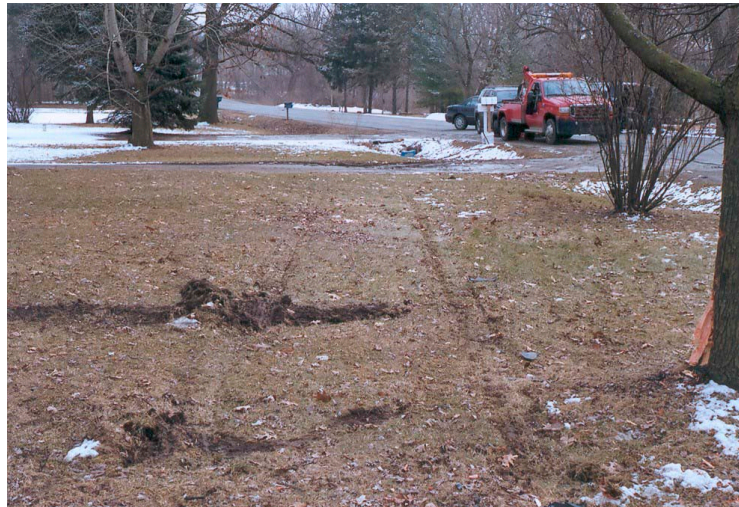
Figure 2. Position of SUV/Truck after being winched from yard

Police cars were positioned behind the tow truck and the accident vehicle to stop traffic. The decedent arrived on-scene at approximately 9:20 a.m. It was his third run of the day. The decedent removed the vehicle from the yard/tree by winching it out from the rear onto the street. The SUV was in Park when in the yard at the tree. After the decedent winched the SUV onto the street, the decedent disengaged the tow truck from the rear of the vehicle and repositioned the back of tow truck to the front of the damaged vehicle.

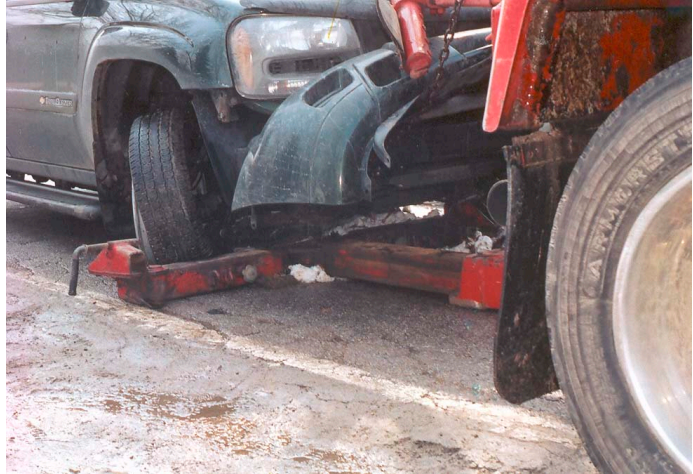
Figure 3. Position of stinger and chains during rescue. Picture taken after decedent pulled from under the vehicle.

The decedent took a floor mat from the tow truck to lie on while he was under the SUV. He did not provide a means of secondary support, such as a jack stand or set the wheel lift device under the vehicle after lifting the front of the vehicle before placing himself under the vehicle. Placing his waist and upper torso just behind the driver's side front axle, and using a screwdriver from his truck, it appears he attempted to release the transmission linkage. The decedent was presumably attempting to either free the transmission or the transfer case. As the decedent attempted to free the transmission or transfer case, the SUV lurched forward and fell onto

- Towing and recovery industry employers should instruct and ensure employees use a secondary means of support when placing any part of heir body under a raised vehicle.

Part 1, General Provisions, Rule 34, of the General Industry Safety Standards states: “An employee shall not place his/her body beneath equipment, such as vehicles, machines, or materials, supported only by a jack, overhead hoist, chain fall, or any other temporary single supporting means, unless safety stands, blocks or other support system capable of supporting the total imposed weight is used to protect the employee in case of failure of the supporting system.” The decedent relied upon the tow chains to hold the vehicle in position when he placed his torso under the vehicle to “pop” the transmission. When the chains failed to secure the vehicle in a raised position, there was not a secondary means to prevent the vehicle from falling onto him. It is important to note that when a secondary means of support is used on a vehicle, it must be placed under factory-approved points on the vehicle, as per the vehicle’s instruction manual. Secondary supports such as safety stands or jack stands should always be used in pairs. When raising the front or rear of a vehicle the stands should not be placed so that the vehicle tilts up only on one corner.
