## MIFACE INVESTIGATION: #05MI066

### SUBJECT: Quality Control Operator Dies After Falling Into Cherry Processing Brine Tank.

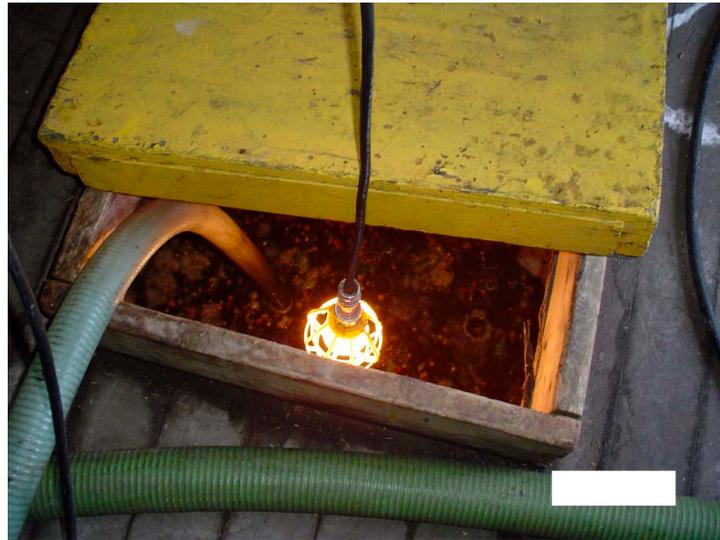
Figure 1 Brine recirculation hose in cherry tank filled with brine and cherries

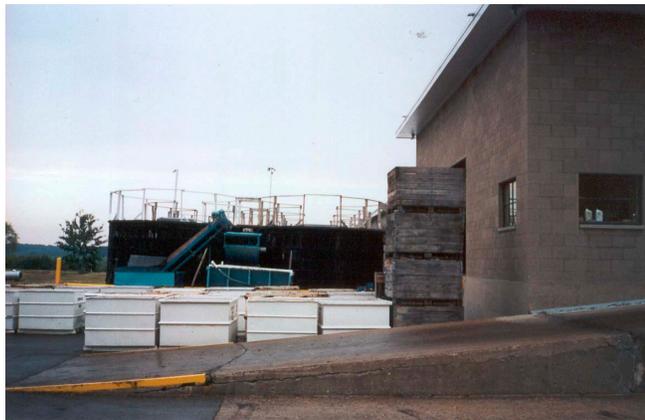
Figure 2. Loading station at primary tank room on day of incident

Cherries arrived at the facility in cherry tanks filled with water and were unloaded and carried from the transport trucks via a forklift to a loading station. The cherries, after being transported by forklift to the loading station, were dumped into a dewatering tank. One or more operators skimmed the top of the dewatering tank for harvest debris, and then the cherries were pumped onto an elevator/conveyor. Operator(s) at the elevator/conveyor inspect the cherries and remove cherries from further processing as needed. The elevator moved the cherries to a free-fall into a brine-receiving tank. As the cherries free-fall, a fan further dewateres them. A worker at the brine-receiving tank skimmed the top of the tank and pushed the cherries toward the pump opening. The cherries are then pumped with the brine into a tank in a tank room via a 4-inch hose. See Figure 2 and Figure 3.

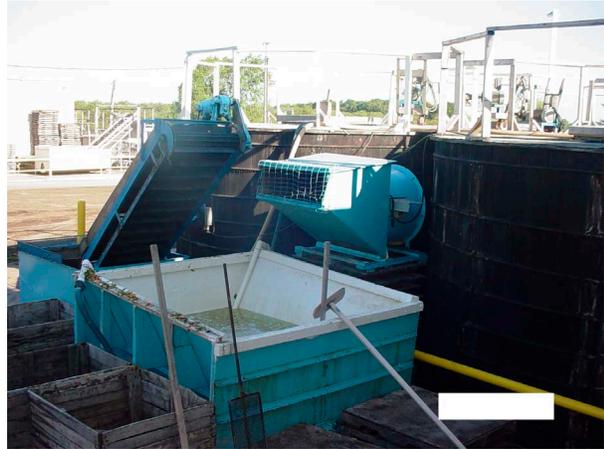
Figure 3. Loading station for primary tank room and location of deceased when supervising crew

The deceased supervised loading station employees from the deck of sunken tanks outside of the primary tank room. Additionally, her job as primary tank room supervisor entailed monitoring the filling of the primary tank tanks, adding or subtracting hoses as needed, and moving hoses to the next tank when one became full. She ascended a couple of stairs to enter the primary tank room.

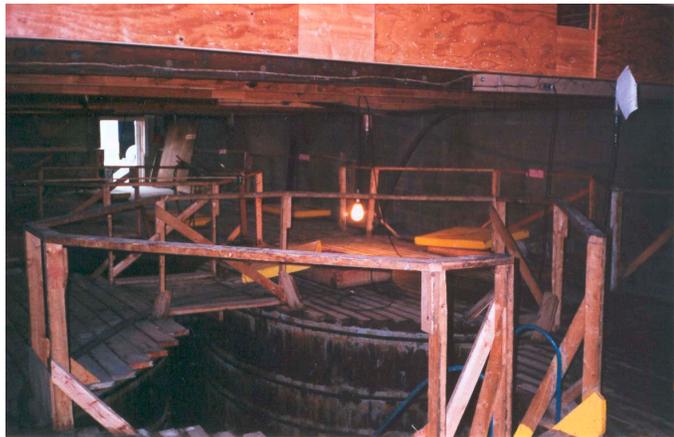
Figure 4. Inside of tank storage room-wood decking on and between tanks

**Storage Room.** The primary tank room the deceased was responsible for was approximately 37 feet wide by 120 feet long by 18 feet tall (See Diagram 1). The windows and doors were open on the day of the incident. The storage room had 14 brine holding tanks that were approximately 10 feet tall and 15 feet in diameter. The primary tank room was lit by natural light and portable non-commercial utility lights that were suspended by nails from the building trusses. (See Figure 4)

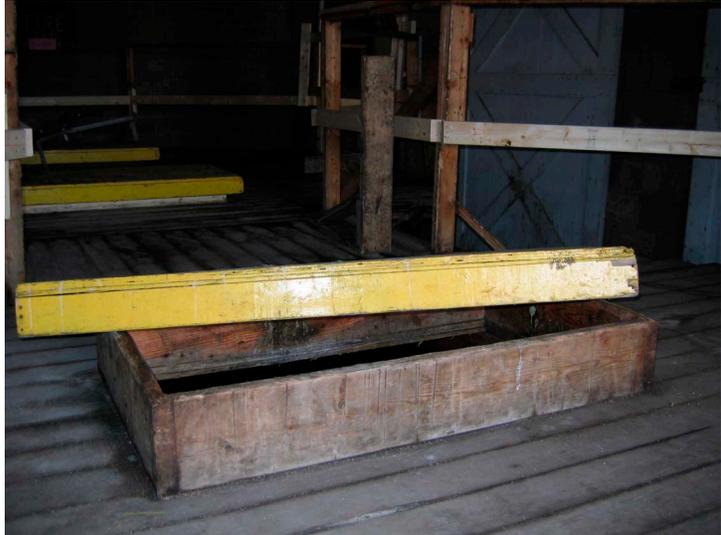
**Cherry/Brine Tanks.** Tank capacity was 65,000 pounds of cherries. The tanks had no internal safety escape mechanism, such as a ladder. Each tank was covered with wood decking that provided walking and equipment access on and between tanks (See Figure 4). Each tank had two openings that were approximately 49 1/2 inches by 28 inches. (See

Figures 5 & 6) One opening would contain incoming cherries from the loading station and one brine recirculation hose. A second brine recirculation hose was placed in the other tank opening. Each of the openings had a 6-inch wood lip that provided the frame to support a heavy cover. The cover was approximately 55 inches long by 33 inches wide and constructed of a 3/4-inch piece of plywood attached to 2-inch by 4-inch pieces of wood. The openings allowed the operator to observe the contents of the holding tank. (See Figure 5)

Figure 5. Example of tank opening and wood cover

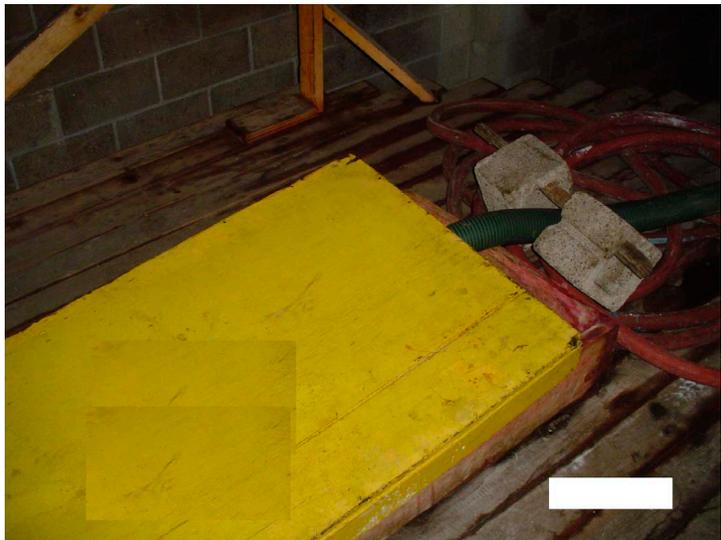
**Storage tank filling process.** To fill the brine tank with fruit, workers removed the tank opening cover and placed the 4-inch fruit supply hose into the inlet opening. A dumbbell was used to hold the hose in position. A 2-inch brine recirculation hose was also positioned in the same opening before the cover was replaced. (See Figure 6)

Figure 6. Cherry/brine supply hose held in position by dumbbell

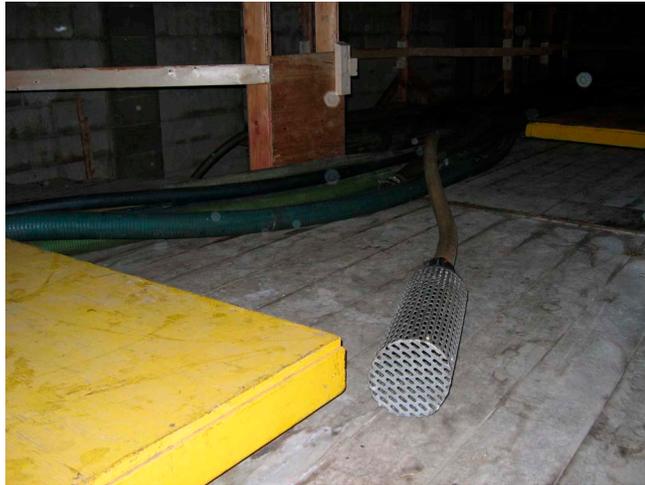
stipulated that two people move both fruit-supply and brine recirculating hoses and carts on the decking. The brine recirculating hoses siphoned off the excess brine from the holding tank and prevented a brine overflow condition in the cherry tank. The brine was returned to the loading station brine-receiving tank. Each brine recirculating hose had quick connect couplings and a metal screen to prevent the cherries from returning to the loading station. (See Figure 7)

Figure 7. Brine recirculation hose with metal screen

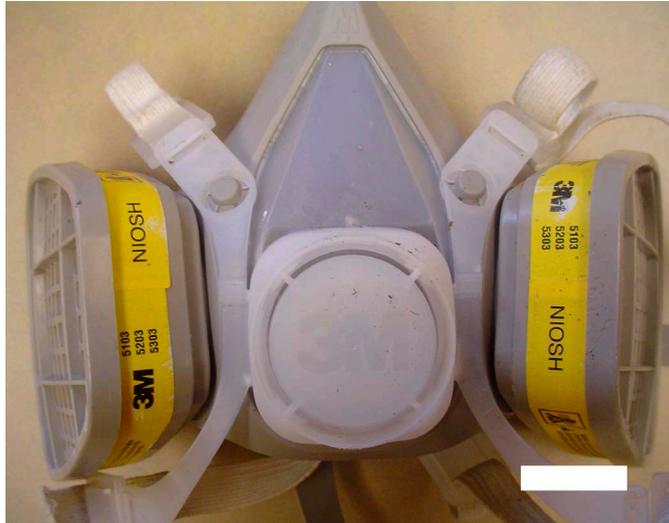
It took two attempts by her coworkers to pull her out of the brine tank. The first attempt was unsuccessful because the coworker who was trying to remove her needed to lift his head out from below the level of the decking to get a breath of fresh air. The coworker tried again and was able to lift her out with the help of another coworker. They laid her on her side on the decking. Her glasses were not on her face. If she was wearing her respirator, it could have been dislodged from her face from the impact of a “head-first entry” into the tank. (See Figure 8)

Figure 8. Respirator deceased had around her neck when found

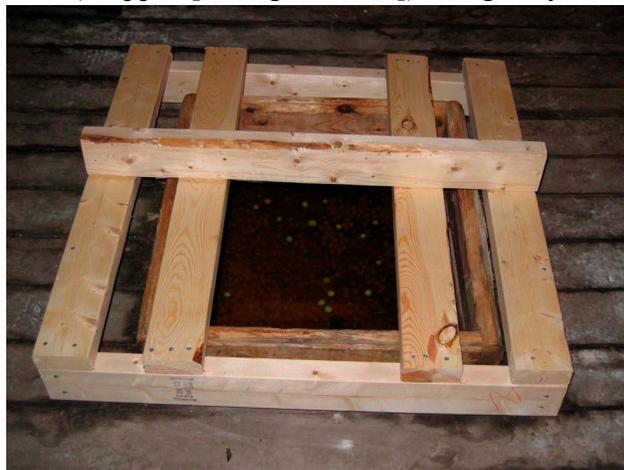
Figure 9. Portable tank opening guard

After the incident, the employer developed a portable tank opening guard that allowed a sightline into the tank to place the hoses into the holding tank and to monitor cherry/brine levels. The hose openings were small enough to prevent an employee from falling into the tank. (See Figure 9)

The company made a good first step to permit operators to perform their required work activities (hose placement and tank cherry/brine monitoring) and prevent the operator from falling into the tank. Engineering controls to minimize SO<sub>2</sub> should be implemented while the holding tank is being filled with cherries and brine, as well as at other times where SO<sub>2</sub> levels could exceed permissible exposure levels. MIFACE recommends that the company explore options to design the guard with a material that can allow proper SO<sub>2</sub> ventilation, allow operators to see through to monitor cherry/brine levels, and not pose a further injury hazard if the employee falls onto it.
