# MIFACE INVESTIGATION #05MI163

## SUBJECT: Construction Laborer Dies After Falling from Ladder

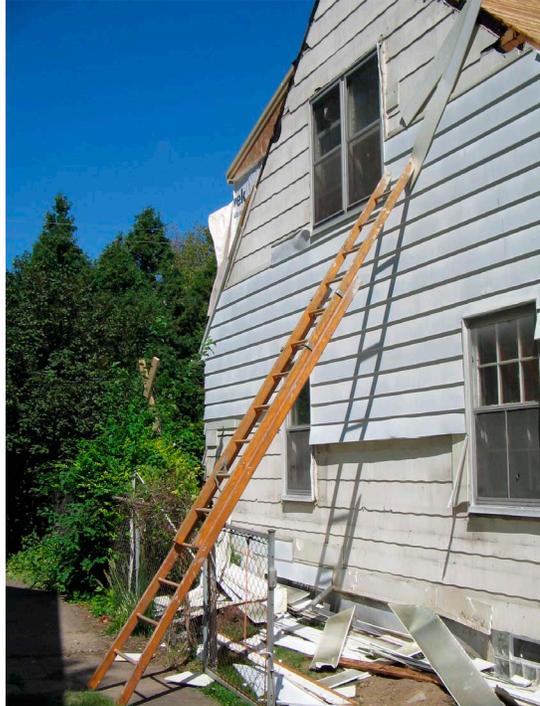
Figure 1. Siding being removed, ladder propped against fence

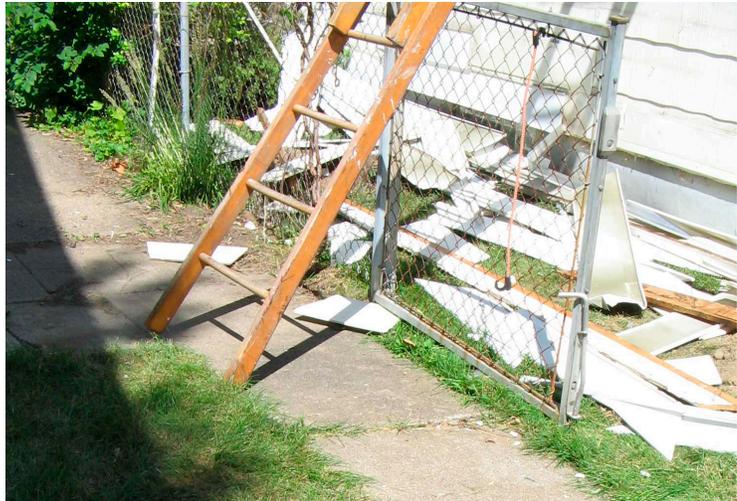
Figure 2. Ladder without safety feet on driveway against fence/gate

The ladder the decedent was working from was positioned over a cyclone gate and fence of a neighboring home. The ladder was resting on the one of the two concrete driveway tire tracks. The ladder was not secured or blocked in any way to increase ladder stability and did not have safety feet (Figure 2). A flexible "bungee cord" was hanging from the gate; the reason for its presence is unknown.

2. The ladder used did not have safety feet nor was the ladder secured. Safety feet and securing a ladder provides stability by minimizing ladder movement. A ladder should always have four-point contact with the working surface, and pressure on each leg should be proportional. The force exerted by the decedent as he was removing the siding may have put a side load on the ladder.

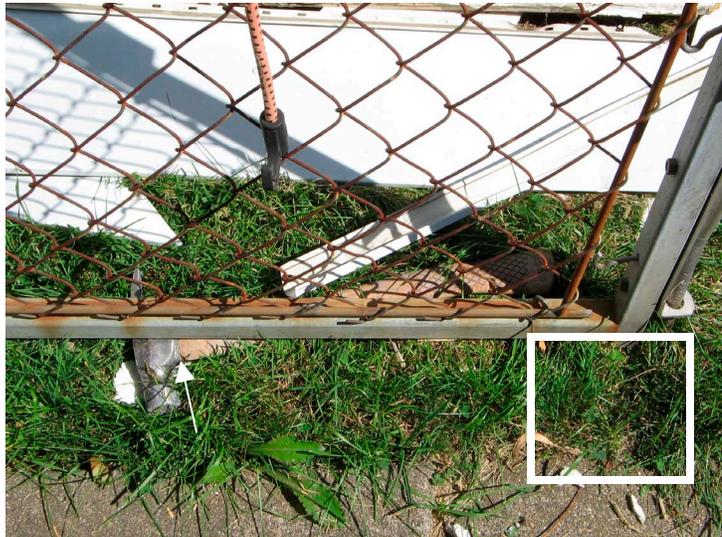
It is unknown how high on the ladder the decedent was standing. He was 6'1" tall, so it is hypothesized that he was not standing on the top three rungs of the ladder to reach above to strip the siding. The police detective stated that the hammer (Figure 3, arrow) was used by the decedent to assist him in removing the siding. The box in Figure 3 shows a divet in the ground caused by either the gate movement from the fall or the decedent/coworker "bracing" the gate by moving it toward the home they were working on.

Figure 3. Hammer used to remove siding

3. It appears that the gate was being used to help support the ladder. The moveable gate was not secured against movement. The box in Figure 3 highlights a divet that the gatepost made in the grass. It is unknown whether the divet was due to gate movement at the time of the incident or whether the workers pulled the gate toward the home being remodeled prior to the incident in an attempt to "dig" the gate into the ground to minimize gate movement. When positioning ladders, it is important to ensure that all of the supporting structures are stable and strong enough to hold the weight that will be placed on them. Under no circumstances should ladders be supported by structures that may inadvertently cause movement of the ladder.

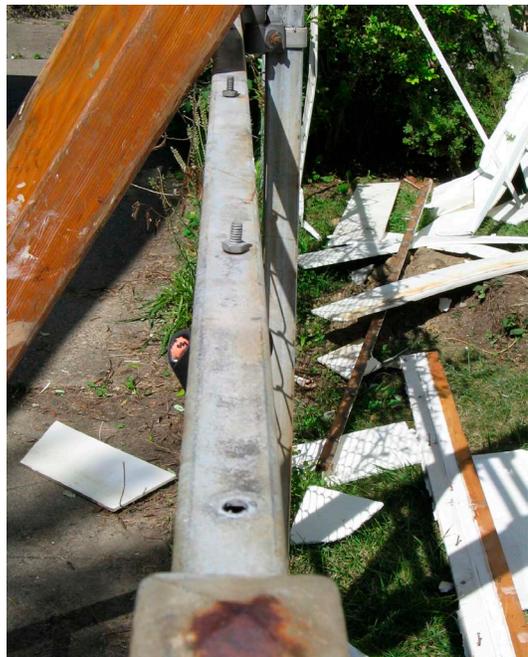
Figure 4. Gate configuration

touching the ground. His midsection was lying across the end cap of the gate, which was about two inches higher than the gate's top bar and across a small nut and bolt, which was about one inch above the top bar (Figure 4). The decedent rolled off the gate and landed on the ground.
