MIFACE INVESTIGATION REPORT: #06MI174

Subject: Hispanic Laborer Dies as a Result of a Trench Collapse

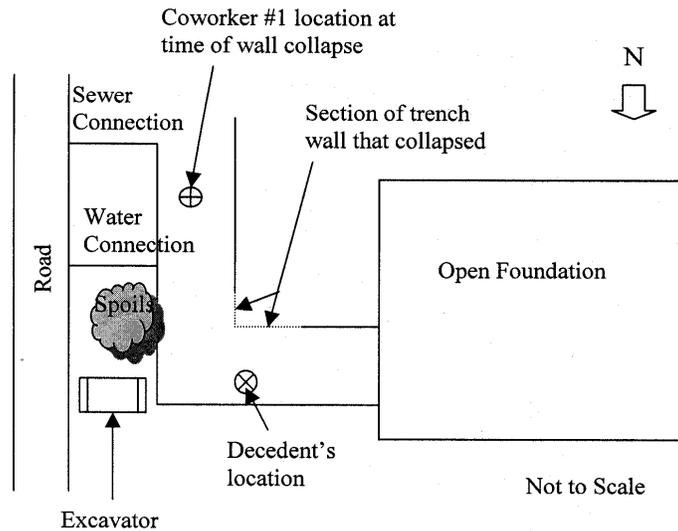
under the footing near the basement while his coworker was laying pipe near the street. There were no trench boxes. The decedent's coworker heard the south corner of the wall collapse and ran to the decedent's location (Diagram A and Figures 1 and 2). He found him under a large chunk of dirt that collapsed from the south corner. The heavy equipment operator told the coworker to call the company. He did so, and the company representative instructed him to call 911. He called 911. Prior to emergency response arrival, a nearby landscape worker heard a call for help and entered the trench with the decedent's coworker to move the dirt chunk from the decedent. The excavator was close enough that the heavy equipment operator used the bucket to dig around the decedent. Emergency response arrived. While attempting rescue, the south wall collapsed again. The decedent was declared dead at the scene.

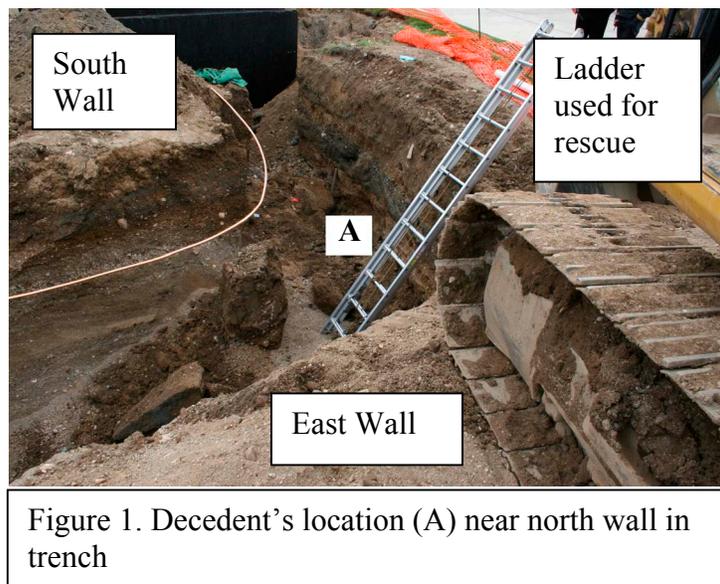
Figure 1. Decedent's location (A) near north wall in trench

The crew foreman dug a nearly vertical, “L”-shaped excavation that was 50 feet long, 9 feet deep, 7 feet wide on top and 6 feet 6 inches wide at the bottom (Diagram A). The soil was sandy material with clay layer top (mixture of a medium clay and runny sand/loam mix). The first 18 inches to 2 feet were composed of clay. The company president indicated that there was a ladder in the trench, but it was not within 25 feet of the

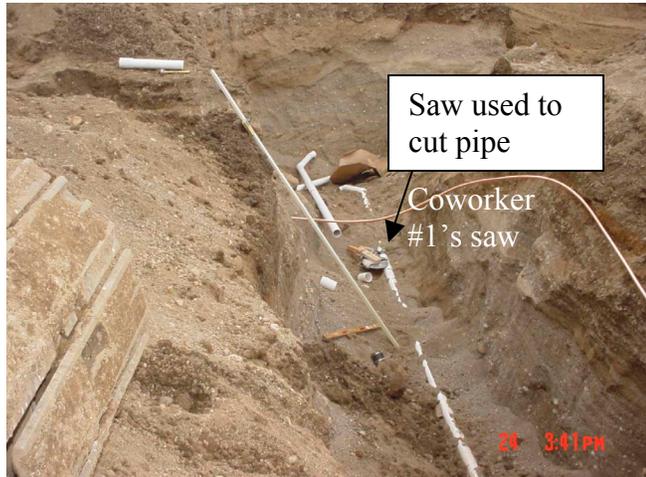
Figure 2. Location of Coworker #1 in trench cutting pipe when trench wall collapse occurred

A large amount of dirt at the southeast corner wall of the trench collapsed. The foreman looked back toward the foundation. The decedent was not where he had last seen him. The foreman jumped down from the excavator and entered the trench with Coworker #1. They could see some of the decedent's hair sticking up out of the soil. The two men began digging by hand in an attempt to rescue him. They were unable to move the chunks of clay, which were estimated to weigh 300 pounds, from around the decedent. They uncovered the decedent's head and one of his hands. Coworker #1 indicated in the police report that the decedent showed no signs of life and was bleeding from his mouth and ear.

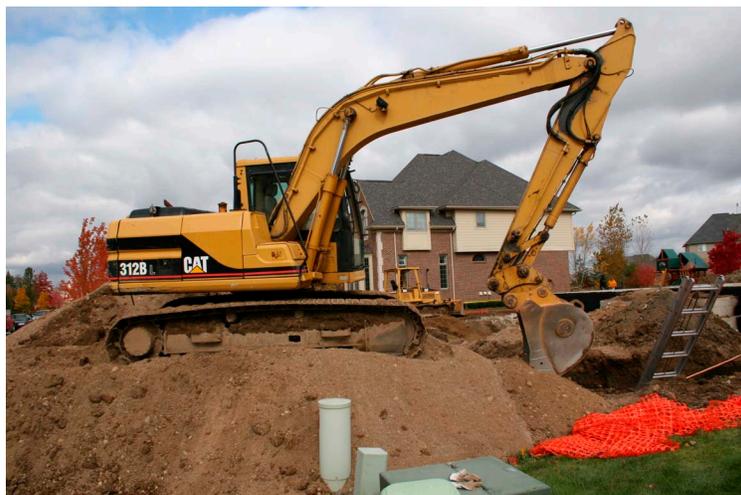
- Rule 933(2): Spoil piles were stored at the edge of an excavation while employees were performing work inside. A Model #312 Caterpillar was stored at the edge of an excavation while an employee was performing work inside.
- Rule 933(5): No ladder was provided within 25 feet of an employee working inside of a near vertical trench 9 feet in depth. The standard requires that an excavation 48 or more inches in depth and occupied by an employee shall be provided with either a ladder extending not less than 3 feet above the top as a means of access or with a ramp meeting the requirements of subrule (6). Lateral travel along the wall of a trench to a ladder or other means of egress shall not exceed 25 feet.
- Rule 941(1): The sides of the excavation were not cut to the proper angle of repose – no shoring or trench box was being used.

Figure 3. Position of excavator and spoils

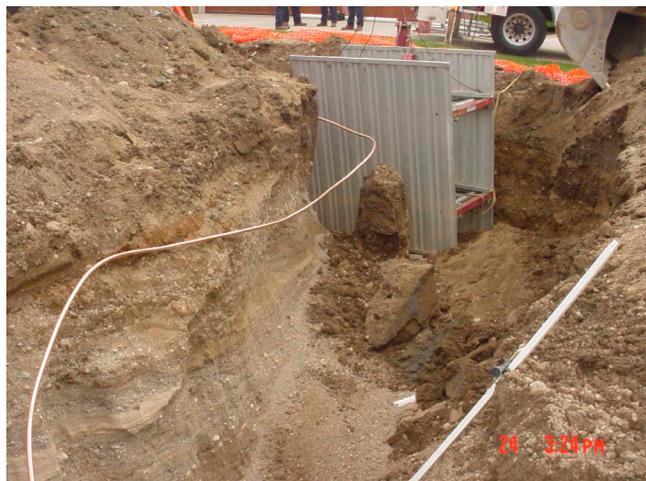
Figure 4. Position of trench box in trench during rescue operation

operations. Two fire fighters entered the trench box, secured the decedent to a long board, and the decedent was lifted from the trench.

The Fire Department's Incident Commander instructed the fire fighter to enter the trench to assess the decedent's status without providing trench wall stabilization/shoring, placing the fire fighter at risk of becoming a victim. The police report stated that due to the risk of trench wall collapse, the police department officer taking pictures of the incident site did not go down into the trench; the fire department took several of the pictures. The MIOSHA file indicated that while attempting rescue, the south wall collapsed again, indicating that the trench wall may have been unstable at the time of the fire fighter's initial entry.

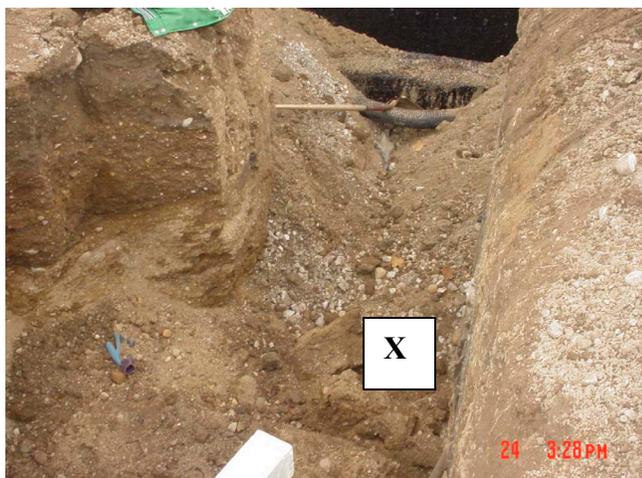
The foreman and company safety officer did not adhere to the written company policy concerning trenching. Per the company handbook, the foreman and safety officer did not ensure that spoil was at least two feet back from the lip of the trench, that employees working in the excavation were within a protective system, and that the trench, which was over five feet, was cut to the angle of repose, sheeted or shored. Additionally, the employees working in the trench did not have a ladder or a ramp within 25 feet from their work area.

Figure 5. Location of decedent (X) in trench

R408.40942 of Part 9 details what must be evaluated during an excavation to protect workers inside the excavation. The selection of preventative measures is based on this evaluation. Methods such as angle of repose, sloping and benching, tight sheeting/sheet piling or trench boxes and shields may be used to protect personnel in the excavation. If either adequate sloping or shoring had been used in this incident, the fatality may have been prevented.
