# MIFACE INVESTIGATION REPORT: #06MI204

## SUBJECT: Security Guard Died as a Result of Carbon Monoxide Poisoning

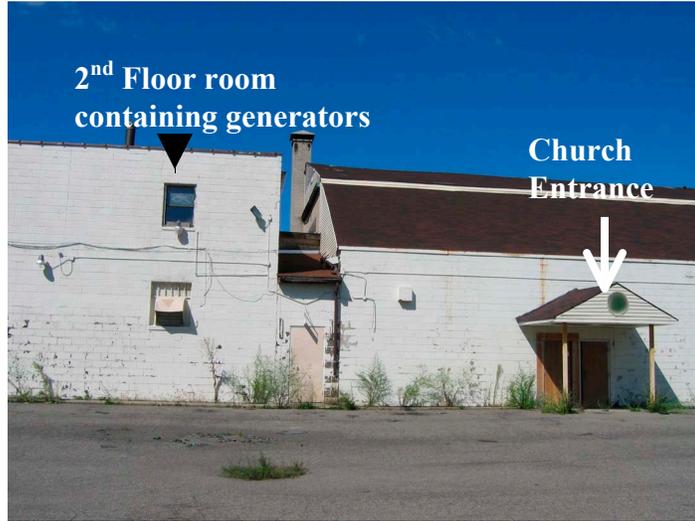
Figure 1. Incident scene showing outside of building

The church building had two distinct areas. The vestibule and sanctuary were located on the first floor. The meeting rooms were located on the second floor and could be accessed via a stairway near the vestibule or by using a door located on the outside of the two-floor attached building (Figure 1). The generators were placed in an upstairs classroom/meeting room. The room dimensions where the generators were located is unknown. This room had one window that was kept locked. The wattage of the generators is unknown. Also unknown is the frequency of use of the generators and how long a time period the generators had been running prior to the incident.
