MIFACE INVESTIGATION REPORT: #07MI072

Subject: Laborer Killed After Being Run Over by the Tractor and Mower He was Operating

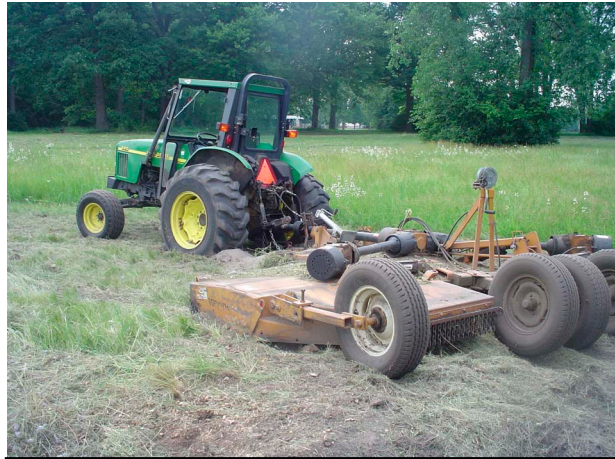
On June 13, 2007, a 45-year-old male laborer was killed when he was run over by both the John Deere 5410 riding tractor and a Woods 3180, 15-foot wide brush hog type mower he was operating (Figure 1). The decedent was driving the tractor/mower in a circular motion to cut two- to three-foot high grass in a park. The ground was uneven, with a rut depth ranging from one inch to a maximum of six inches. The decedent either exited the tractor or fell from the tractor seat and was run over by both the tractor and the mower deck. Another employee entered the park at 1:30 p.m. looking for the decedent and

Figure 1. Tractor and mower involved in the incident

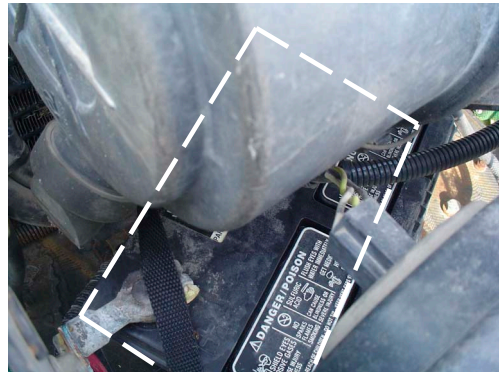
Figure 2. Sideways movement of battery

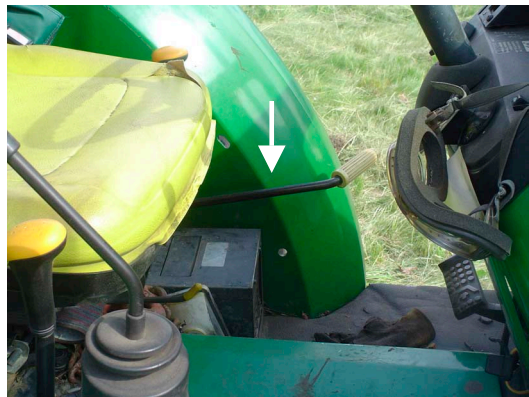
Figure 3. PTO lever engaged for mower blades to turn

A coworker entered the park at approximately 1:30 p.m. and looked for the decedent. The coworker found the decedent's tractor running, the tires were spinning, and the power take off (PTO) for the bat wing engaged for the mower's cutter blades to turn (Figure 3). Not seeing the decedent in the cab or nearby, his coworker looked for him. He found him lying face down on the ground approximately 10 to 15 feet from the tractor. The decedent was not wearing goggles or earplugs as required by city policy. The coworker called 911, and then called the maintenance yard to which they were assigned.

It is unknown if the victim attempted to dismount while the tractor and PTO were running. A safe work practice is to shut off the tractor and PTO before dismounting. General shutdown procedures for a tractor are: disengage the PTO, lower equipment attachments to the ground, place the transmission into neutral or park, set the brakes, allow the engine to cool at a fast idle, turn off the engine and remove the key. The operator's seat of farm tractors and other machines provides a workstation from which the operator can maintain proper control of the machine. Proper control is necessary not only during operation of a tractor or machine, but also whenever an engine is started. While seated in the operator's seat, an operator should check the engine throttle position, disengage the clutch and shift the transmission into neutral or park before the engine is started. Setting the brakes will prevent the tractor from rolling before the operator engages the transmission. Before starting a tractor engine, the operator should also ensure the power take off is disengaged.

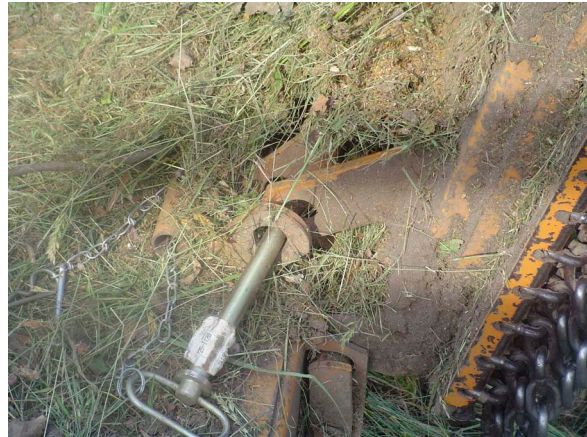
While at the incident scene, the MIOSHA compliance officer found that one of the locking pins, used to lock a side of the mower wing in a raised position, was bent and could not be used (Figure 4).

Figure 4. Bent mower locking pin

- Employers should maintain equipment in proper working condition in accordance with the manufacturer's guidelines and document such maintenance.

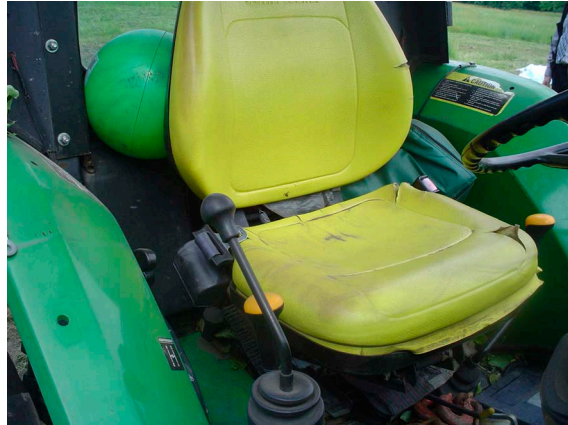
If the decedent was on the tractor seat and fell from the seat, he obviously was not wearing the tractor's seat belt. The responding police indicated that the employee was thrown from the tractor cab and was run over.

Figure 5. Seatbelt available on the tractor

safety restraint system (Figure 5). Employers should require, regardless of on-road or off-road use, that employees use the safety restraint system supplied by the equipment manufacturer at all times while operating the equipment. Employers should ensure such restraints are in place and in good working condition.

- Employers should establish a seat belt or seatbelt/shoulder harness restraint policy (when equipment is so equipped), include the seat belt requirement in their safety manual and safety training programs, and enforce its use.
